Profile/Photo Observation Report

Street:	S HOBART RD	Flow Control:	Not Controlled
City:	Hobart, IN	Year Renewed:	
Location:	Light Highway	Tape/Media #:	
Purpose:	Maintenance Related	Dia/Height:	12"
Use:	Sanitary	Material:	PVC
Drain Area:	NA	Lining:	Cured in Place
Category:	NA		
Comment:	Flow direction wrong.

Location Details:		Direction of Survey:	Upstream
US MH:	M-808-031	DS MH:	M-808-030
		Total Length Surveyed (ft):	194.2

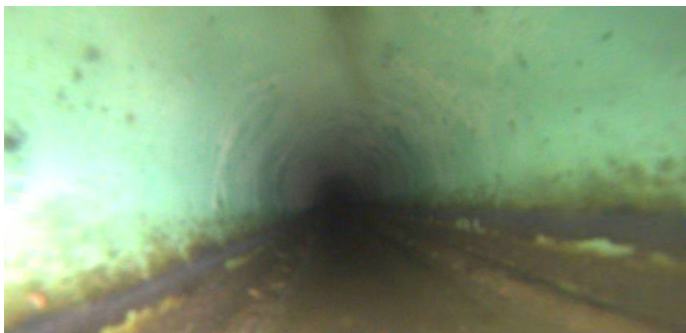
Code: **AMH**
Description: **Manhole**

Distance (ft): **.0**
Structural Grade: **0**
O&M Grade: **0**
Clock Start/From:
Clock To:
1st Value:
2nd Value:
Value Percent:
Continuous Index:
Within 8" of Joint: **NO**
Remarks: **M-808-030**

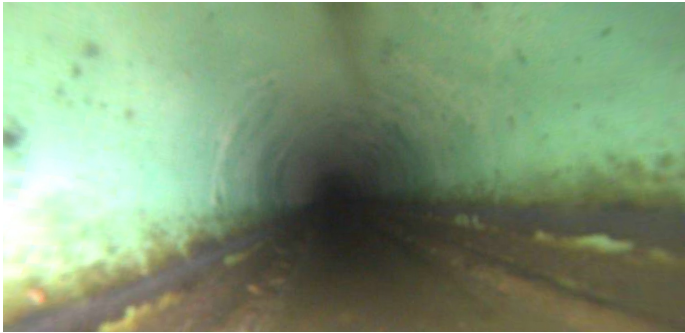
Code:	MWL
Description:	Water Level

Distance (ft):	.0
Structural Grade:	0
O&M Grade:	0
Clock Start/From:	
Clock To:	
1st Value:	
2nd Value:	
Value Percent:	10.000
Continuous Index:	
Within 8" of Joint:	NO
Remarks:

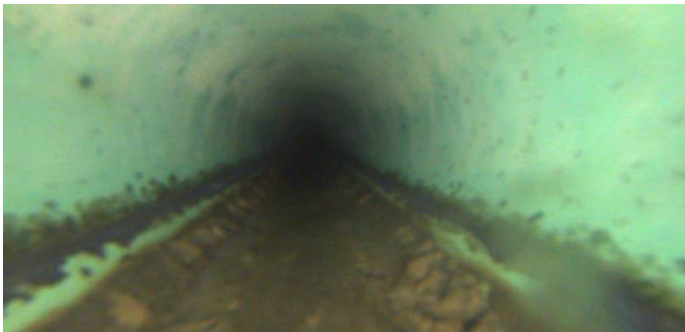
Code:	DAGS
Description:	Deposits Attached Grease

Distance (ft):	8.5
Structural Grade:	0
O&M Grade:	2
Clock Start/From:	4
Clock To:	8
1st Value:	
2nd Value:	
Value Percent:	5.000
Continuous Index:	S01
Within 8" of Joint:	NO
Remarks:

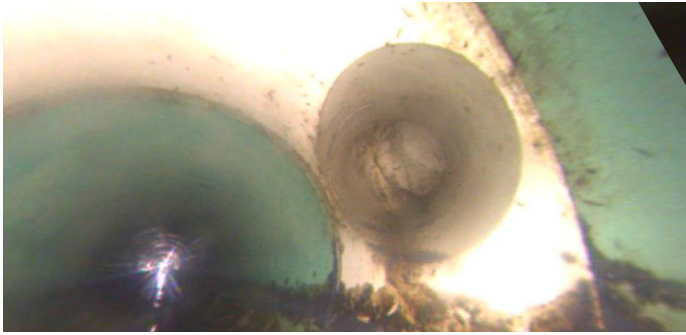
Code: **TF**
Description: **Tap Factory**

Distance (ft): **28.9**
Structural Grade: **0**
O&M Grade: **0**
Clock Start/From: **10**
Clock To:
1st Value: **4.000**
2nd Value:
Value Percent:
Continuous Index:
Within 8" of Joint:
Remarks:

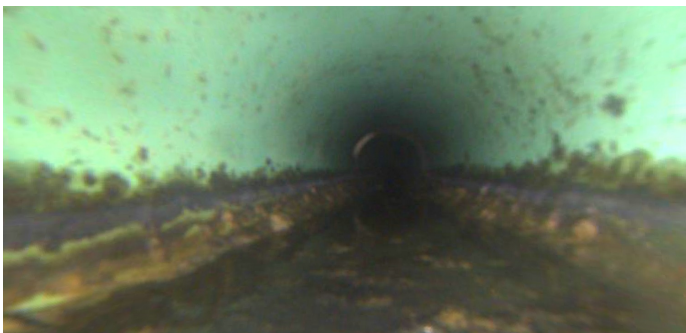
Code: **MSA**
Description: **Abandoned Survey**

Distance (ft): **194.2**
Structural Grade: **0**
O&M Grade: **0**
Clock Start/From:
Clock To:
1st Value:
2nd Value:
Value Percent:
Continuous Index:
Within 8" of Joint: **NO**
Remarks: **DEBRIS UNDER WATER**

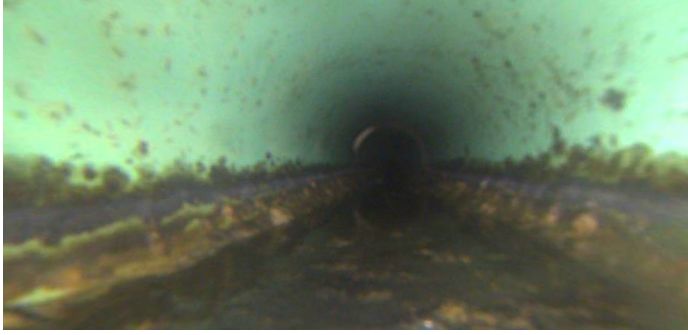
Code:	DAGS
Description:	Deposits Attached Grease
Distance (ft):	194.2
Structural Grade:	0
O&M Grade:	2
Clock Start/From:	4
Clock To:	8
1st Value:	
2nd Value:	
Value Percent:	5.000
Continuous Index:	F01
Within 8" of Joint:	NO
Remarks:
