Profile/Photo Observation Report

Street:	Hobart	Flow Control:	Not Controlled
City:	Hobart, IN	Year Renewed:	
Location:	Light Highway	Tape/Media #:	
Purpose:	Maintenance Related	Dia/Height:	12"
Use:	Sanitary	Material:	PVC
Drain Area:	NA	Lining:	Cured in Place
Category:	NA		
Comment:	Flow direction wrong.

Location Details:		Direction of Survey:	Upstream
US MH:	M-808-031	DS MH:	M-808-030
		Total Length Surveyed (ft):	194.2

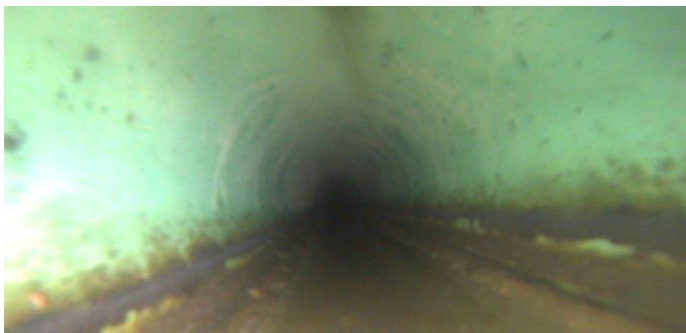
Code: **AMH**
Description: **Manhole**

Distance (ft): **.0**
Structural Grade: **0**
O&M Grade: **0**
Clock Start/From:
Clock To:
1st Value:
2nd Value:
Value Percent:
Continuous Index:
Within 8" of Joint: **NO**
Remarks: **M-808-030**

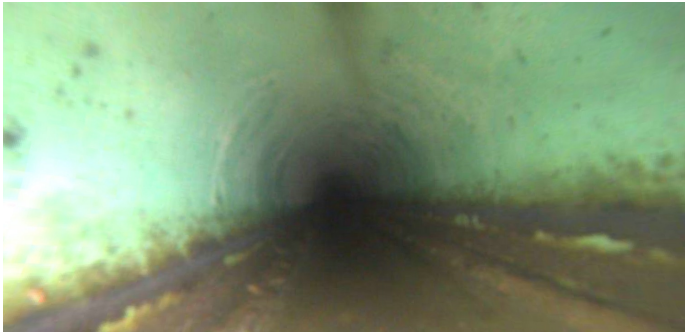
Code:	MWL
Description:	Water Level

Distance (ft):	.0
Structural Grade:	0
O&M Grade:	0
Clock Start/From:	
Clock To:	
1st Value:	
2nd Value:	
Value Percent:	10.000
Continuous Index:	
Within 8" of Joint:	NO
Remarks:

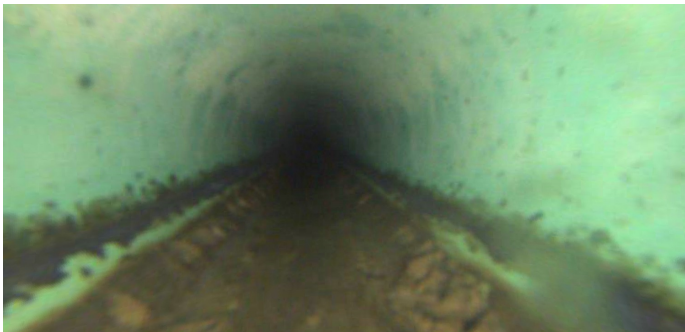
Code:	DAGS
Description:	Deposits Attached Grease

Distance (ft):	8.5
Structural Grade:	0
O&M Grade:	2
Clock Start/From:	4
Clock To:	8
1st Value:	
2nd Value:	
Value Percent:	5.000
Continuous Index:	S01
Within 8" of Joint:	NO
Remarks:

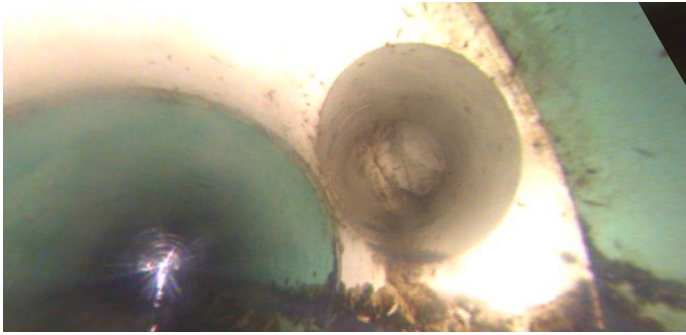
Code: **TF**
Description: **Tap Factory**

Distance (ft): **28.9**
Structural Grade: **0**
O&M Grade: **0**
Clock Start/From: **10**
Clock To:
1st Value: **4.000**
2nd Value:
Value Percent:
Continuous Index:
Within 8" of Joint:
Remarks:

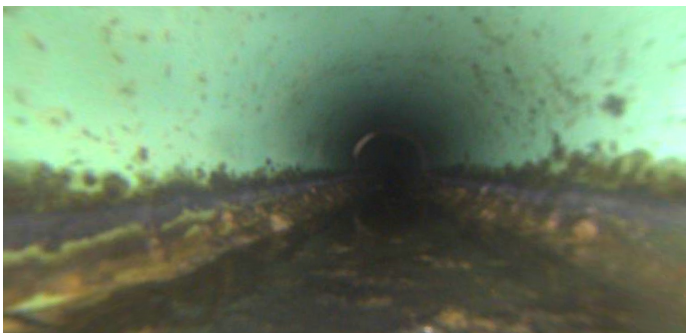
Code: **MSA**
Description: **Abandoned Survey**

Distance (ft): **194.2**
Structural Grade: **0**
O&M Grade: **0**
Clock Start/From:
Clock To:
1st Value:
2nd Value:
Value Percent:
Continuous Index:
Within 8" of Joint: **NO**
Remarks: **DEBRIS UNDER WATER**

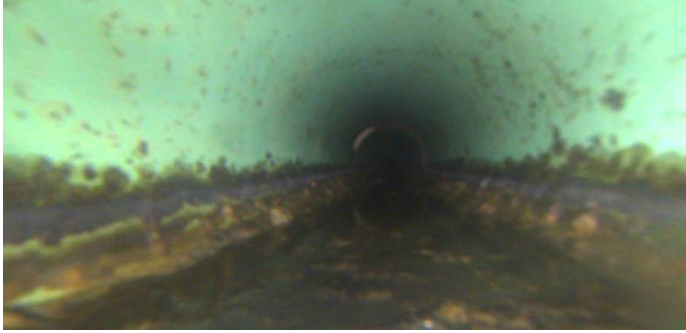
Code:	DAGS
Description:	Deposits Attached Grease
Distance (ft):	194.2
Structural Grade:	0
O&M Grade:	2
Clock Start/From:	4
Clock To:	8
1st Value:	
2nd Value:	
Value Percent:	5.000
Continuous Index:	F01
Within 8" of Joint:	NO
Remarks:
