Profile/Photo Observation Report

Street:	Hobart Rd.	Flow Control:	Not Controlled
City:	Hobart, IN	Year Renewed:	
Location:	Light Highway	Tape/Media #:	
Purpose:	Routine Assessment	Dia/Height:	12"
Use:	Sanitary	Material:	PVC
Drain Area:	NA	Lining:	
Category:	NA		
Comment:

Location Details:		Direction of Survey:	Downstream
US MH:	M-808-031	DS MH:	M-808-030
		Total Length Surveyed (ft):	182.1

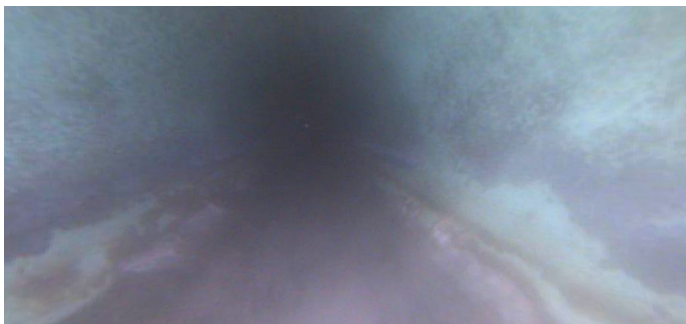
Code: **AMH**
Description: **Manhole**

Distance (ft): **.0**
Structural Grade: **0**
O&M Grade: **0**
Clock Start/From:
Clock To:
1st Value:
2nd Value:
Value Percent:
Continuous Index:
Within 8" of Joint: **NO**
Remarks: **M-808-031**

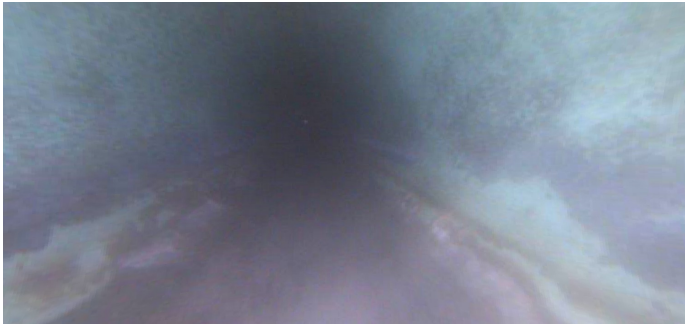
Code:	MWL
Description:	Water Level

Distance (ft):	.0
Structural Grade:	0
O&M Grade:	0
Clock Start/From:	
Clock To:	
1st Value:	
2nd Value:	
Value Percent:	5.000
Continuous Index:	
Within 8" of Joint:	NO
Remarks:

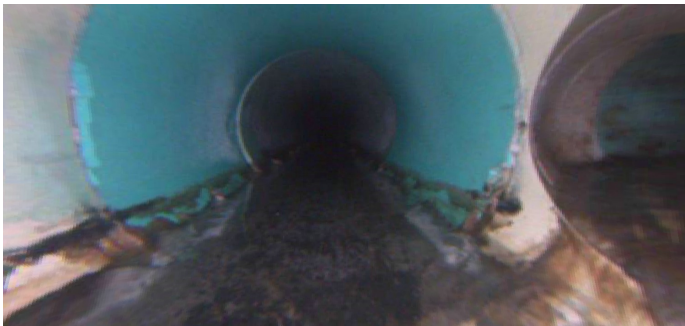
Code:	TF
Description:	Tap Factory

Distance (ft):	121.0
Structural Grade:	0
O&M Grade:	0
Clock Start/From:	3
Clock To:	
1st Value:	4.000
2nd Value:	
Value Percent:	
Continuous Index:	
Within 8" of Joint:	
Remarks:

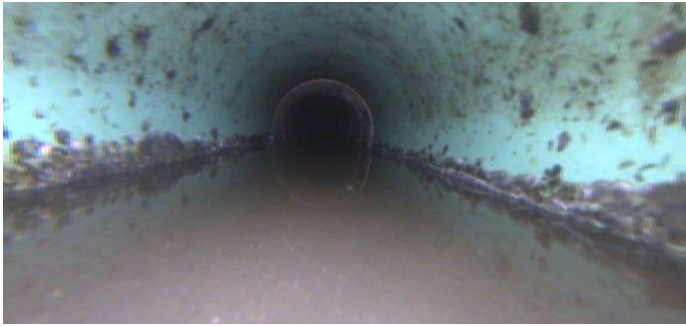
Code:	MSA
Description:	Abandoned Survey
Distance (ft):	182.1
Structural Grade:	0
O&M Grade:	0
Clock Start/From:	
Clock To:	
1st Value:	
2nd Value:	
Value Percent:	
Continuous Index:	
Within 8" of Joint:	NO
Remarks:	camera stopped
