Profile/Photo Observation Report

| Street: | S HOBART RD | Flow Control: | Not Controlled |

| US MH: | M-808-031 | DS MH: | M-808-030 |

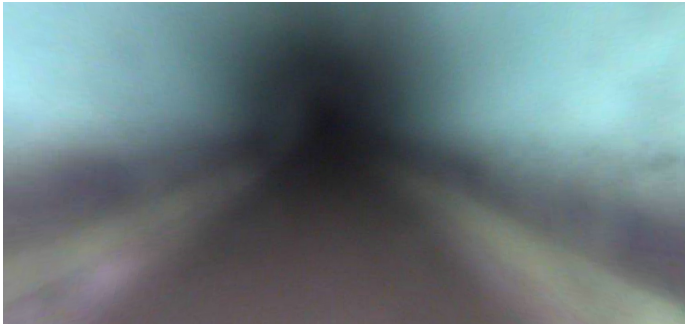
| Code: | MWL |
| Description: | Water Level |

| Value Percent: | 5.000 |

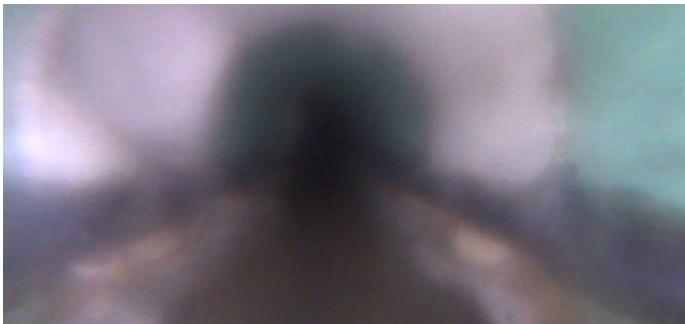
| Code: | TF |
| Description: | Tap Factory |

| Distance (ft): | 26.9 |
| Clock Start/From: | 9 |
| 1st Value: | 4.000 |

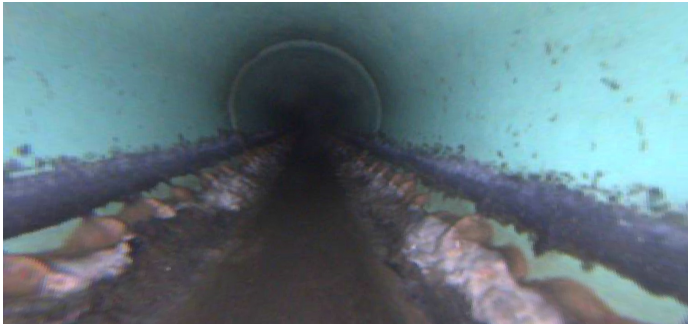
| Code: | MSA |
| Description: | Abandoned Survey |
| Distance (ft): | 159.1 |
| Remarks: | camera stopped |
