Profile/Photo Observation Report

Street:	Hobart Rd.	Flow Control:	Not Controlled
City:	Hobart, IN	Year Renewed:	
Location:	Light Highway	Tape/Media #:	
Purpose:	Routine Assessment	Dia/Height:	12"
Use:	Sanitary	Material:	PVC
Drain Area:	NA	Lining:	
Category:	NA		
Comment:

Location Details:		Direction of Survey:	Upstream
US MH:	M-808-031	DS MH:	M-808-030
		Total Length Surveyed (ft):	159.1

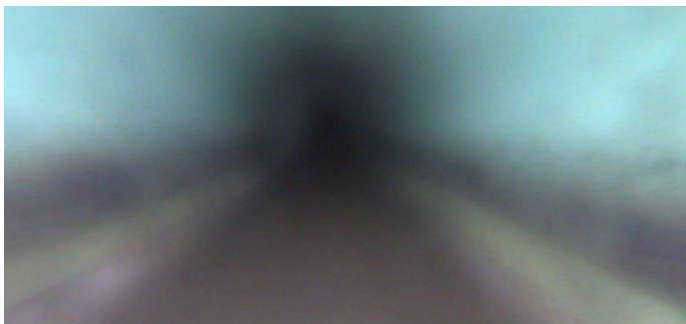
Code: **AMH**
Description: **Manhole**

Distance (ft): **.0**
Structural Grade: **0**
O&M Grade: **0**
Clock Start/From:
Clock To:
1st Value:
2nd Value:
Value Percent:
Continuous Index:
Within 8" of Joint: **NO**
Remarks: **M-808-030**

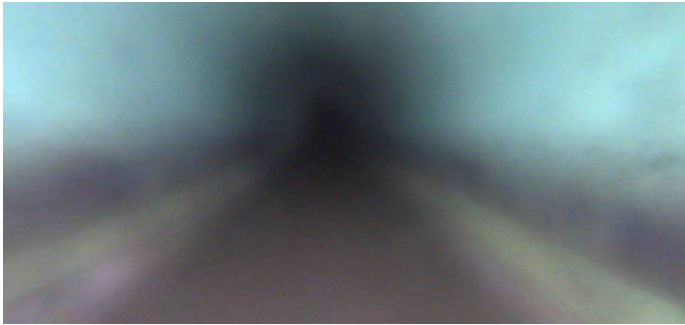
Code:	MWL
Description:	Water Level

Distance (ft):	.0
Structural Grade:	0
O&M Grade:	0
Clock Start/From:	
Clock To:	
1st Value:	
2nd Value:	
Value Percent:	5.000
Continuous Index:	
Within 8" of Joint:	NO
Remarks:

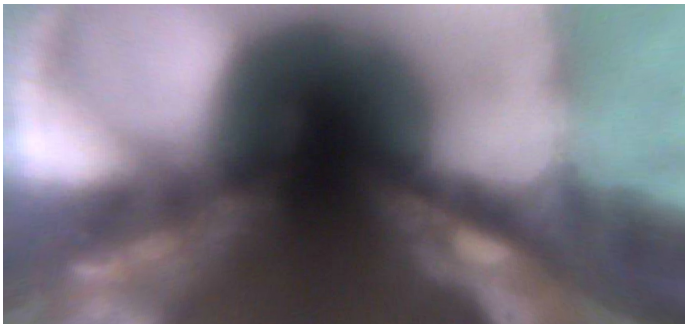
Code:	TF
Description:	Tap Factory

Distance (ft):	26.9
Structural Grade:	0
O&M Grade:	0
Clock Start/From:	9
Clock To:	
1st Value:	4.000
2nd Value:	
Value Percent:	
Continuous Index:	
Within 8" of Joint:	
Remarks:

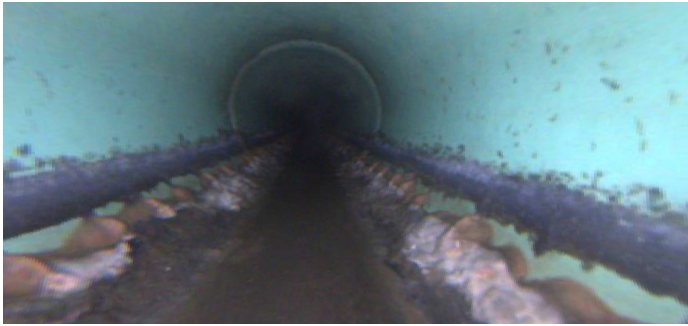
Code:	MSA
Description:	Abandoned Survey
Distance (ft):	159.1
Structural Grade:	0
O&M Grade:	0
Clock Start/From:	
Clock To:	
1st Value:	
2nd Value:	
Value Percent:	
Continuous Index:	
Within 8" of Joint:	NO
Remarks:	camera stopped
