## Profile/Photo Observation Report

Street:	<b>GROSBEAK CT</b>	Flow Control:	<b>Not Controlled</b>
City:	<b>Hobart, IN</b>	Year Renewed:	
Location:	<b>Sidewalk</b>	Tape/Media #:	
Purpose:	<b>Maintenance Related</b>	Dia/Height:	<b>8"</b>
Use:	<b>Sanitary</b>	Material:	<b>PVC</b>
Drain Area:	<b>NA</b>	Lining:	
Category:	<b>NA</b>		
Comment:

Location Details:		Direction of Survey:	<b>Upstream</b>
US MH:	<b>M-809-002</b>	DS MH:	<b>M-809-003</b>
		Total Length Surveyed (ft):	<b>72.4</b>

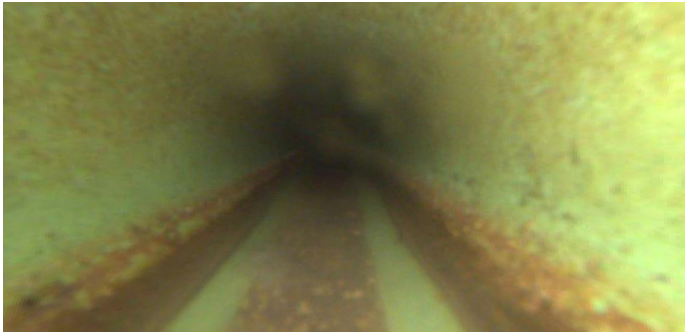
Code:	<b>MWL</b>
Description:	<b>Water Level</b>

Distance (ft):	<b>.0</b>
Structural Grade:	<b>0</b>
O&M Grade:	<b>0</b>
Clock Start/From:	
Clock To:	
1st Value:	
2nd Value:	
Value Percent:	<b>5.000</b>
Continuous Index:	
Within 8" of Joint:	<b>NO</b>
Remarks:

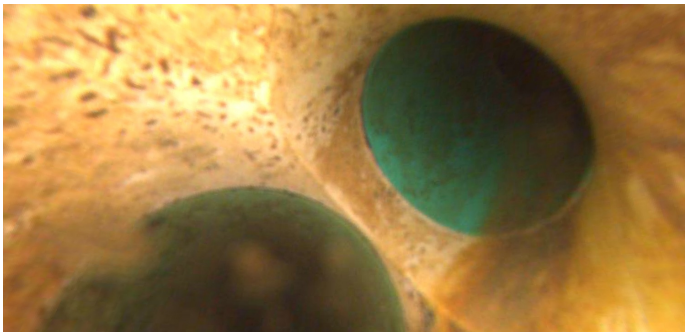
Code:	<b>TF</b>
Description:	<b>Tap Factory</b>

Distance (ft):	<b>10.4</b>
Structural Grade:	<b>0</b>
O&M Grade:	<b>0</b>
Clock Start/From:	<b>2</b>
Clock To:	
1st Value:	<b>4.000</b>
2nd Value:	
Value Percent:	
Continuous Index:	
Within 8" of Joint:	
Remarks:

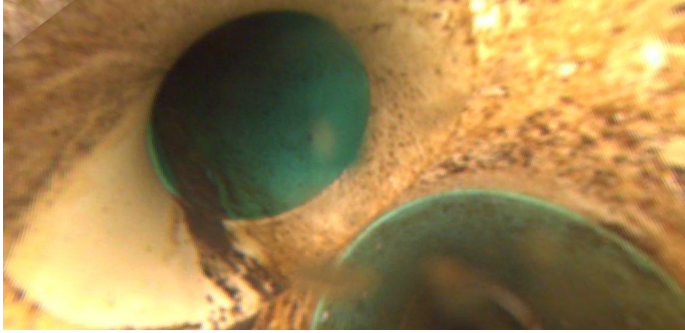
Code: **TF**  
Description: **Tap Factory**

Distance (ft): **51.1**  
Structural Grade: **0**  
O&M Grade: **0**  
Clock Start/From: **11**  
Clock To:  
1st Value: **4.000**  
2nd Value:  
Value Percent:  
Continuous Index:  
Within 8" of Joint: **YES**  
Remarks:

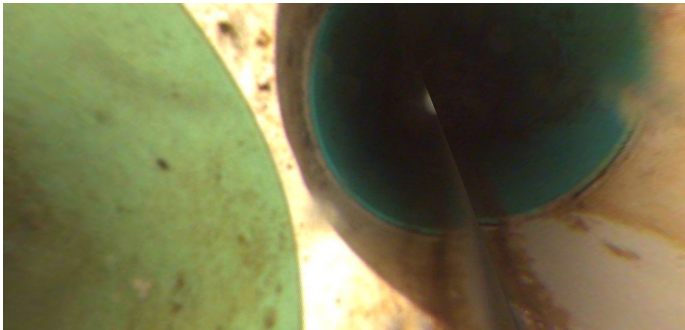
Code: **TF**  
Description: **Tap Factory**

Distance (ft): **53.3**  
Structural Grade: **0**  
O&M Grade: **0**  
Clock Start/From: **1**  
Clock To:  
1st Value: **4.000**  
2nd Value:  
Value Percent:  
Continuous Index:  
Within 8" of Joint: **YES**  
Remarks:

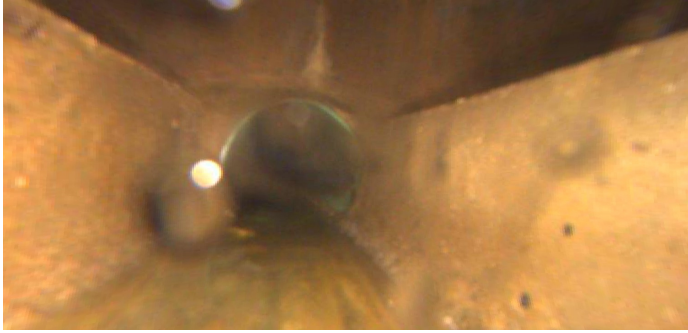
Code:	<b>AMH</b>
Description:	<b>Manhole</b>
Distance (ft):	<b>72.4</b>
Structural Grade:	<b>0</b>
O&M Grade:	<b>0</b>
Clock Start/From:	
Clock To:	
1st Value:	
2nd Value:	
Value Percent:	
Continuous Index:	
Within 8" of Joint:	<b>NO</b>
Remarks:	<b>M-809-002</b>
