## Profile/Photo Observation Report

Street:	<b>GROSBEAK CT &amp; TANAGER ST</b>	Flow Control:	<b>Not Controlled</b>
City:	<b>Hobart, IN</b>	Year Renewed:	
Location:	<b>Sidewalk</b>	Tape/Media #:	
Purpose:	<b>Maintenance Related</b>	Dia/Height:	<b>8"</b>
Use:	<b>Sanitary</b>	Material:	<b>PVC</b>
Drain Area:	<b>NA</b>	Lining:	
Category:	<b>NA</b>		
Comment:

Location Details:		Direction of Survey:	<b>Downstream</b>
US MH:	<b>M-809-005</b>	DS MH:	<b>M-809-006</b>
		Total Length Surveyed (ft):	<b>99.9</b>

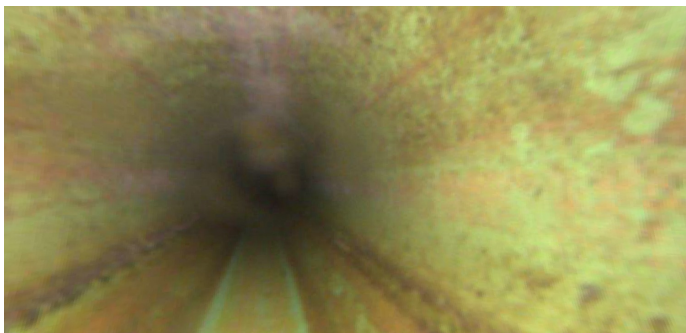
Code: **AMH**  
Description: **Manhole**

Distance (ft): **.0**  
Structural Grade: **0**  
O&M Grade: **0**  
Clock Start/From:  
Clock To:  
1st Value:  
2nd Value:  
Value Percent:  
Continuous Index:  
Within 8" of Joint: **NO**  
Remarks: **M-809-005**

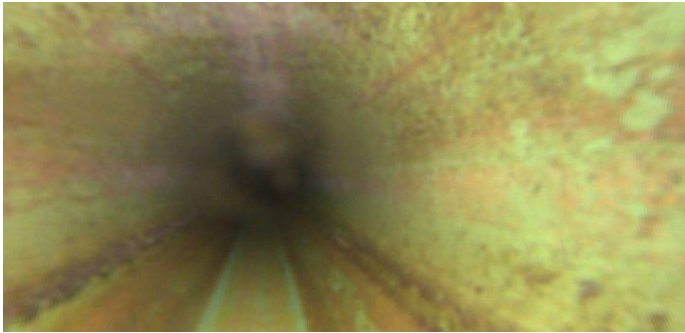
Code:	<b>MWL</b>
Description:	<b>Water Level</b>

Distance (ft):	<b>.0</b>
Structural Grade:	<b>0</b>
O&M Grade:	<b>0</b>
Clock Start/From:	
Clock To:	
1st Value:	
2nd Value:	
Value Percent:	<b>5.000</b>
Continuous Index:	
Within 8" of Joint:	<b>NO</b>
Remarks:

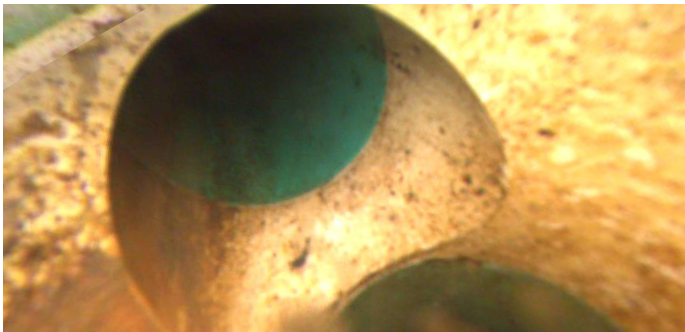
Code:	<b>TF</b>
Description:	<b>Tap Factory</b>

Distance (ft):	<b>19.1</b>
Structural Grade:	<b>0</b>
O&M Grade:	<b>0</b>
Clock Start/From:	<b>11</b>
Clock To:	
1st Value:	<b>4.000</b>
2nd Value:	
Value Percent:	
Continuous Index:	
Within 8" of Joint:	
Remarks:

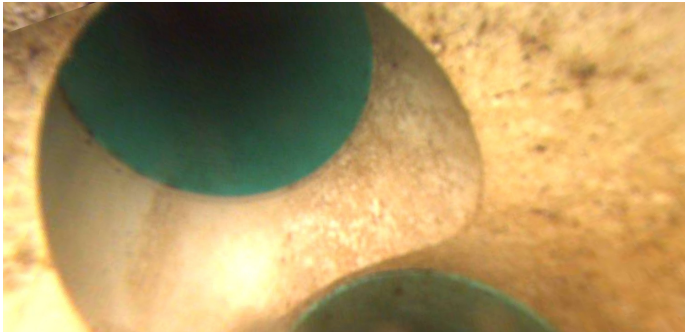
Code: **TF**  
Description: **Tap Factory**

Distance (ft): **57.9**  
Structural Grade: **0**  
O&M Grade: **0**  
Clock Start/From: **11**  
Clock To:  
1st Value: **4.000**  
2nd Value:  
Value Percent:  
Continuous Index:  
Within 8" of Joint:  
Remarks:

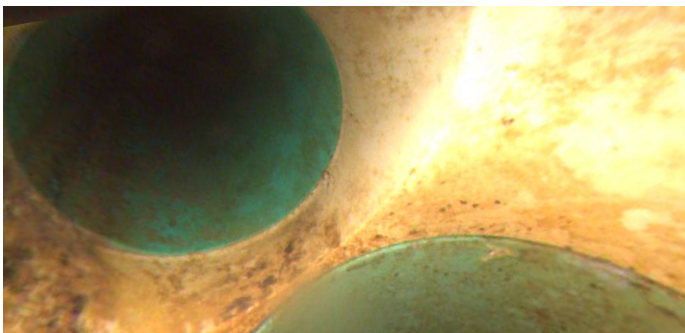
Code: **TF**  
Description: **Tap Factory**

Distance (ft): **59.8**  
Structural Grade: **0**  
O&M Grade: **0**  
Clock Start/From: **1**  
Clock To:  
1st Value: **4.000**  
2nd Value:  
Value Percent:  
Continuous Index:  
Within 8" of Joint:  
Remarks:

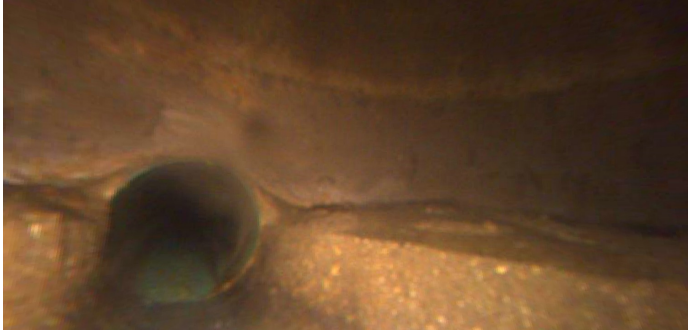
Code:	AMH
Description:	Manhole
Distance (ft):	99.9
Structural Grade:	0
O&M Grade:	0
Clock Start/From:	
Clock To:	
1st Value:	
2nd Value:	
Value Percent:	
Continuous Index:	
Within 8" of Joint:	NO
Remarks:	M-809-006
