Profile/Photo Observation Report

Date:	03/23/2018	Weather:		Coding:	PACP 6.0
Pipe Length (ft):	189.2	Owner:	NA	Pre Clean:	Not Known
P.O.#:		Surveyor:	Justin Gonzales	PSR:	P-809-006-009
Customer:		Clean Date:	01/01/1900	Shape:	C

Street:	GROSBEAK CT & TANAGER ST	Flow Control:	Not Controlled
City:	Hobart, IN	Year Renewed:	
Location:	Ditch	Tape/Media #:	
Purpose:	Maintenance Related	Dia/Height:	8"
Use:	Sanitary	Material:	PVC
Drain Area:	NA	Lining:	
Category:	NA		
Comment:

Location Details:		Direction of Survey:	Upstream
US MH:	M-809-006	DS MH:	M-809-009
		Total Length Surveyed (ft):	185.0

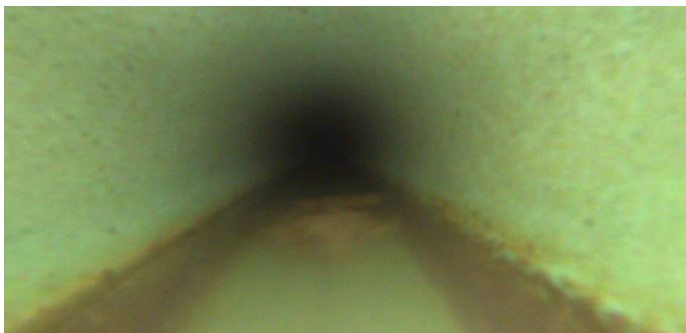
Code: **AMH**
Description: **Manhole**

Distance (ft): **.0**
Structural Grade: **0**
O&M Grade: **0**
Clock Start/From:
Clock To:
1st Value:
2nd Value:
Value Percent:
Continuous Index:
Within 8" of Joint: **NO**
Remarks: **M-809-009**

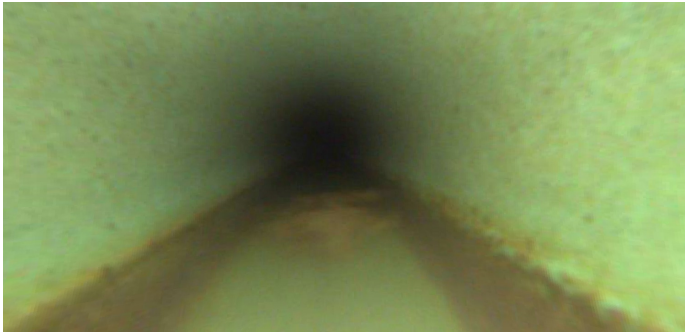
Code:	MWL
Description:	Water Level

Distance (ft):	.0
Structural Grade:	0
O&M Grade:	0
Clock Start/From:	
Clock To:	
1st Value:	
2nd Value:	
Value Percent:	10.000
Continuous Index:	
Within 8" of Joint:	NO
Remarks:

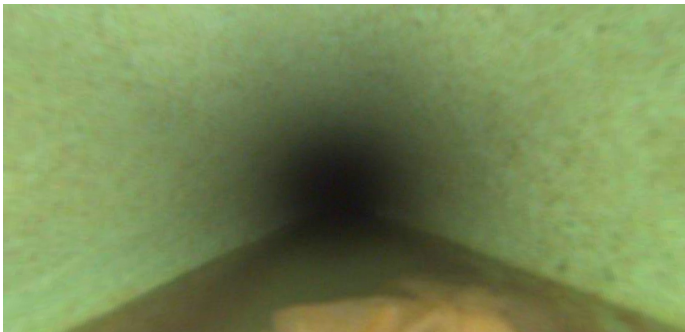
Code:	DAZ
Description:	Deposits Attached Other

Distance (ft):	1.7
Structural Grade:	0
O&M Grade:	2
Clock Start/From:	7
Clock To:	5
1st Value:	
2nd Value:	
Value Percent:	5.000
Continuous Index:	S01
Within 8" of Joint:	YES
Remarks:	WANDER

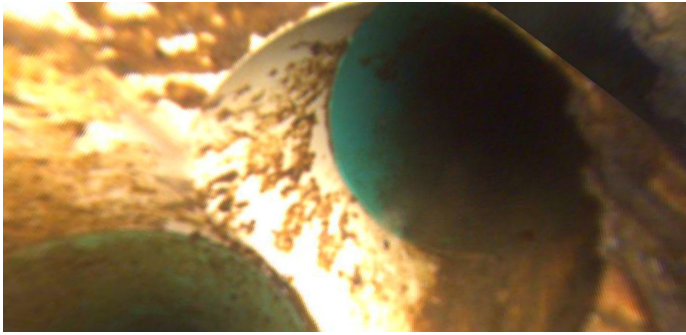
Code: **TF**
Description: **Tap Factory**

Distance (ft): **25.0**
Structural Grade: **0**
O&M Grade: **0**
Clock Start/From: **2**
Clock To:
1st Value: **4.000**
2nd Value:
Value Percent:
Continuous Index:
Within 8" of Joint:
Remarks:

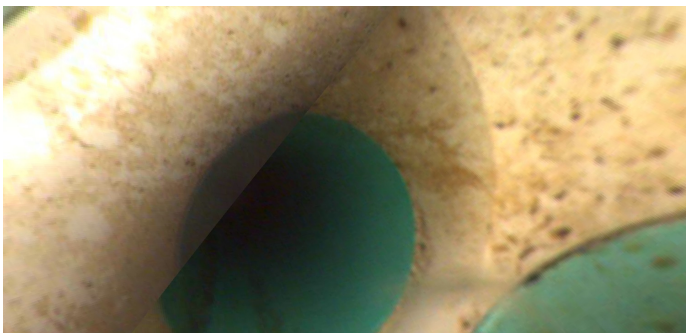
Code: **TF**
Description: **Tap Factory**

Distance (ft): **76.7**
Structural Grade: **0**
O&M Grade: **0**
Clock Start/From: **10**
Clock To:
1st Value: **4.000**
2nd Value:
Value Percent:
Continuous Index:
Within 8" of Joint:
Remarks:

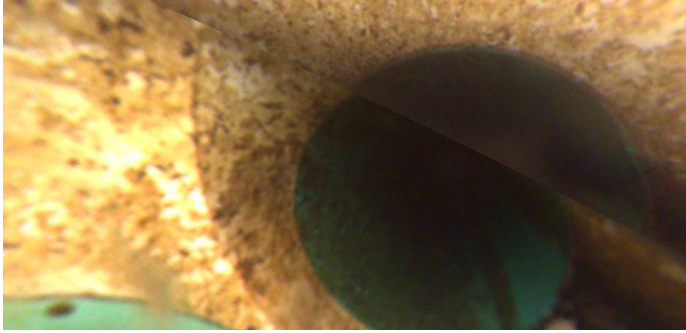
Code: **TF**
Description: **Tap Factory**

Distance (ft): **78.3**
Structural Grade: **0**
O&M Grade: **0**
Clock Start/From: **2**
Clock To:
1st Value: **4.000**
2nd Value:
Value Percent:
Continuous Index:
Within 8" of Joint:
Remarks:

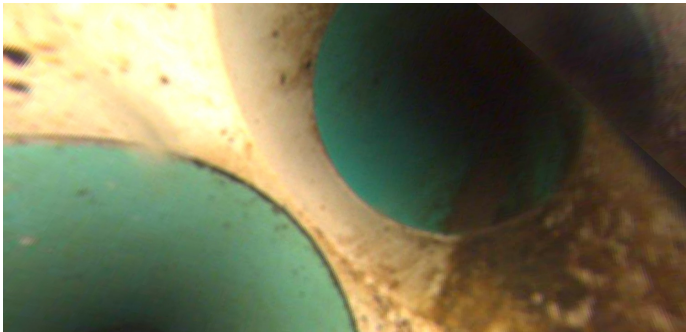
Code: **TF**
Description: **Tap Factory**

Distance (ft): **117.0**
Structural Grade: **0**
O&M Grade: **0**
Clock Start/From: **1**
Clock To:
1st Value: **4.000**
2nd Value:
Value Percent:
Continuous Index:
Within 8" of Joint:
Remarks:

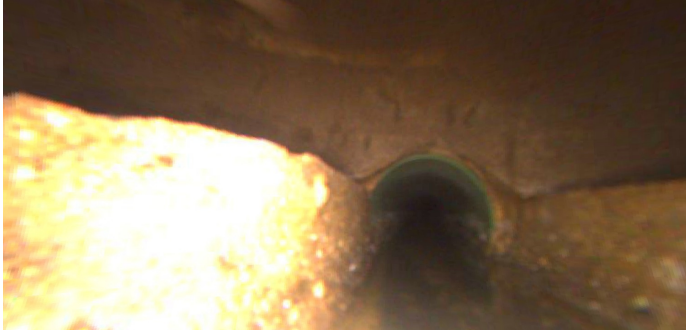
Code: **AMH**
Description: **Manhole**

Distance (ft): **185.0**
Structural Grade: **0**
O&M Grade: **0**
Clock Start/From:
Clock To:
1st Value:
2nd Value:
Value Percent:
Continuous Index:
Within 8" of Joint: **NO**
Remarks: **M-809-006**

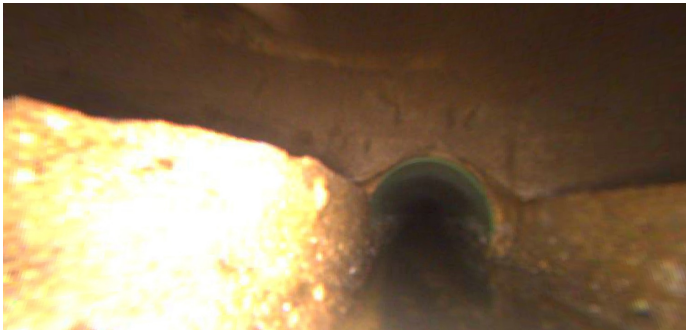
Code: **DAZ**
Description: **Deposits Attached Other**

Distance (ft): **185.0**
Structural Grade: **0**
O&M Grade: **2**
Clock Start/From: **7**
Clock To: **5**
1st Value:
2nd Value:
Value Percent: **5.000**
Continuous Index: **F01**
Within 8" of Joint: **YES**
Remarks: **WANDER**
