## Profile/Photo Observation Report

Street:	<b>Oak</b>	Flow Control:	<b>Not Controlled</b>
City:	<b>Hobart, IN</b>	Year Renewed:	
Location:	<b>Ditch</b>	Tape/Media #:	
Purpose:	<b>Maintenance Related</b>	Dia/Height:	<b>8"</b>
Use:	<b>Sanitary</b>	Material:	<b>PVC</b>
Drain Area:	<b>NA</b>	Lining:	
Category:	<b>NA</b>		
Comment:

Location Details:		Direction of Survey:	<b>Upstream</b>
US MH:	<b>M-809-006</b>	DS MH:	<b>M-809-009</b>
		Total Length Surveyed (ft):	<b>185.0</b>

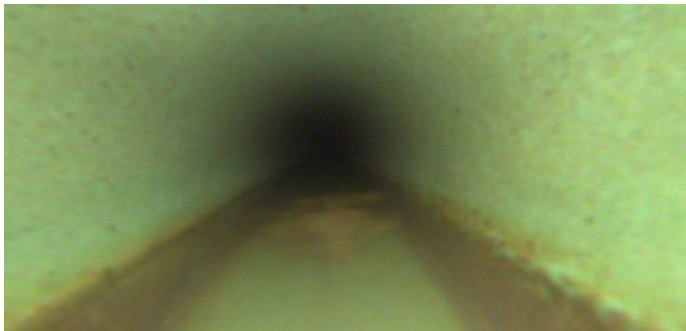
Code: **AMH**  
Description: **Manhole**

Distance (ft): **.0**  
Structural Grade: **0**  
O&M Grade: **0**  
Clock Start/From:  
Clock To:  
1st Value:  
2nd Value:  
Value Percent:  
Continuous Index:  
Within 8" of Joint: **NO**  
Remarks: **M-809-009**

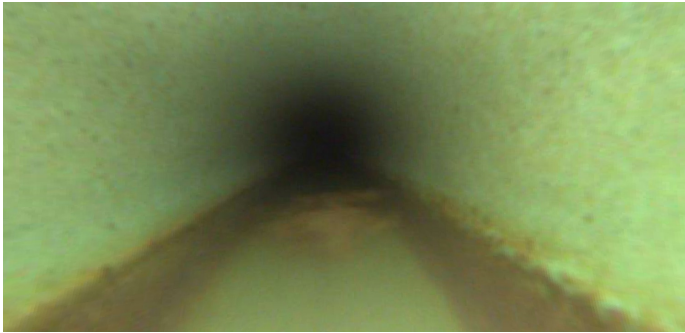
Code:	<b>MWL</b>
Description:	<b>Water Level</b>

Distance (ft):	<b>.0</b>
Structural Grade:	<b>0</b>
O&M Grade:	<b>0</b>
Clock Start/From:	
Clock To:	
1st Value:	
2nd Value:	
Value Percent:	<b>10.000</b>
Continuous Index:	
Within 8" of Joint:	<b>NO</b>
Remarks:

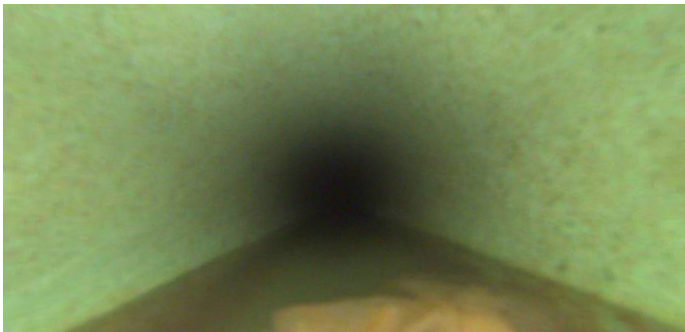
Code:	<b>DAZ</b>
Description:	<b>Deposits Attached Other</b>

Distance (ft):	<b>1.7</b>
Structural Grade:	<b>0</b>
O&M Grade:	<b>2</b>
Clock Start/From:	<b>7</b>
Clock To:	<b>5</b>
1st Value:	
2nd Value:	
Value Percent:	<b>5.000</b>
Continuous Index:	<b>S01</b>
Within 8" of Joint:	<b>YES</b>
Remarks:	<b>WANDER</b>

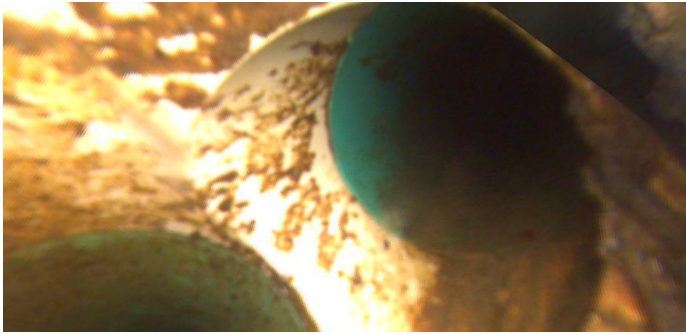
Code: **TF**  
Description: **Tap Factory**

Distance (ft): **25.0**  
Structural Grade: **0**  
O&M Grade: **0**  
Clock Start/From: **2**  
Clock To:  
1st Value: **4.000**  
2nd Value:  
Value Percent:  
Continuous Index:  
Within 8" of Joint:  
Remarks:

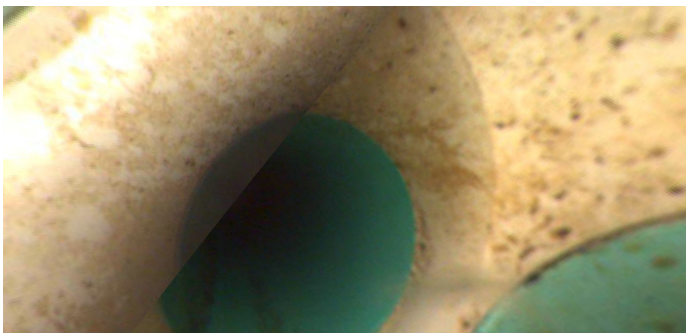
Code: **TF**  
Description: **Tap Factory**

Distance (ft): **76.7**  
Structural Grade: **0**  
O&M Grade: **0**  
Clock Start/From: **10**  
Clock To:  
1st Value: **4.000**  
2nd Value:  
Value Percent:  
Continuous Index:  
Within 8" of Joint:  
Remarks:

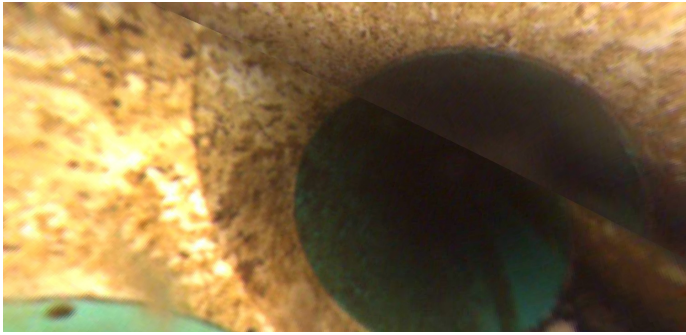
Code: **TF**  
Description: **Tap Factory**

Distance (ft): **78.3**  
Structural Grade: **0**  
O&M Grade: **0**  
Clock Start/From: **2**  
Clock To:  
1st Value: **4.000**  
2nd Value:  
Value Percent:  
Continuous Index:  
Within 8" of Joint:  
Remarks:

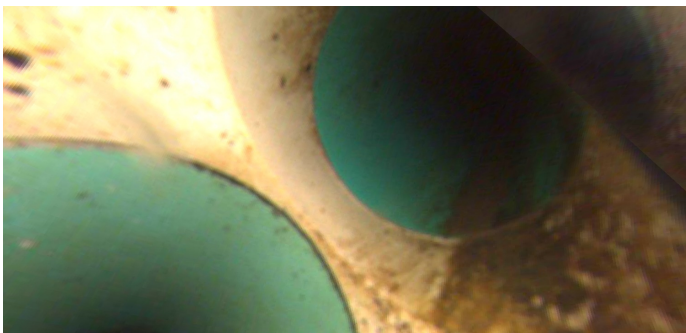
Code: **TF**  
Description: **Tap Factory**

Distance (ft): **117.0**  
Structural Grade: **0**  
O&M Grade: **0**  
Clock Start/From: **1**  
Clock To:  
1st Value: **4.000**  
2nd Value:  
Value Percent:  
Continuous Index:  
Within 8" of Joint:  
Remarks:

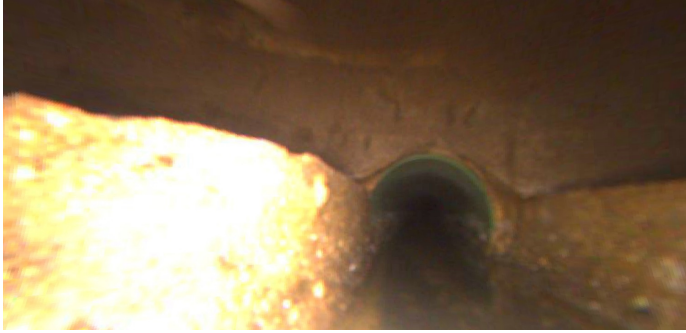
Code: **AMH**  
Description: **Manhole**

Distance (ft): **185.0**  
Structural Grade: **0**  
O&M Grade: **0**  
Clock Start/From:  
Clock To:  
1st Value:  
2nd Value:  
Value Percent:  
Continuous Index:  
Within 8" of Joint: **NO**  
Remarks: **M-809-006**

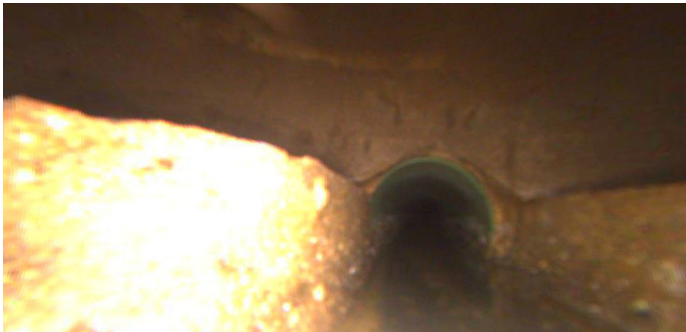
Code: **DAZ**  
Description: **Deposits Attached Other**

Distance (ft): **185.0**  
Structural Grade: **0**  
O&M Grade: **2**  
Clock Start/From: **7**  
Clock To: **5**  
1st Value:  
2nd Value:  
Value Percent: **5.000**  
Continuous Index: **F01**  
Within 8" of Joint: **YES**  
Remarks: **WANDER**
