Profile/Photo Observation Report

Date:	03/26/2018	Weather:		Coding:	PACP 6.0
Pipe Length (ft):	100.0	Owner:	NA	Pre Clean:	Not Known
P.O.#:		Surveyor:	Byrd Fitzgerald	PSR:	P-809-008-007
Customer:		Clean Date:	01/01/1900	Shape:	C

Street:	TANAGER ST	Flow Control:	Not Controlled
City:	Hobart, IN	Year Renewed:	
Location:	Sidewalk	Tape/Media #:	
Purpose:	Maintenance Related	Dia/Height:	8"
Use:	Sanitary	Material:	PVC
Drain Area:	NA	Lining:	
Category:	NA		
Comment:	Flow direction wrong.

Location Details:		Direction of Survey:	Downstream
US MH:	M-809-007	DS MH:	M-809-008
		Total Length Surveyed (ft):	96.6

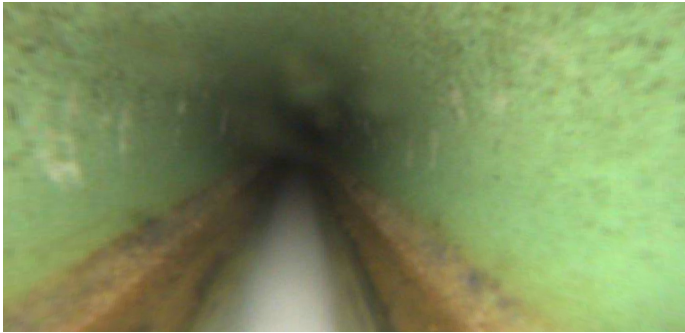
Code:	MWL
Description:	Water Level

Distance (ft):	.0
Structural Grade:	0
O&M Grade:	0
Clock Start/From:	
Clock To:	
1st Value:	
2nd Value:	
Value Percent:	5.000
Continuous Index:	
Within 8" of Joint:	NO
Remarks:

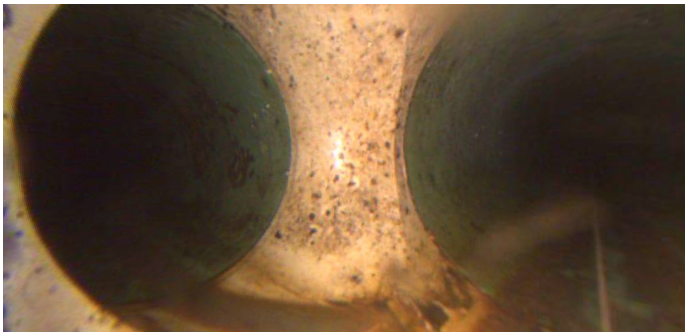
Code:	TF
Description:	Tap Factory

Distance (ft):	22.3
Structural Grade:	0
O&M Grade:	0
Clock Start/From:	3
Clock To:	
1st Value:	4.000
2nd Value:	
Value Percent:	
Continuous Index:	
Within 8" of Joint:	
Remarks:

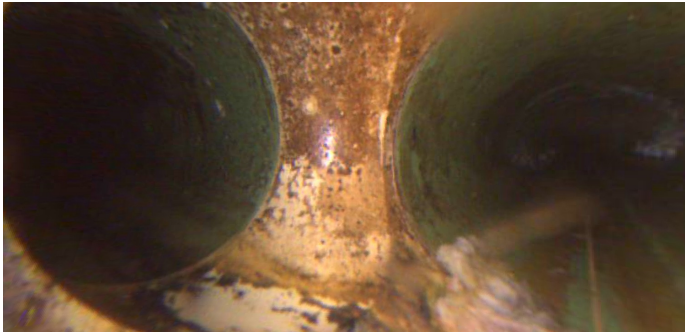
Code: **TF**
Description: **Tap Factory**

Distance (ft): **60.9**
Structural Grade: **0**
O&M Grade: **0**
Clock Start/From: **3**
Clock To:
1st Value: **5.000**
2nd Value:
Value Percent:
Continuous Index:
Within 8" of Joint:
Remarks:

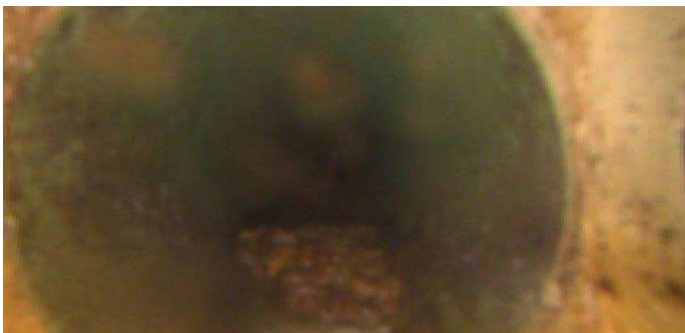
Code: **DSZ**
Description: **Deposits Settled Other**

Distance (ft): **90.5**
Structural Grade: **0**
O&M Grade: **2**
Clock Start/From: **6**
Clock To:
1st Value:
2nd Value:
Value Percent: **5.000**
Continuous Index:
Within 8" of Joint: **NO**
Remarks: **debris**

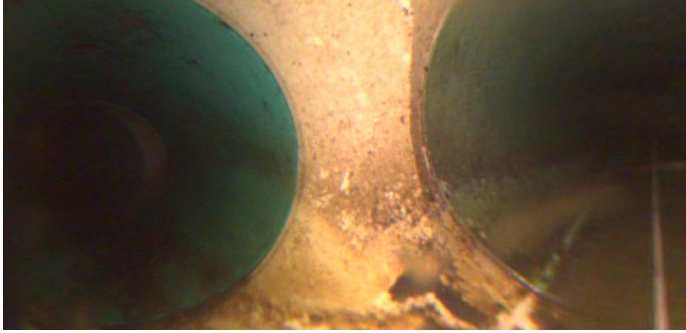
Code: **TF**
Description: **Tap Factory**

Distance (ft): **91.0**
Structural Grade: **0**
O&M Grade: **0**
Clock Start/From: **3**
Clock To:
1st Value: **4.000**
2nd Value:
Value Percent:
Continuous Index:
Within 8" of Joint:
Remarks:

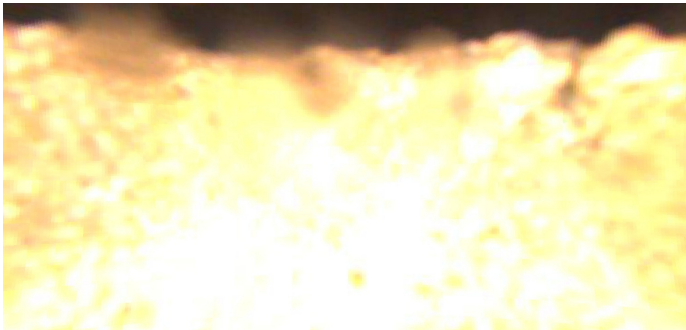
Code: **AMH**
Description: **Manhole**

Distance (ft): **96.6**
Structural Grade: **0**
O&M Grade: **0**
Clock Start/From:
Clock To:
1st Value:
2nd Value:
Value Percent:
Continuous Index:
Within 8" of Joint: **NO**
Remarks: **M-809-008**
