Profile/Photo Observation Report

Street:	Tanager	Flow Control:	Not Controlled
City:	Hobart, IN	Year Renewed:	
Location:	Sidewalk	Tape/Media #:	
Purpose:	Maintenance Related	Dia/Height:	8"
Use:	Sanitary	Material:	PVC
Drain Area:	NA	Lining:	
Category:	NA		
Comment:	Flow direction wrong.

Location Details:		Direction of Survey:	Downstream
US MH:	M-809-007	DS MH:	M-809-008
		Total Length Surveyed (ft):	96.6

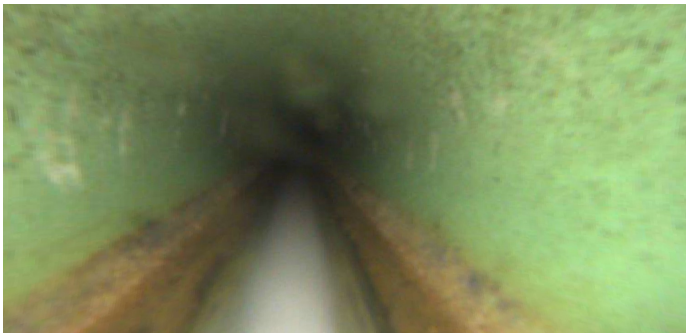
Code:	MWL
Description:	Water Level

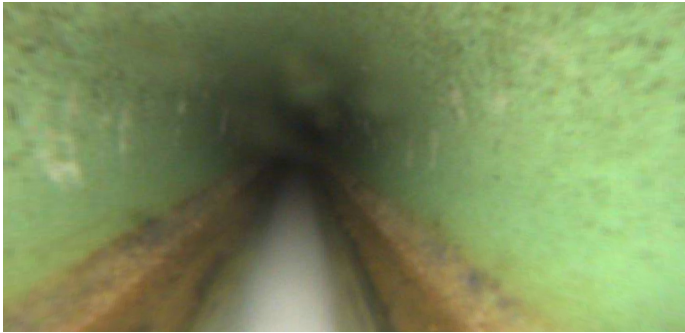
Code:	TF
Description:	Tap Factory

Distance (ft):	22.3
Structural Grade:	0
O&M Grade:	0
Clock Start/From:	3
Clock To:	
1st Value:	4.000
2nd Value:	
Value Percent:	
Continuous Index:	
Within 8" of Joint:	
Remarks:

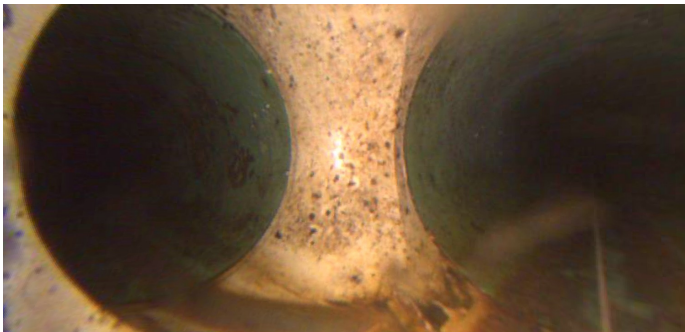
Code: **TF**
Description: **Tap Factory**

Distance (ft): **60.9**
Structural Grade: **0**
O&M Grade: **0**
Clock Start/From: **3**
Clock To:
1st Value: **5.000**
2nd Value:
Value Percent:
Continuous Index:
Within 8" of Joint:
Remarks:

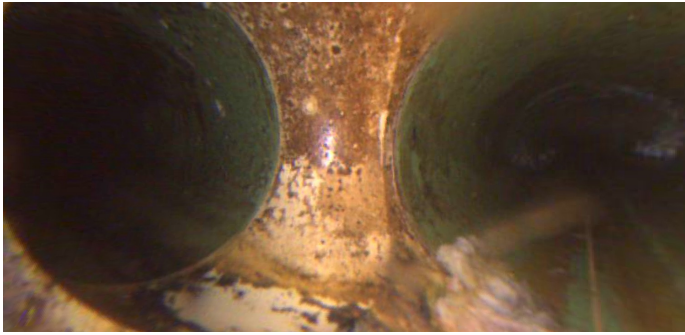
Code: **DSZ**
Description: **Deposits Settled Other**

Distance (ft): **90.5**
Structural Grade: **0**
O&M Grade: **2**
Clock Start/From: **6**
Clock To:
1st Value:
2nd Value:
Value Percent: **5.000**
Continuous Index:
Within 8" of Joint: **NO**
Remarks: **debris**

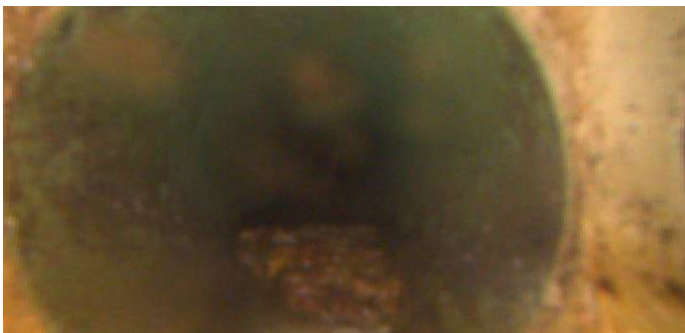
Code: **TF**
Description: **Tap Factory**

Distance (ft): **91.0**
Structural Grade: **0**
O&M Grade: **0**
Clock Start/From: **3**
Clock To:
1st Value: **4.000**
2nd Value:
Value Percent:
Continuous Index:
Within 8" of Joint:
Remarks:

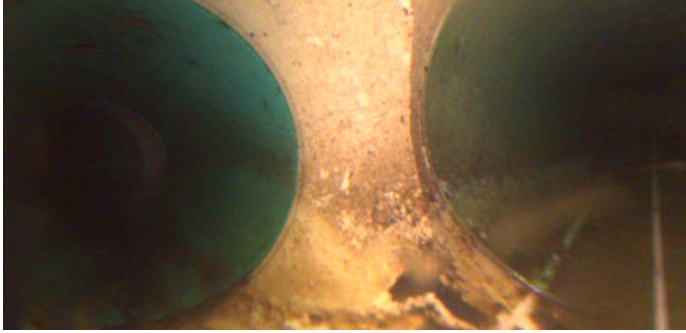
Code: **AMH**
Description: **Manhole**

Distance (ft): **96.6**
Structural Grade: **0**
O&M Grade: **0**
Clock Start/From:
Clock To:
1st Value:
2nd Value:
Value Percent:
Continuous Index:
Within 8" of Joint: **NO**
Remarks: **M-809-008**
