Profile/Photo Observation Report

Street:	Oak	Flow Control:	Not Controlled
City:	Hobart, IN	Year Renewed:	
Location:	Ditch	Tape/Media #:	
Purpose:	Maintenance Related	Dia/Height:	8"
Use:	Sanitary	Material:	PVC
Drain Area:	NA	Lining:	
Category:	NA		
Comment:	battery at 53'.

Location Details:		Direction of Survey:	Downstream
US MH:	M-809-009	DS MH:	M-809-010
		Total Length Surveyed (ft):	54.3

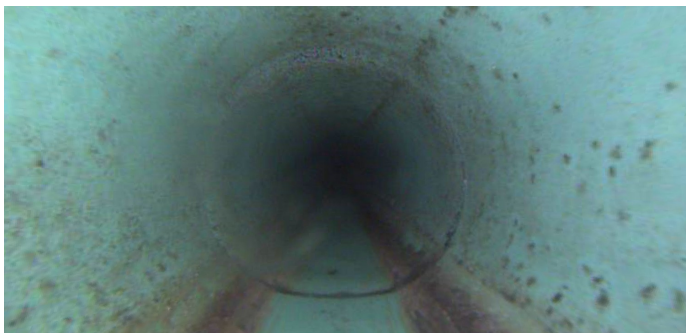
Code: **AMH**
Description: **Manhole**

Distance (ft): **.0**
Structural Grade: **0**
O&M Grade: **0**
Clock Start/From:
Clock To:
1st Value:
2nd Value:
Value Percent:
Continuous Index:
Within 8" of Joint: **NO**
Remarks: **M-809-009**

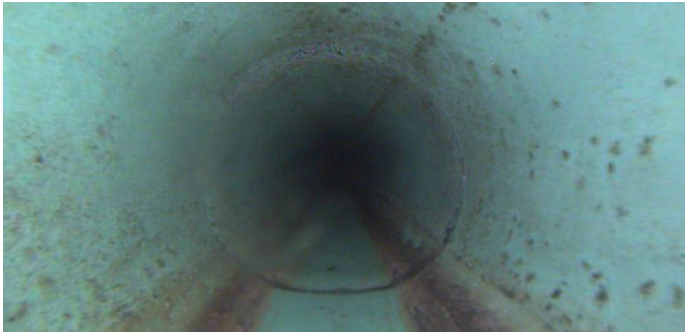
Code:	MWL
Description:	Water Level

Distance (ft):	.0
Structural Grade:	0
O&M Grade:	0
Clock Start/From:	
Clock To:	
1st Value:	
2nd Value:	
Value Percent:	5.000
Continuous Index:	
Within 8" of Joint:	NO
Remarks:

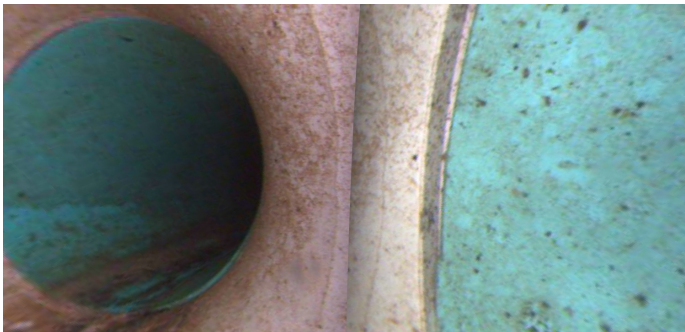
Code:	TF
Description:	Tap Factory

Distance (ft):	14.9
Structural Grade:	0
O&M Grade:	0
Clock Start/From:	10
Clock To:	
1st Value:	4.000
2nd Value:	
Value Percent:	
Continuous Index:	
Within 8" of Joint:	
Remarks:

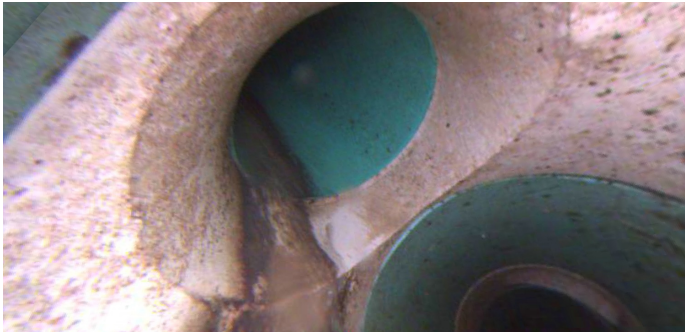
Code: **TFA**
Description: **Tap Factory Active**

Distance (ft): **16.6**
Structural Grade: **0**
O&M Grade: **0**
Clock Start/From: **2**
Clock To:
1st Value: **4.000**
2nd Value:
Value Percent:
Continuous Index:
Within 8" of Joint:
Remarks:

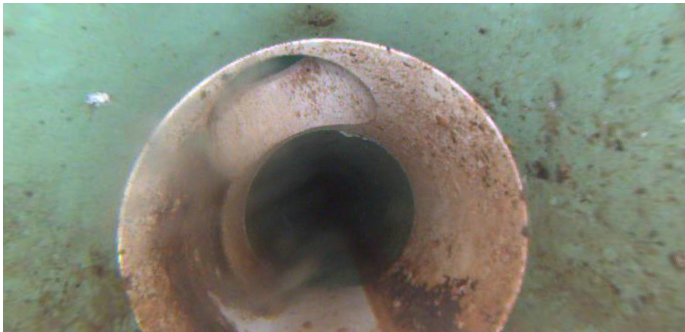
Code: **TF**
Description: **Tap Factory**

Distance (ft): **54.3**
Structural Grade: **0**
O&M Grade: **0**
Clock Start/From: **11**
Clock To:
1st Value: **4.000**
2nd Value:
Value Percent:
Continuous Index:
Within 8" of Joint:
Remarks:

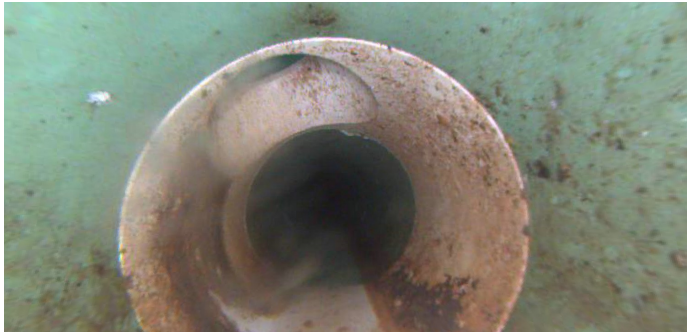
Code:	MSA
Description:	Abandoned Survey
Distance (ft):	54.3
Structural Grade:	0
O&M Grade:	0
Clock Start/From:	
Clock To:	
1st Value:	
2nd Value:	
Value Percent:	
Continuous Index:	
Within 8" of Joint:	NO
Remarks:	unknown
