Profile/Photo Observation Report

Street:	Oak	Flow Control:	Not Controlled
City:	Hobart, IN	Year Renewed:	
Location:	Ditch	Tape/Media #:	
Purpose:	Maintenance Related	Dia/Height:	8"
Use:	Sanitary	Material:	PVC
Drain Area:	NA	Lining:	
Category:	NA		
Comment:	Reverse. user set max at 65'.

Location Details:		Direction of Survey:	Upstream
US MH:	M-809-009	DS MH:	M-809-010
		Total Length Surveyed (ft):	66.6

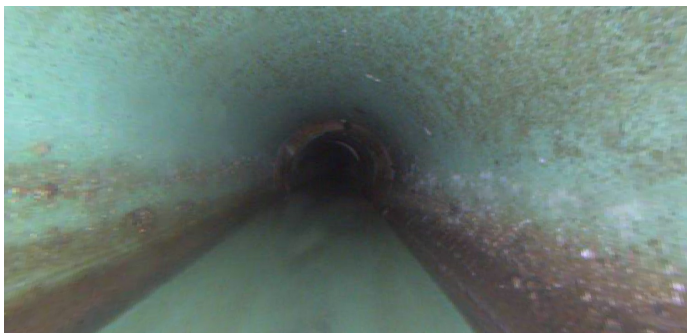
Code: **AMH**
Description: **Manhole**

Distance (ft): **.0**
Structural Grade: **0**
O&M Grade: **0**
Clock Start/From:
Clock To:
1st Value:
2nd Value:
Value Percent:
Continuous Index:
Within 8" of Joint: **NO**
Remarks: **M-809-010**

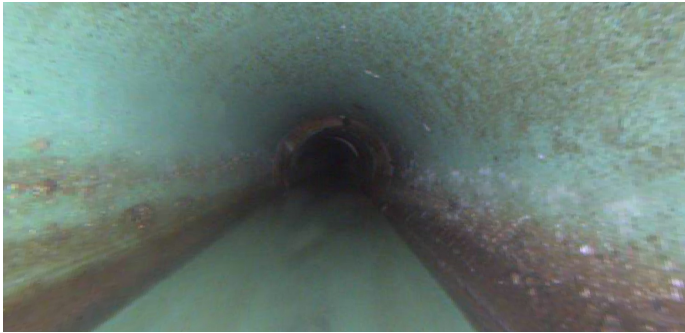
Code:	MWL
Description:	Water Level

Distance (ft):	.0
Structural Grade:	0
O&M Grade:	0
Clock Start/From:	
Clock To:	
1st Value:	
2nd Value:	
Value Percent:	5.000
Continuous Index:	
Within 8" of Joint:	NO
Remarks:

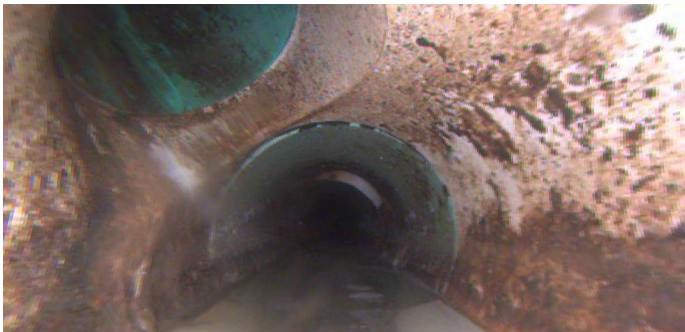
Code:	TF
Description:	Tap Factory

Distance (ft):	2.5
Structural Grade:	0
O&M Grade:	0
Clock Start/From:	11
Clock To:	
1st Value:	4.000
2nd Value:	
Value Percent:	
Continuous Index:	
Within 8" of Joint:	YES
Remarks:

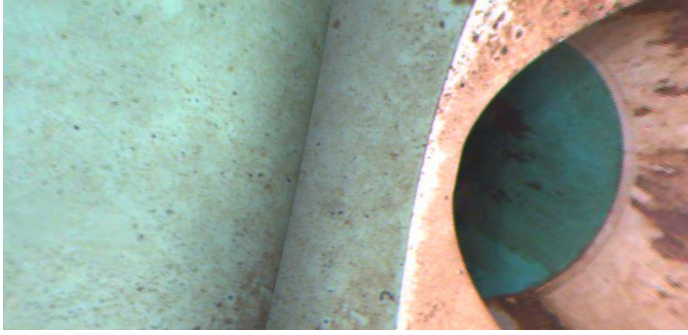
Code: **TF**
Description: **Tap Factory**

Distance (ft): **4.8**
Structural Grade: **0**
O&M Grade: **0**
Clock Start/From: **2**
Clock To:
1st Value: **4.000**
2nd Value:
Value Percent:
Continuous Index:
Within 8" of Joint: **YES**
Remarks:

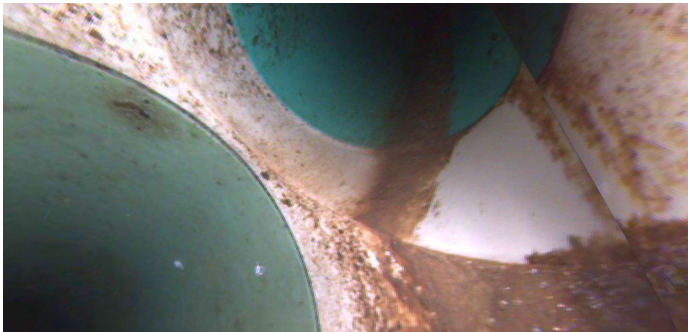
Code: **TF**
Description: **Tap Factory**

Distance (ft): **40.0**
Structural Grade: **0**
O&M Grade: **0**
Clock Start/From: **2**
Clock To:
1st Value: **4.000**
2nd Value:
Value Percent:
Continuous Index:
Within 8" of Joint: **YES**
Remarks:

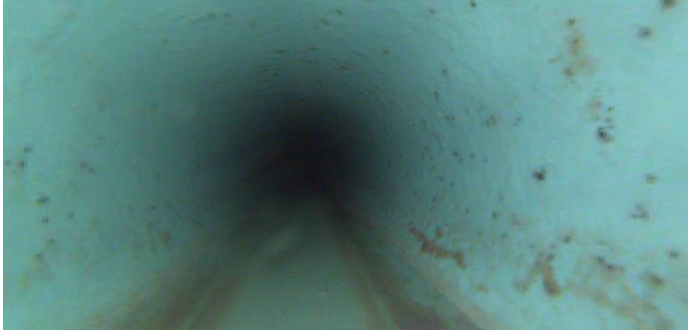
Code:	MSA
Description:	Abandoned Survey
Distance (ft):	66.6
Structural Grade:	0
O&M Grade:	0
Clock Start/From:	
Clock To:	
1st Value:	
2nd Value:	
Value Percent:	
Continuous Index:	
Within 8" of Joint:	NO
Remarks:	no blockage
