Profile/Photo Observation Report

Date:	03/24/2018	Weather:		Coding:	PACP 6.0
Pipe Length (ft):	189.7	Owner:	NA	Pre Clean:	Not Known
P.O.#:		Surveyor:	Justin Gonzales	PSR:	P-809-011-012
Customer:		Clean Date:	01/01/1900	Shape:	C

Street:	GROSBEAK CT	Flow Control:	Not Controlled
City:	Hobart, IN	Year Renewed:	
Location:	Ditch	Tape/Media #:	
Purpose:	Maintenance Related	Dia/Height:	8"
Use:	Sanitary	Material:	PVC
Drain Area:	NA	Lining:	
Category:	NA		
Comment:	battery at 152'.

Location Details:		Direction of Survey:	Upstream
US MH:	M-809-011	DS MH:	M-809-012
		Total Length Surveyed (ft):	153.9

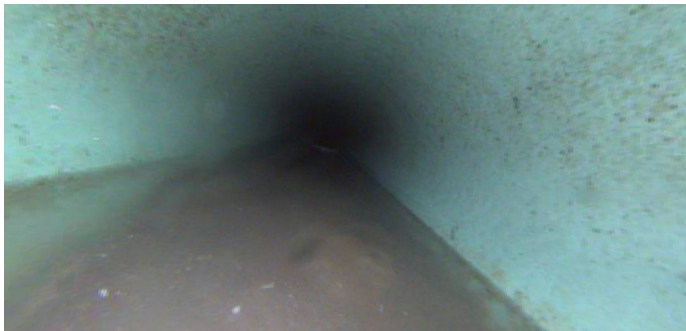
Code: **AMH**
Description: **Manhole**

Distance (ft): **.0**
Structural Grade: **0**
O&M Grade: **0**
Clock Start/From:
Clock To:
1st Value:
2nd Value:
Value Percent:
Continuous Index:
Within 8" of Joint: **NO**
Remarks: **M-809-012**

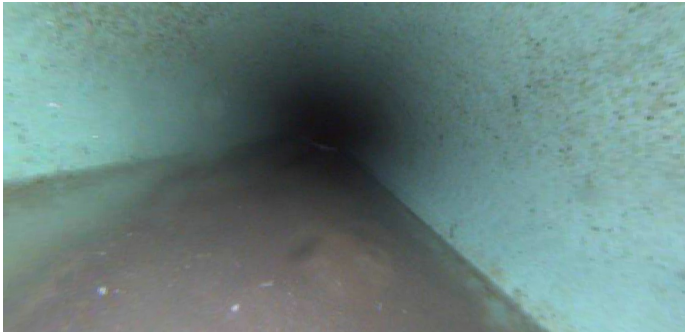
Code:	MWL
Description:	Water Level

Distance (ft):	.0
Structural Grade:	0
O&M Grade:	0
Clock Start/From:	
Clock To:	
1st Value:	
2nd Value:	
Value Percent:	10.000
Continuous Index:	
Within 8" of Joint:	NO
Remarks:

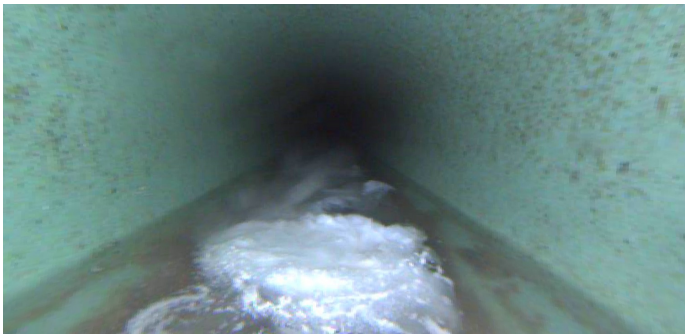
Code:	MGO
Description:	General Observation

Distance (ft):	6.4
Structural Grade:	0
O&M Grade:	0
Clock Start/From:	
Clock To:	
1st Value:	
2nd Value:	
Value Percent:	
Continuous Index:	
Within 8" of Joint:	NO
Remarks:	TOILET TISSUE

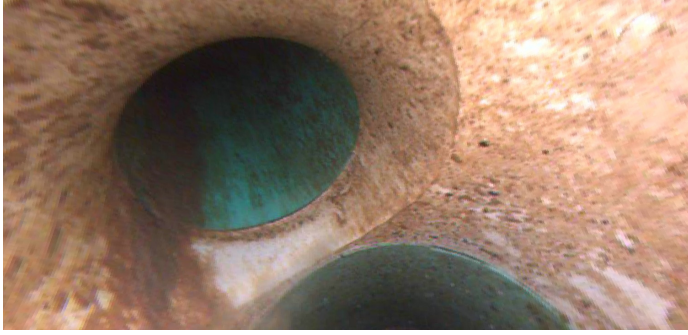
Code: **TF**
Description: **Tap Factory**

Distance (ft): **25.0**
Structural Grade: **0**
O&M Grade: **0**
Clock Start/From: **10**
Clock To:
1st Value: **4.000**
2nd Value:
Value Percent:
Continuous Index:
Within 8" of Joint:
Remarks:

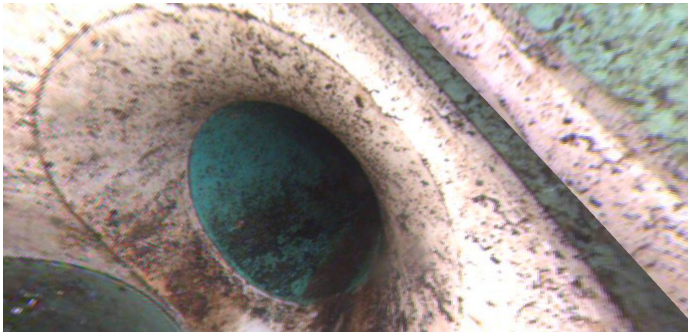
Code: **TF**
Description: **Tap Factory**

Distance (ft): **26.6**
Structural Grade: **0**
O&M Grade: **0**
Clock Start/From: **2**
Clock To:
1st Value: **4.000**
2nd Value:
Value Percent:
Continuous Index:
Within 8" of Joint:
Remarks:

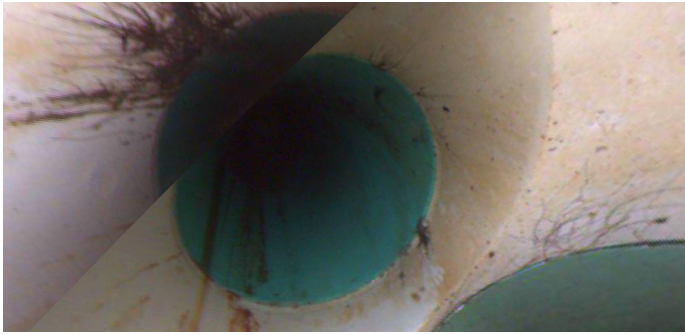
Code: **TFD**
Description: **Tap Factory Defective**

Distance (ft): **78.0**
Structural Grade: **0**
O&M Grade: **2**
Clock Start/From: **11**
Clock To:
1st Value: **4.000**
2nd Value:
Value Percent:
Continuous Index:
Within 8" of Joint:
Remarks: **RF COMING FROM TAP**

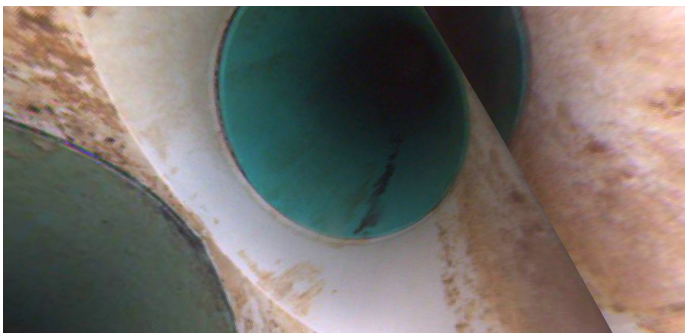
Code: **TF**
Description: **Tap Factory**

Distance (ft): **79.6**
Structural Grade: **0**
O&M Grade: **0**
Clock Start/From: **1**
Clock To:
1st Value: **4.000**
2nd Value:
Value Percent:
Continuous Index:
Within 8" of Joint:
Remarks:

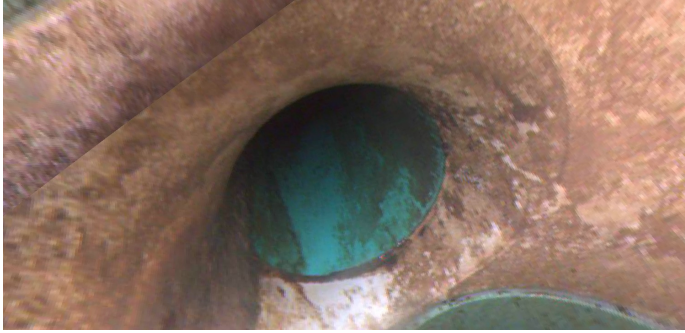
Code: **TF**
Description: **Tap Factory**

Distance (ft): **143.4**
Structural Grade: **0**
O&M Grade: **0**
Clock Start/From: **11**
Clock To:
1st Value: **4.000**
2nd Value:
Value Percent:
Continuous Index:
Within 8" of Joint:
Remarks:

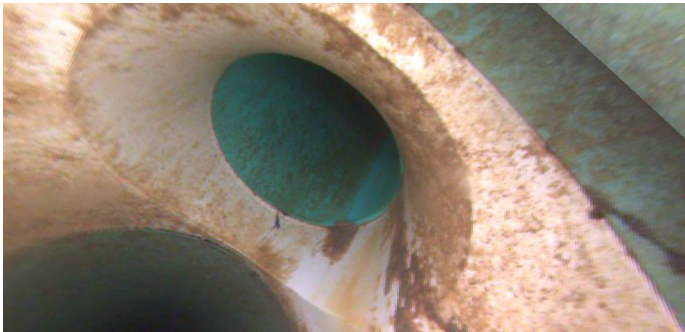
Code: **TF**
Description: **Tap Factory**

Distance (ft): **144.9**
Structural Grade: **0**
O&M Grade: **0**
Clock Start/From: **1**
Clock To:
1st Value: **4.000**
2nd Value:
Value Percent:
Continuous Index:
Within 8" of Joint:
Remarks:

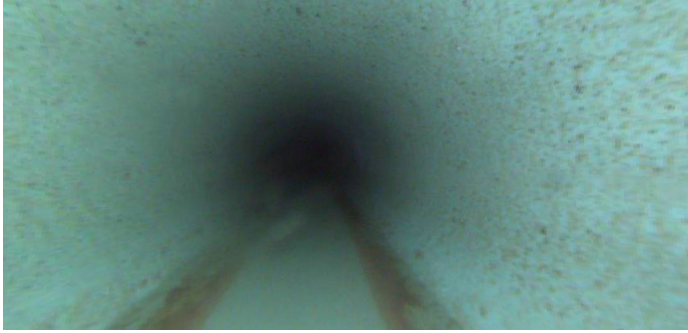
Code:	MSA
Description:	Abandoned Survey
Distance (ft):	153.9
Structural Grade:	0
O&M Grade:	0
Clock Start/From:	
Clock To:	
1st Value:	
2nd Value:	
Value Percent:	
Continuous Index:	
Within 8" of Joint:	NO
Remarks:	ROBOT HAS STOPPED
