Profile/Photo Observation Report

Street:	Oak	Flow Control:	Not Controlled
City:	Hobart, IN	Year Renewed:	
Location:	Ditch	Tape/Media #:	
Purpose:	Maintenance Related	Dia/Height:	8"
Use:	Sanitary	Material:	PVC
Drain Area:	NA	Lining:	
Category:	NA		
Comment:	battery at 152'.

Location Details:		Direction of Survey:	Upstream
US MH:	M-809-011	DS MH:	M-809-012
		Total Length Surveyed (ft):	153.9

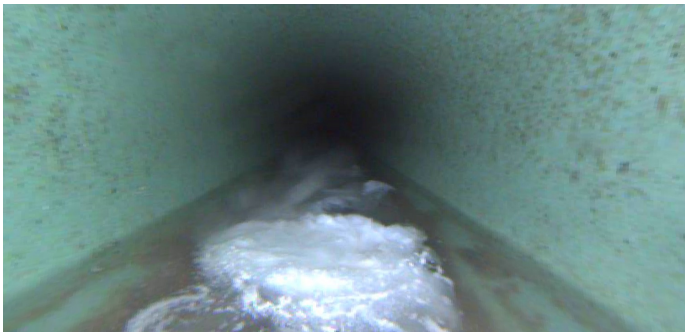
Code:	MGO
Description:	General Observation

Distance (ft):	6.4
Structural Grade:	0
O&M Grade:	0
Clock Start/From:	
Clock To:	
1st Value:	
2nd Value:	
Value Percent:	
Continuous Index:	
Within 8" of Joint:	NO
Remarks:	TOILET TISSUE

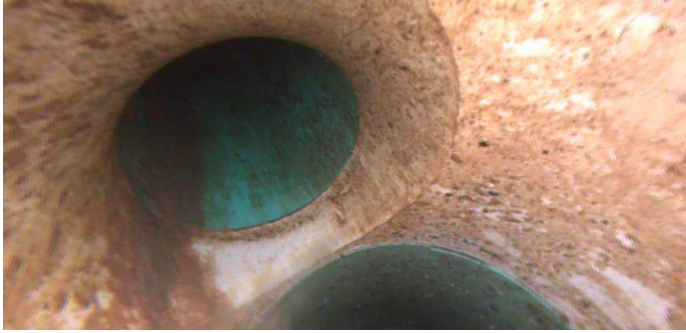
Code: **TF**
Description: **Tap Factory**

Distance (ft): **25.0**
Structural Grade: **0**
O&M Grade: **0**
Clock Start/From: **10**
Clock To:
1st Value: **4.000**
2nd Value:
Value Percent:
Continuous Index:
Within 8" of Joint:
Remarks:

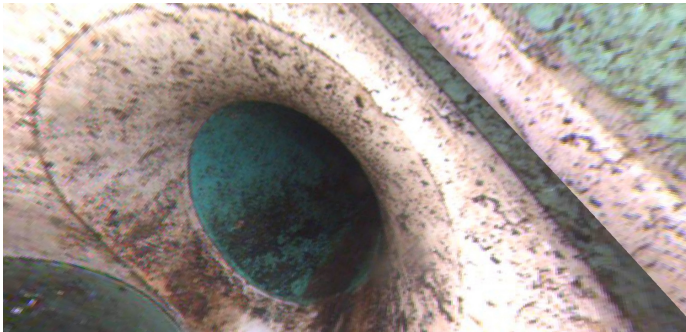
Code: **TF**
Description: **Tap Factory**

Distance (ft): **26.6**
Structural Grade: **0**
O&M Grade: **0**
Clock Start/From: **2**
Clock To:
1st Value: **4.000**
2nd Value:
Value Percent:
Continuous Index:
Within 8" of Joint:
Remarks:

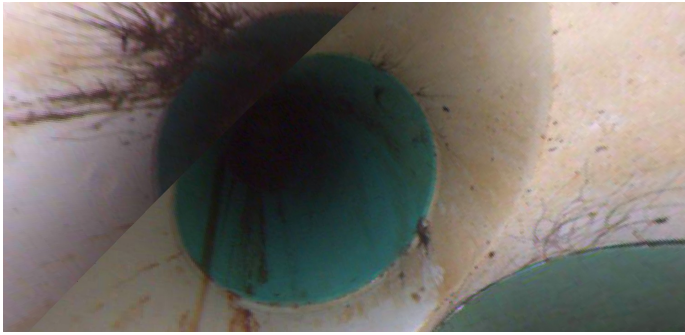
Code: **TFD**
Description: **Tap Factory Defective**

Distance (ft): **78.0**
Structural Grade: **0**
O&M Grade: **2**
Clock Start/From: **11**
Clock To:
1st Value: **4.000**
2nd Value:
Value Percent:
Continuous Index:
Within 8" of Joint:
Remarks: **RF COMING FROM TAP**

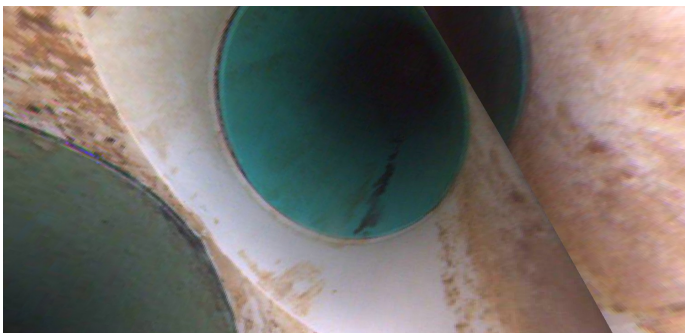
Code: **TF**
Description: **Tap Factory**

Distance (ft): **79.6**
Structural Grade: **0**
O&M Grade: **0**
Clock Start/From: **1**
Clock To:
1st Value: **4.000**
2nd Value:
Value Percent:
Continuous Index:
Within 8" of Joint:
Remarks:

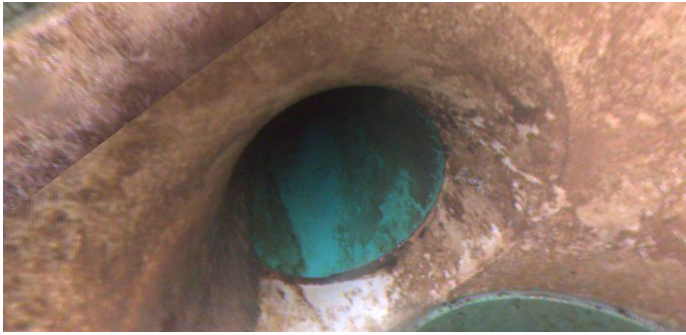
Code: **TF**
Description: **Tap Factory**

Distance (ft): **143.4**
Structural Grade: **0**
O&M Grade: **0**
Clock Start/From: **11**
Clock To:
1st Value: **4.000**
2nd Value:
Value Percent:
Continuous Index:
Within 8" of Joint:
Remarks:

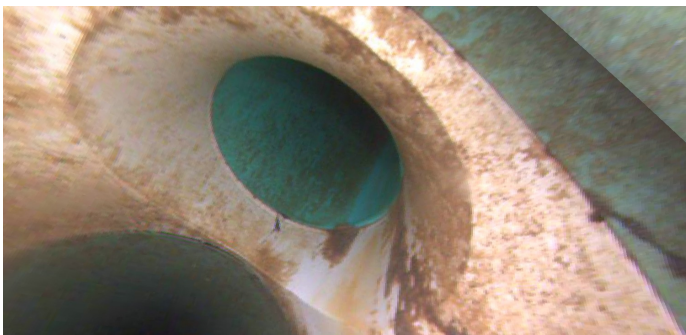
Code: **TF**
Description: **Tap Factory**

Distance (ft): **144.9**
Structural Grade: **0**
O&M Grade: **0**
Clock Start/From: **1**
Clock To:
1st Value: **4.000**
2nd Value:
Value Percent:
Continuous Index:
Within 8" of Joint:
Remarks:

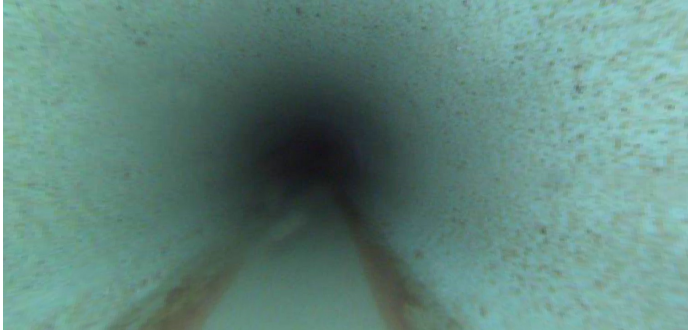
Code:	MSA
Description:	Abandoned Survey
Distance (ft):	153.9
Structural Grade:	0
O&M Grade:	0
Clock Start/From:	
Clock To:	
1st Value:	
2nd Value:	
Value Percent:	
Continuous Index:	
Within 8" of Joint:	NO
Remarks:	ROBOT HAS STOPPED
