## Profile/Photo Observation Report

Street:	<b>GROSBEAK CT</b>	Flow Control:	<b>Not Controlled</b>
City:	<b>Hobart, IN</b>	Year Renewed:	
Location:	<b>Ditch</b>	Tape/Media #:	
Purpose:	<b>Maintenance Related</b>	Dia/Height:	<b>8"</b>
Use:	<b>Sanitary</b>	Material:	<b>PVC</b>
Drain Area:	<b>NA</b>	Lining:	
Category:	<b>NA</b>		
Comment:	<b>Reverse setup. user set max.</b>

Location Details:		Direction of Survey:	<b>Downstream</b>
US MH:	<b>M-809-011</b>	DS MH:	<b>M-809-012</b>
		Total Length Surveyed (ft):	<b>76.7</b>

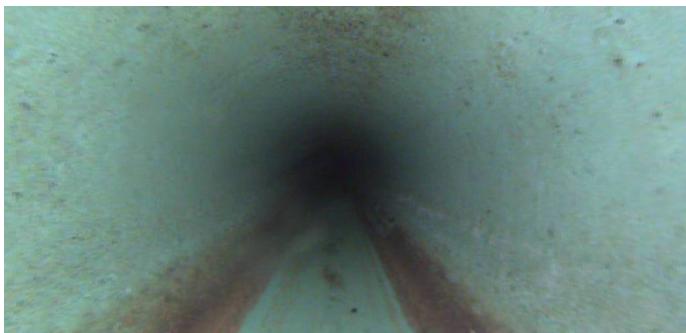
Code: **AMH**  
Description: **Manhole**

Distance (ft): **.0**  
Structural Grade: **0**  
O&M Grade: **0**  
Clock Start/From:  
Clock To:  
1st Value:  
2nd Value:  
Value Percent:  
Continuous Index:  
Within 8" of Joint: **NO**  
Remarks: **M-809-011**

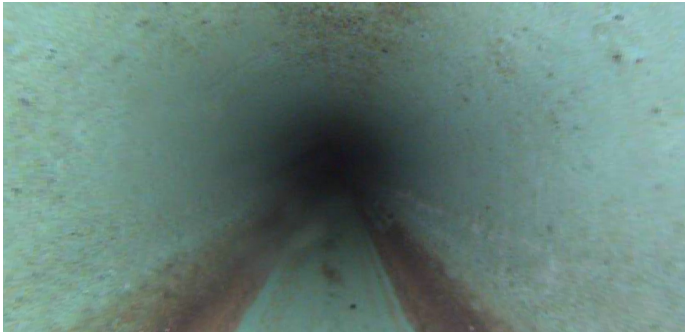
Code:	<b>MWL</b>
Description:	<b>Water Level</b>

Distance (ft):	<b>.0</b>
Structural Grade:	<b>0</b>
O&M Grade:	<b>0</b>
Clock Start/From:	
Clock To:	
1st Value:	
2nd Value:	
Value Percent:	<b>5.000</b>
Continuous Index:	
Within 8" of Joint:	<b>NO</b>
Remarks:

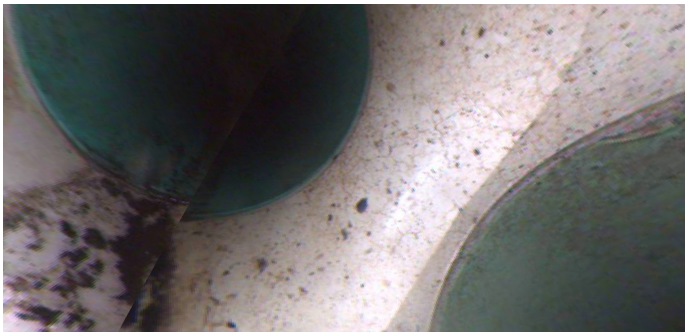
Code:	<b>TF</b>
Description:	<b>Tap Factory</b>

Distance (ft):	<b>12.3</b>
Structural Grade:	<b>0</b>
O&M Grade:	<b>0</b>
Clock Start/From:	<b>10</b>
Clock To:	
1st Value:	<b>4.000</b>
2nd Value:	
Value Percent:	
Continuous Index:	
Within 8" of Joint:	<b>YES</b>
Remarks:

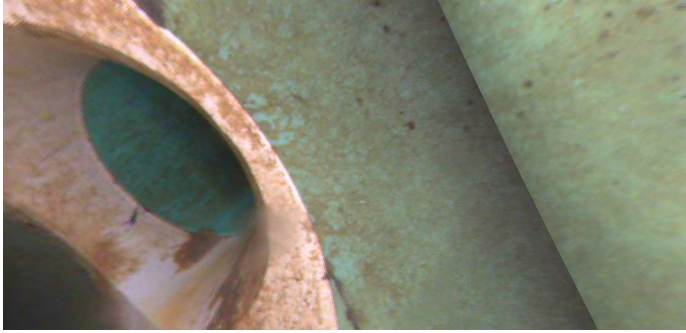
Code: **TF**  
Description: **Tap Factory**

Distance (ft): **38.8**  
Structural Grade: **0**  
O&M Grade: **0**  
Clock Start/From: **10**  
Clock To:  
1st Value: **4.000**  
2nd Value:  
Value Percent:  
Continuous Index:  
Within 8" of Joint: **YES**  
Remarks:

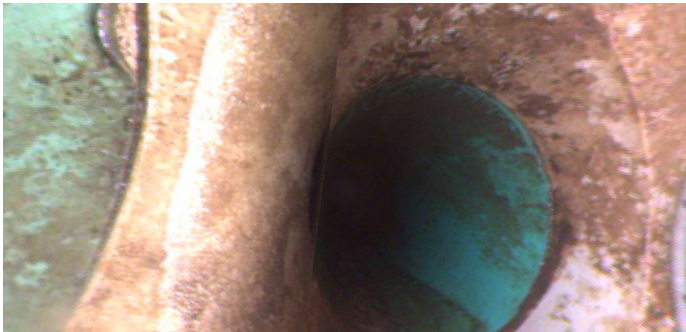
Code: **TF**  
Description: **Tap Factory**

Distance (ft): **40.0**  
Structural Grade: **0**  
O&M Grade: **0**  
Clock Start/From: **2**  
Clock To:  
1st Value: **4.000**  
2nd Value:  
Value Percent:  
Continuous Index:  
Within 8" of Joint: **YES**  
Remarks:

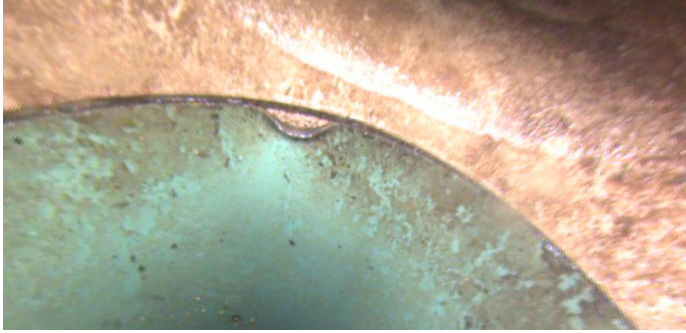
Code: **MGO**  
Description: **General Observation**

Distance (ft): **40.0**  
Structural Grade: **0**  
O&M Grade: **0**  
Clock Start/From:  
Clock To:  
1st Value:  
2nd Value:  
Value Percent:  
Continuous Index:  
Within 8" of Joint: **NO**  
Remarks: **material peeling?**

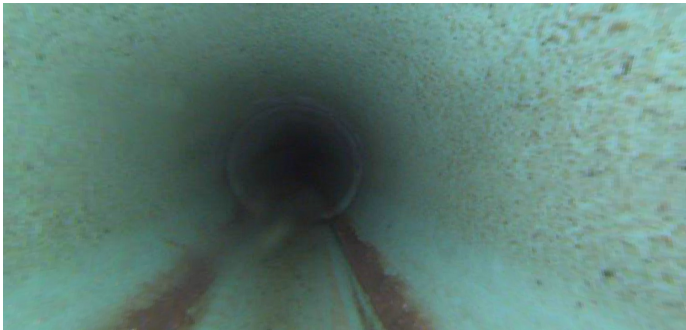
Code: **MSA**  
Description: **Abandoned Survey**

Distance (ft): **76.7**  
Structural Grade: **0**  
O&M Grade: **0**  
Clock Start/From:  
Clock To:  
1st Value:  
2nd Value:  
Value Percent:  
Continuous Index:  
Within 8" of Joint: **NO**  
Remarks: **no blockage**
