## Profile/Photo Observation Report

Street:	<b>Oak</b>	Flow Control:	<b>Not Controlled</b>
City:	<b>Hobart, IN</b>	Year Renewed:	
Location:	<b>Ditch</b>	Tape/Media #:	
Purpose:	<b>Maintenance Related</b>	Dia/Height:	<b>8"</b>
Use:	<b>Sanitary</b>	Material:	<b>PVC</b>
Drain Area:	<b>NA</b>	Lining:	
Category:	<b>NA</b>		
Comment:	<b>Reverse setup. user set max.</b>

Location Details:		Direction of Survey:	<b>Downstream</b>
US MH:	<b>M-809-011</b>	DS MH:	<b>M-809-012</b>
		Total Length Surveyed (ft):	<b>76.7</b>

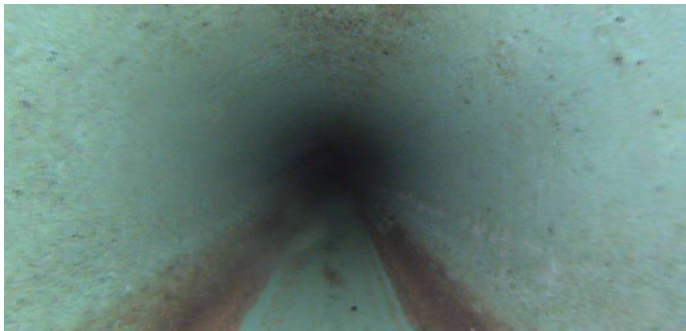
Code: **AMH**  
Description: **Manhole**

Distance (ft): **.0**  
Structural Grade: **0**  
O&M Grade: **0**  
Clock Start/From:  
Clock To:  
1st Value:  
2nd Value:  
Value Percent:  
Continuous Index:  
Within 8" of Joint: **NO**  
Remarks: **M-809-011**

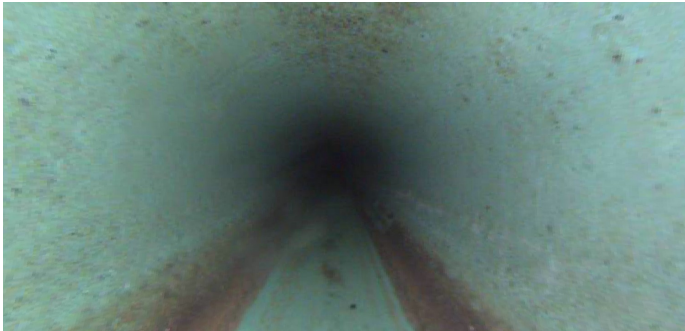
Code:	<b>MWL</b>
Description:	<b>Water Level</b>

Distance (ft):	<b>.0</b>
Structural Grade:	<b>0</b>
O&M Grade:	<b>0</b>
Clock Start/From:	
Clock To:	
1st Value:	
2nd Value:	
Value Percent:	<b>5.000</b>
Continuous Index:	
Within 8" of Joint:	<b>NO</b>
Remarks:

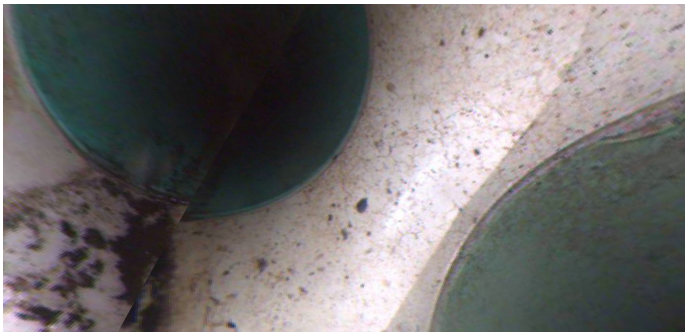
Code:	<b>TF</b>
Description:	<b>Tap Factory</b>

Distance (ft):	<b>12.3</b>
Structural Grade:	<b>0</b>
O&M Grade:	<b>0</b>
Clock Start/From:	<b>10</b>
Clock To:	
1st Value:	<b>4.000</b>
2nd Value:	
Value Percent:	
Continuous Index:	
Within 8" of Joint:	<b>YES</b>
Remarks:

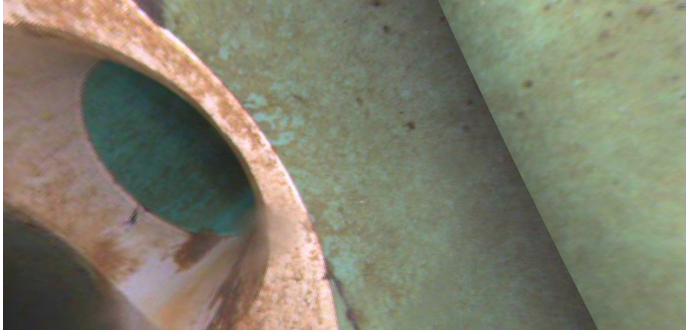
Code: **TF**  
Description: **Tap Factory**

Distance (ft): **38.8**  
Structural Grade: **0**  
O&M Grade: **0**  
Clock Start/From: **10**  
Clock To:  
1st Value: **4.000**  
2nd Value:  
Value Percent:  
Continuous Index:  
Within 8" of Joint: **YES**  
Remarks:

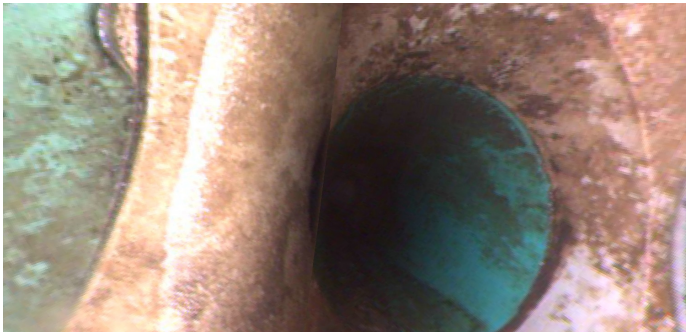
Code: **TF**  
Description: **Tap Factory**

Distance (ft): **40.0**  
Structural Grade: **0**  
O&M Grade: **0**  
Clock Start/From: **2**  
Clock To:  
1st Value: **4.000**  
2nd Value:  
Value Percent:  
Continuous Index:  
Within 8" of Joint: **YES**  
Remarks:

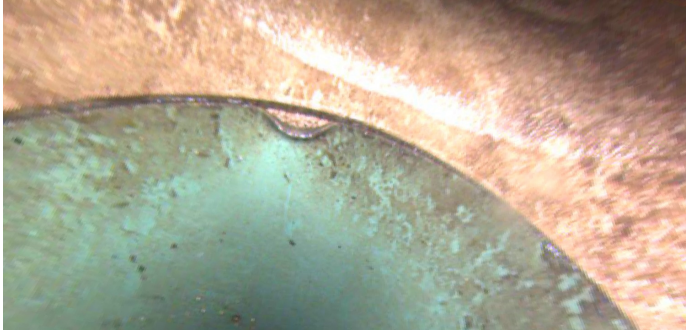
Code: **MGO**  
Description: **General Observation**

Distance (ft): **40.0**  
Structural Grade: **0**  
O&M Grade: **0**  
Clock Start/From:  
Clock To:  
1st Value:  
2nd Value:  
Value Percent:  
Continuous Index:  
Within 8" of Joint: **NO**  
Remarks: **material peeling?**

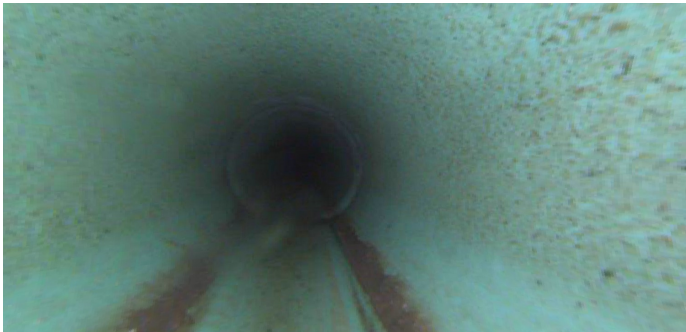
Code: **MSA**  
Description: **Abandoned Survey**

Distance (ft): **76.7**  
Structural Grade: **0**  
O&M Grade: **0**  
Clock Start/From:  
Clock To:  
1st Value:  
2nd Value:  
Value Percent:  
Continuous Index:  
Within 8" of Joint: **NO**  
Remarks: **no blockage**
