Profile/Photo Observation Report

Street:	GROSBEAK CT	Flow Control:	Not Controlled
City:	Hobart, IN	Year Renewed:	
Location:	Ditch	Tape/Media #:	
Purpose:	Maintenance Related	Dia/Height:	8"
Use:	Sanitary	Material:	PVC
Drain Area:	NA	Lining:	
Category:	NA		
Comment:	mh confirmed.

Location Details:		Direction of Survey:	Downstream
US MH:	M-809-012	DS MH:	M-809-013
		Total Length Surveyed (ft):	157.6

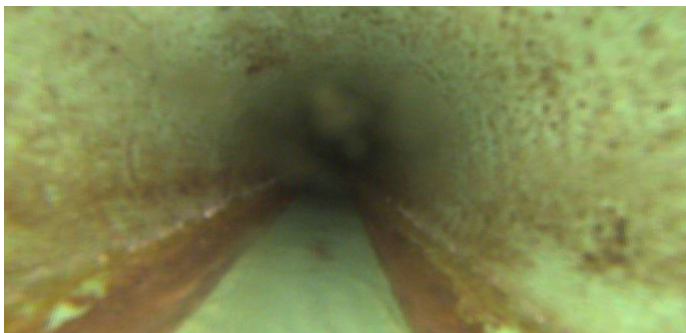
Code: **AMH**
Description: **Manhole**

Distance (ft): **.0**
Structural Grade: **0**
O&M Grade: **0**
Clock Start/From:
Clock To:
1st Value:
2nd Value:
Value Percent:
Continuous Index:
Within 8" of Joint: **NO**
Remarks: **M-809-012**

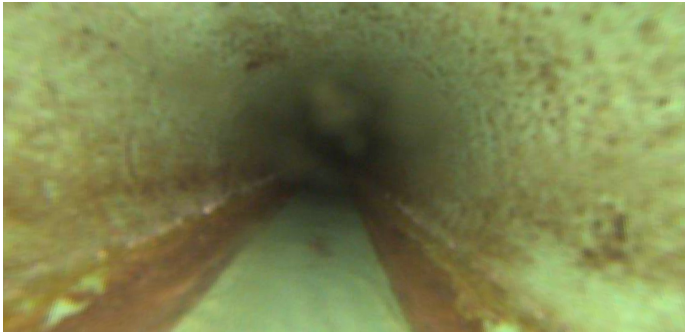
Code:	MWL
Description:	Water Level

Distance (ft):	.0
Structural Grade:	0
O&M Grade:	0
Clock Start/From:	
Clock To:	
1st Value:	
2nd Value:	
Value Percent:	5.000
Continuous Index:	
Within 8" of Joint:	NO
Remarks:

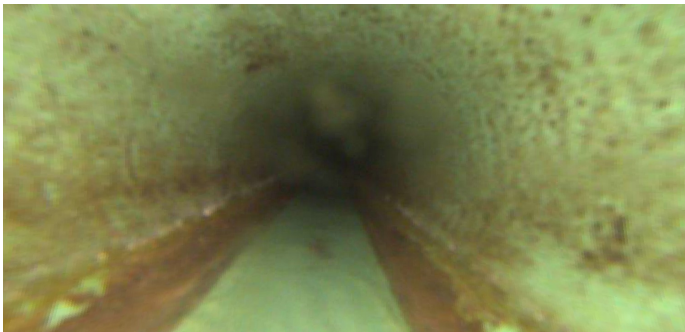
Code:	DAZ
Description:	Deposits Attached Other

Distance (ft):	.0
Structural Grade:	0
O&M Grade:	2
Clock Start/From:	7
Clock To:	5
1st Value:	
2nd Value:	
Value Percent:	5.000
Continuous Index:	S01
Within 8" of Joint:	YES
Remarks:	WANDER

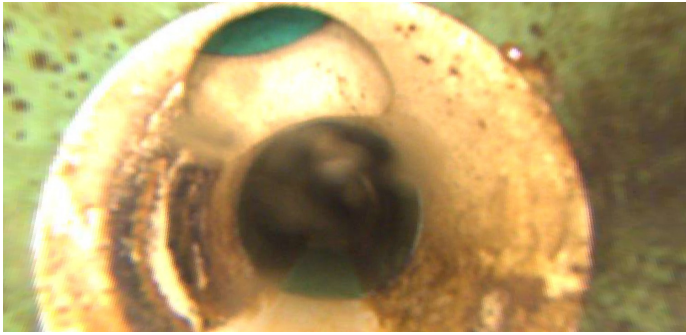
Code: **TF**
Description: **Tap Factory**

Distance (ft): **21.9**
Structural Grade: **0**
O&M Grade: **0**
Clock Start/From: **11**
Clock To:
1st Value: **4.000**
2nd Value:
Value Percent:
Continuous Index:
Within 8" of Joint:
Remarks:

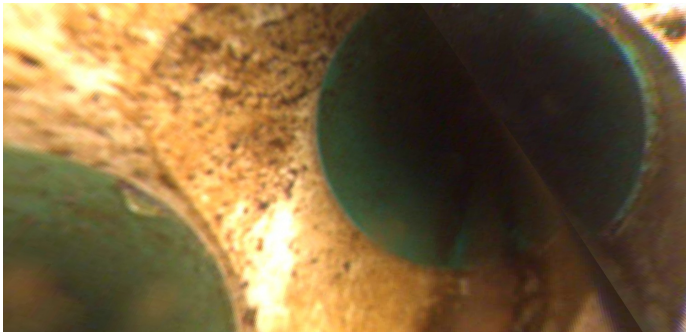
Code: **TF**
Description: **Tap Factory**

Distance (ft): **24.0**
Structural Grade: **0**
O&M Grade: **0**
Clock Start/From: **2**
Clock To:
1st Value: **4.000**
2nd Value:
Value Percent:
Continuous Index:
Within 8" of Joint:
Remarks:

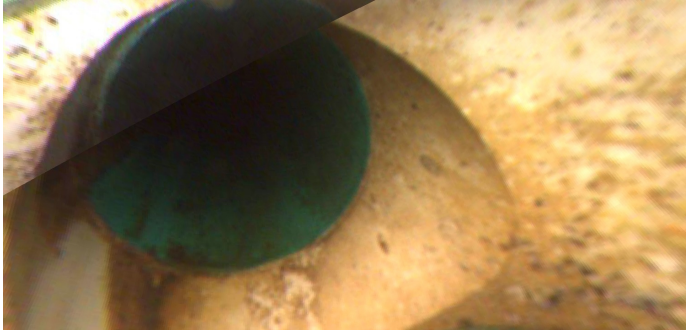
Code: **TF**
Description: **Tap Factory**

Distance (ft): **62.7**
Structural Grade: **0**
O&M Grade: **0**
Clock Start/From: **11**
Clock To:
1st Value: **4.000**
2nd Value:
Value Percent:
Continuous Index:
Within 8" of Joint:
Remarks:

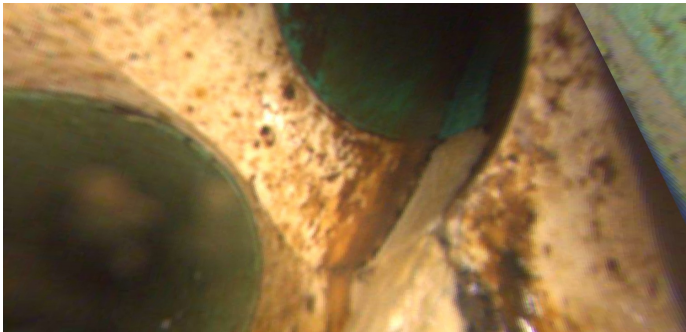
Code: **TFA**
Description: **Tap Factory Active**

Distance (ft): **64.2**
Structural Grade: **0**
O&M Grade: **0**
Clock Start/From: **1**
Clock To:
1st Value: **4.000**
2nd Value:
Value Percent:
Continuous Index:
Within 8" of Joint:
Remarks:

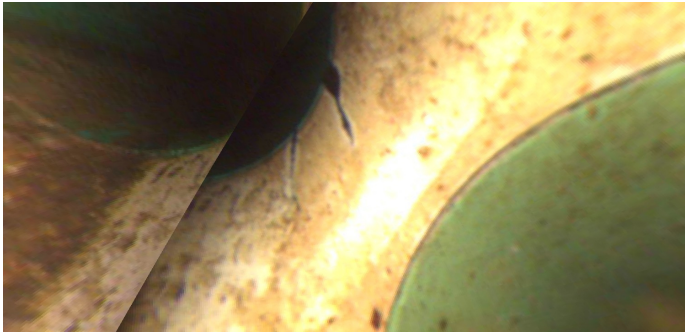
Code: **TF**
Description: **Tap Factory**

Distance (ft): **128.7**
Structural Grade: **0**
O&M Grade: **0**
Clock Start/From: **11**
Clock To:
1st Value: **4.000**
2nd Value:
Value Percent:
Continuous Index:
Within 8" of Joint:
Remarks:

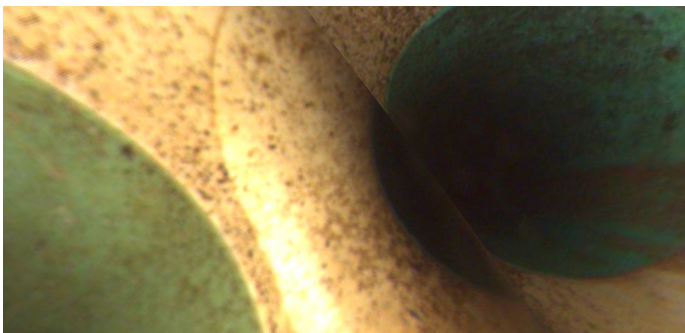
Code: **TF**
Description: **Tap Factory**

Distance (ft): **130.3**
Structural Grade: **0**
O&M Grade: **0**
Clock Start/From: **1**
Clock To:
1st Value: **4.000**
2nd Value:
Value Percent:
Continuous Index:
Within 8" of Joint:
Remarks:
