Profile/Photo Observation Report

Date:	03/24/2018	Weather:		Coding:	PACP 6.0
Pipe Length (ft):	160.7	Owner:	NA	Pre Clean:	Not Known
P.O.#:		Surveyor:	Justin Gonzales	PSR:	P-809-012-013
Customer:		Clean Date:	01/01/1900	Shape:	C

Street:	Oak	Flow Control:	Not Controlled
City:	Hobart, IN	Year Renewed:	
Location:	Ditch	Tape/Media #:	
Purpose:	Maintenance Related	Dia/Height:	8"
Use:	Sanitary	Material:	PVC
Drain Area:	NA	Lining:	
Category:	NA		
Comment:	mh confirmed.

Location Details:		Direction of Survey:	Downstream
US MH:	M-809-012	DS MH:	M-809-013
		Total Length Surveyed (ft):	157.6

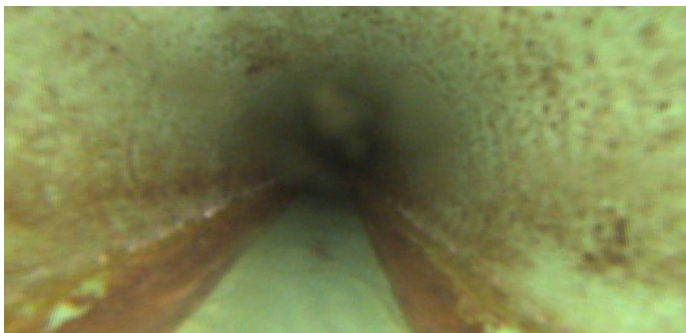
Code: **AMH**
Description: **Manhole**

Distance (ft): **.0**
Structural Grade: **0**
O&M Grade: **0**
Clock Start/From:
Clock To:
1st Value:
2nd Value:
Value Percent:
Continuous Index:
Within 8" of Joint: **NO**
Remarks: **M-809-012**

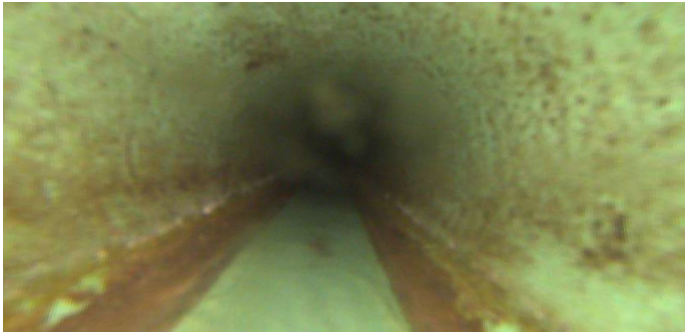
Code:	MWL
Description:	Water Level

Distance (ft):	.0
Structural Grade:	0
O&M Grade:	0
Clock Start/From:	
Clock To:	
1st Value:	
2nd Value:	
Value Percent:	5.000
Continuous Index:	
Within 8" of Joint:	NO
Remarks:

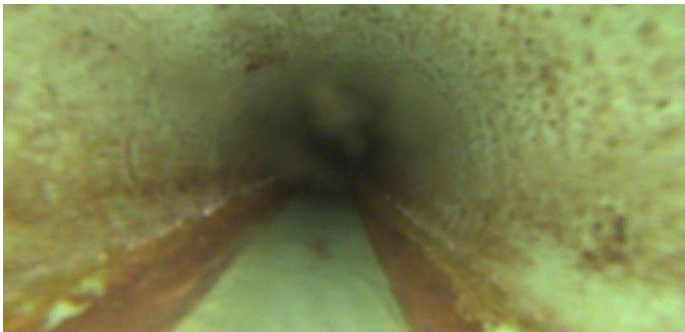
Code:	DAZ
Description:	Deposits Attached Other

Distance (ft):	.0
Structural Grade:	0
O&M Grade:	2
Clock Start/From:	7
Clock To:	5
1st Value:	
2nd Value:	
Value Percent:	5.000
Continuous Index:	S01
Within 8" of Joint:	YES
Remarks:	WANDER

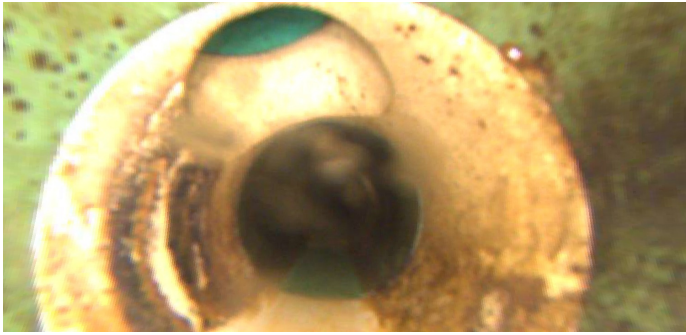
Code: **TF**
Description: **Tap Factory**

Distance (ft): **21.9**
Structural Grade: **0**
O&M Grade: **0**
Clock Start/From: **11**
Clock To:
1st Value: **4.000**
2nd Value:
Value Percent:
Continuous Index:
Within 8" of Joint:
Remarks:

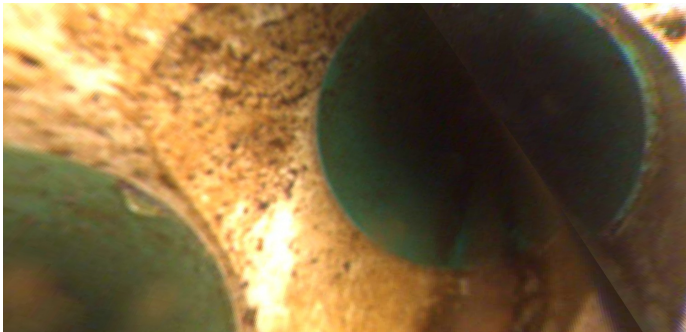
Code: **TF**
Description: **Tap Factory**

Distance (ft): **24.0**
Structural Grade: **0**
O&M Grade: **0**
Clock Start/From: **2**
Clock To:
1st Value: **4.000**
2nd Value:
Value Percent:
Continuous Index:
Within 8" of Joint:
Remarks:

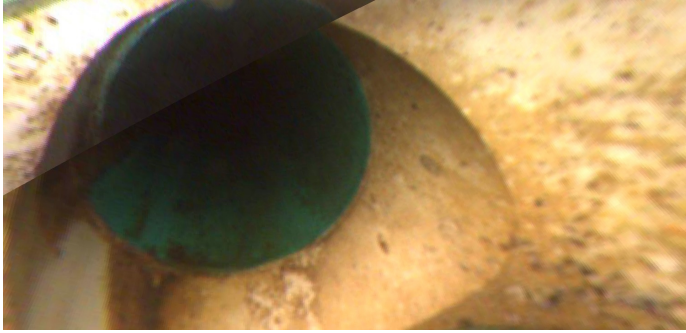
Code: **TF**
Description: **Tap Factory**

Distance (ft): **62.7**
Structural Grade: **0**
O&M Grade: **0**
Clock Start/From: **11**
Clock To:
1st Value: **4.000**
2nd Value:
Value Percent:
Continuous Index:
Within 8" of Joint:
Remarks:

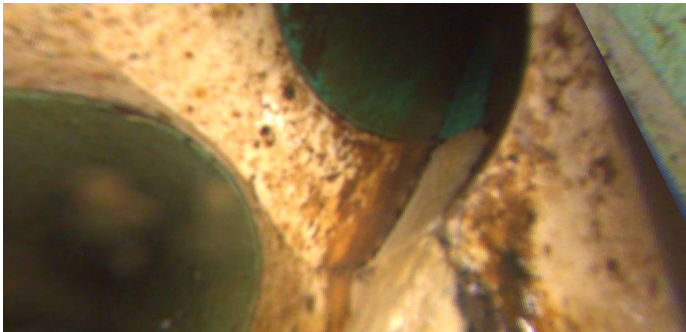
Code: **TFA**
Description: **Tap Factory Active**

Distance (ft): **64.2**
Structural Grade: **0**
O&M Grade: **0**
Clock Start/From: **1**
Clock To:
1st Value: **4.000**
2nd Value:
Value Percent:
Continuous Index:
Within 8" of Joint:
Remarks:

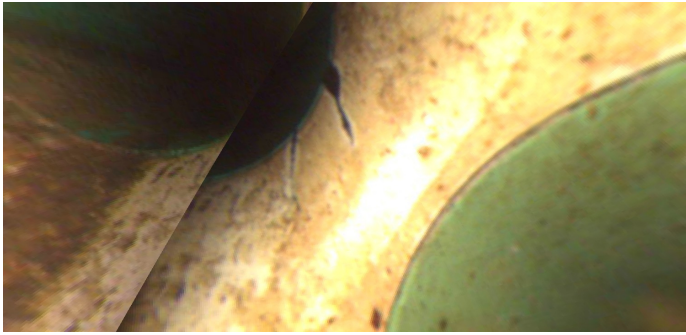
Code: **TF**
Description: **Tap Factory**

Distance (ft): **128.7**
Structural Grade: **0**
O&M Grade: **0**
Clock Start/From: **11**
Clock To:
1st Value: **4.000**
2nd Value:
Value Percent:
Continuous Index:
Within 8" of Joint:
Remarks:

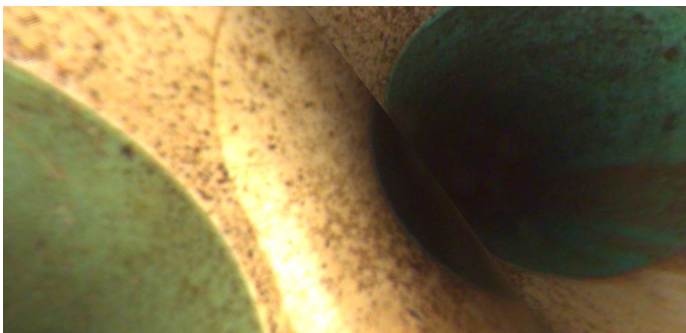
Code: **TF**
Description: **Tap Factory**

Distance (ft): **130.3**
Structural Grade: **0**
O&M Grade: **0**
Clock Start/From: **1**
Clock To:
1st Value: **4.000**
2nd Value:
Value Percent:
Continuous Index:
Within 8" of Joint:
Remarks:
