## Profile/Photo Observation Report

Street:	<b>TANAGER ST</b>	Flow Control:	<b>Not Controlled</b>
City:	<b>Hobart, IN</b>	Year Renewed:	
Location:	<b>Sidewalk</b>	Tape/Media #:	
Purpose:	<b>Maintenance Related</b>	Dia/Height:	<b>8"</b>
Use:	<b>Sanitary</b>	Material:	<b>PVC</b>
Drain Area:	<b>NA</b>	Lining:	
Category:	<b>NA</b>		
Comment:

Location Details:		Direction of Survey:	<b>Upstream</b>
US MH:	<b>M-809-013</b>	DS MH:	<b>M-809-018</b>
		Total Length Surveyed (ft):	<b>306.8</b>

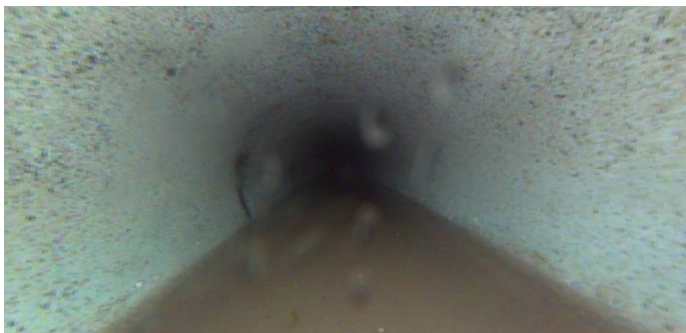
Code: **AMH**  
Description: **Manhole**

Distance (ft): **.0**  
Structural Grade: **0**  
O&M Grade: **0**  
Clock Start/From:  
Clock To:  
1st Value:  
2nd Value:  
Value Percent:  
Continuous Index:  
Within 8" of Joint: **NO**  
Remarks: **M-809-018**

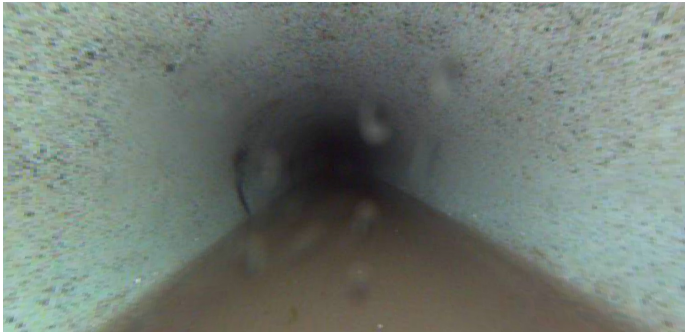
Code:	<b>MWL</b>
Description:	<b>Water Level</b>

Distance (ft):	<b>.0</b>
Structural Grade:	<b>0</b>
O&M Grade:	<b>0</b>
Clock Start/From:	
Clock To:	
1st Value:	
2nd Value:	
Value Percent:	<b>5.000</b>
Continuous Index:	
Within 8" of Joint:	<b>NO</b>
Remarks:

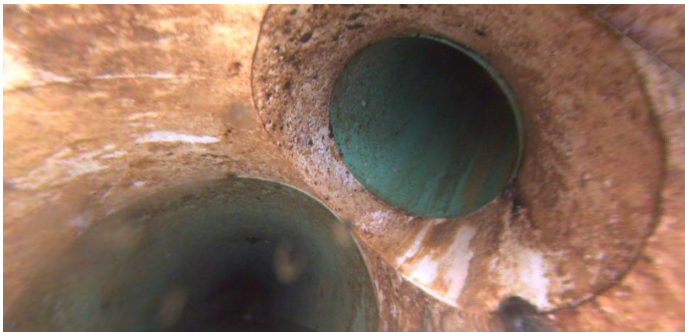
Code:	<b>TF</b>
Description:	<b>Tap Factory</b>

Distance (ft):	<b>62.5</b>
Structural Grade:	<b>0</b>
O&M Grade:	<b>0</b>
Clock Start/From:	<b>2</b>
Clock To:	
1st Value:	<b>4.000</b>
2nd Value:	
Value Percent:	
Continuous Index:	
Within 8" of Joint:	
Remarks:

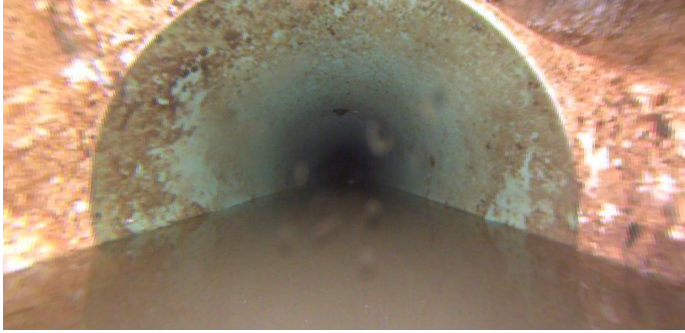
Code: **MWL**  
Description: **Water Level**

Distance (ft): **62.8**  
Structural Grade: **0**  
O&M Grade: **0**  
Clock Start/From:  
Clock To:  
1st Value:  
2nd Value:  
Value Percent: **25.000**  
Continuous Index:  
Within 8" of Joint: **NO**  
Remarks:

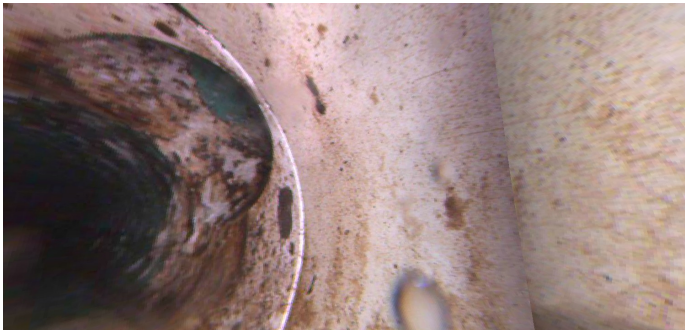
Code: **TF**  
Description: **Tap Factory**

Distance (ft): **144.7**  
Structural Grade: **0**  
O&M Grade: **0**  
Clock Start/From: **10**  
Clock To:  
1st Value: **4.000**  
2nd Value:  
Value Percent:  
Continuous Index:  
Within 8" of Joint: **YES**  
Remarks:

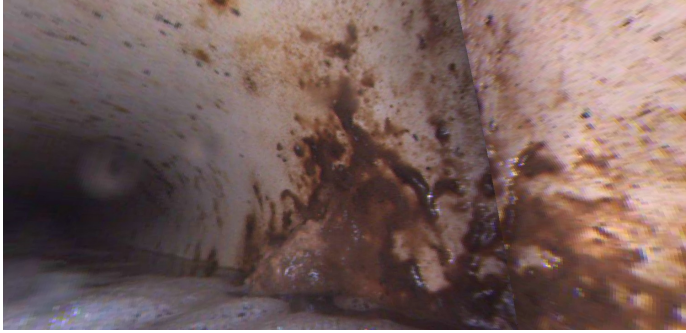
Code: **DAGS**  
Description: **Deposits Attached Grease**

Distance (ft): **144.7**  
Structural Grade: **0**  
O&M Grade: **2**  
Clock Start/From: **4**  
Clock To:  
1st Value:  
2nd Value:  
Value Percent: **5.000**  
Continuous Index:  
Within 8" of Joint: **NO**  
Remarks:

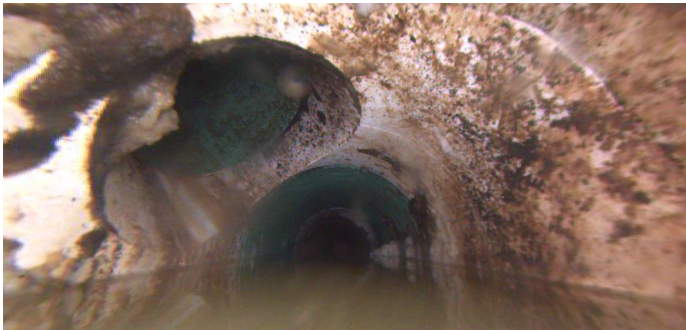
Code: **TF**  
Description: **Tap Factory**

Distance (ft): **203.7**  
Structural Grade: **0**  
O&M Grade: **0**  
Clock Start/From: **11**  
Clock To:  
1st Value: **4.000**  
2nd Value:  
Value Percent:  
Continuous Index:  
Within 8" of Joint:  
Remarks:

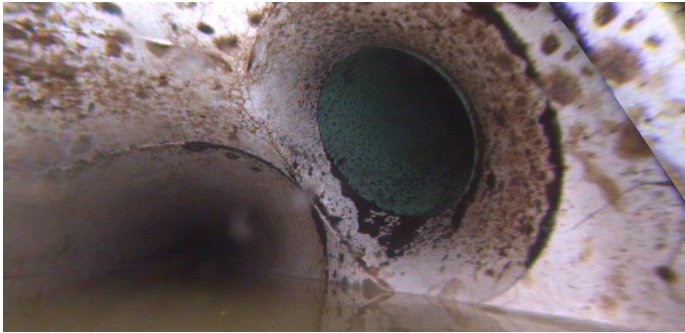
Code: **TF**  
Description: **Tap Factory**

Distance (ft): **205.5**  
Structural Grade: **0**  
O&M Grade: **0**  
Clock Start/From: **2**  
Clock To:  
1st Value: **4.000**  
2nd Value:  
Value Percent:  
Continuous Index:  
Within 8" of Joint:  
Remarks:

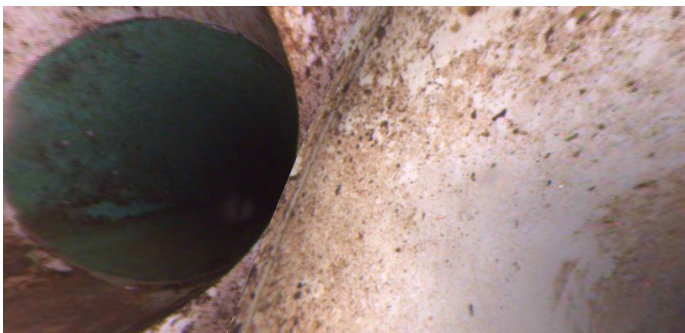
Code: **TF**  
Description: **Tap Factory**

Distance (ft): **264.5**  
Structural Grade: **0**  
O&M Grade: **0**  
Clock Start/From: **10**  
Clock To:  
1st Value: **4.000**  
2nd Value:  
Value Percent:  
Continuous Index:  
Within 8" of Joint: **YES**  
Remarks:

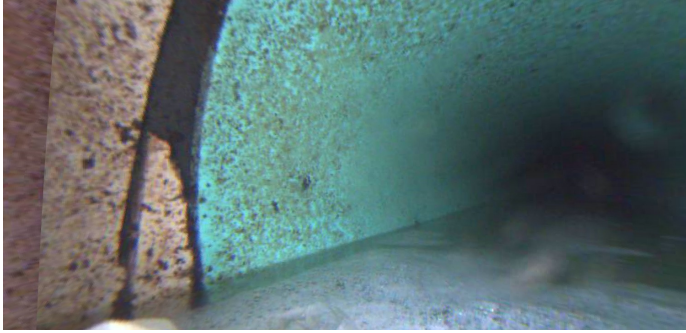
Code: **B**  
Description: **Broken**

Distance (ft): **267.3**  
Structural Grade: **3**  
O&M Grade: **0**  
Clock Start/From: **9**  
Clock To:  
1st Value:  
2nd Value:  
Value Percent:  
Continuous Index:  
Within 8" of Joint: **YES**  
Remarks:
