Profile/Photo Observation Report

Date:	03/24/2018	Weather:		Coding:	PACP 6.0
Pipe Length (ft):	313.4	Owner:	NA	Pre Clean:	Not Known
P.O.#:		Surveyor:	Byrd Fitzgerald	PSR:	P-809-013-018
Customer:		Clean Date:	01/01/1900	Shape:	C

Street:	Oak	Flow Control:	Not Controlled
City:	Hobart, IN	Year Renewed:	
Location:	Sidewalk	Tape/Media #:	
Purpose:	Maintenance Related	Dia/Height:	8"
Use:	Sanitary	Material:	PVC
Drain Area:	NA	Lining:	
Category:	NA		
Comment:

Location Details:		Direction of Survey:	Upstream
US MH:	M-809-013	DS MH:	M-809-018
		Total Length Surveyed (ft):	306.8

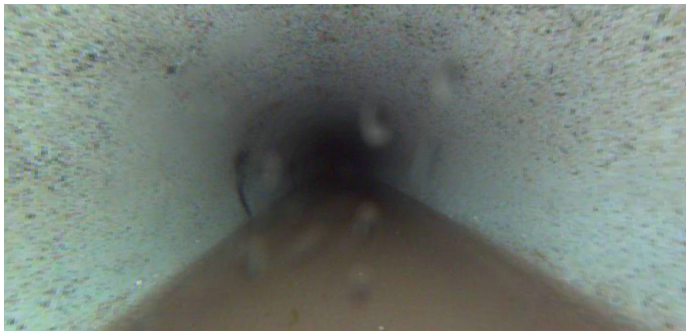
Code: **AMH**
Description: **Manhole**

Distance (ft): **.0**
Structural Grade: **0**
O&M Grade: **0**
Clock Start/From:
Clock To:
1st Value:
2nd Value:
Value Percent:
Continuous Index:
Within 8" of Joint: **NO**
Remarks: **M-809-018**

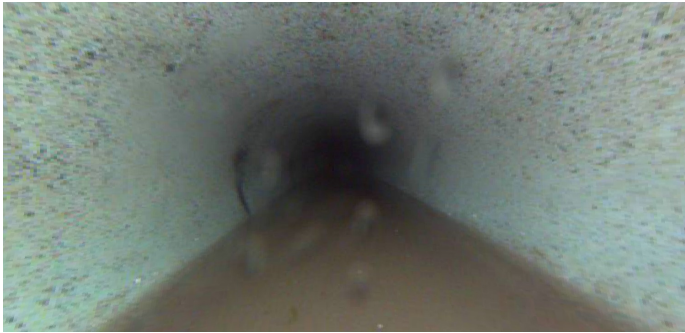
Code:	MWL
Description:	Water Level

Distance (ft):	.0
Structural Grade:	0
O&M Grade:	0
Clock Start/From:	
Clock To:	
1st Value:	
2nd Value:	
Value Percent:	5.000
Continuous Index:	
Within 8" of Joint:	NO
Remarks:

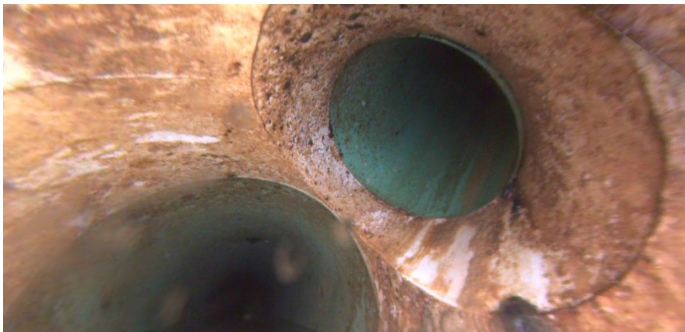
Code:	TF
Description:	Tap Factory

Distance (ft):	62.5
Structural Grade:	0
O&M Grade:	0
Clock Start/From:	2
Clock To:	
1st Value:	4.000
2nd Value:	
Value Percent:	
Continuous Index:	
Within 8" of Joint:	
Remarks:

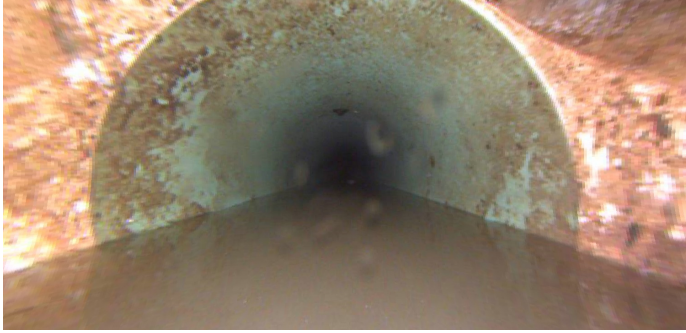
Code: **MWL**
Description: **Water Level**

Distance (ft): **62.8**
Structural Grade: **0**
O&M Grade: **0**
Clock Start/From:
Clock To:
1st Value:
2nd Value:
Value Percent: **25.000**
Continuous Index:
Within 8" of Joint: **NO**
Remarks:

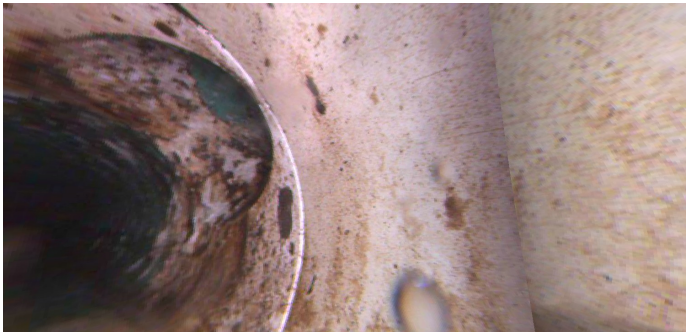
Code: **TF**
Description: **Tap Factory**

Distance (ft): **144.7**
Structural Grade: **0**
O&M Grade: **0**
Clock Start/From: **10**
Clock To:
1st Value: **4.000**
2nd Value:
Value Percent:
Continuous Index:
Within 8" of Joint: **YES**
Remarks:

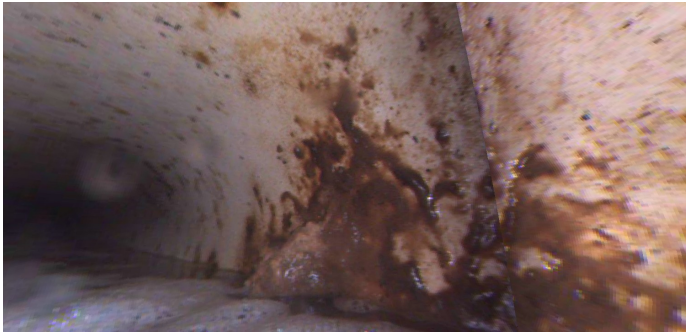
Code: **DAGS**
Description: **Deposits Attached Grease**

Distance (ft): **144.7**
Structural Grade: **0**
O&M Grade: **2**
Clock Start/From: **4**
Clock To:
1st Value:
2nd Value:
Value Percent: **5.000**
Continuous Index:
Within 8" of Joint: **NO**
Remarks:

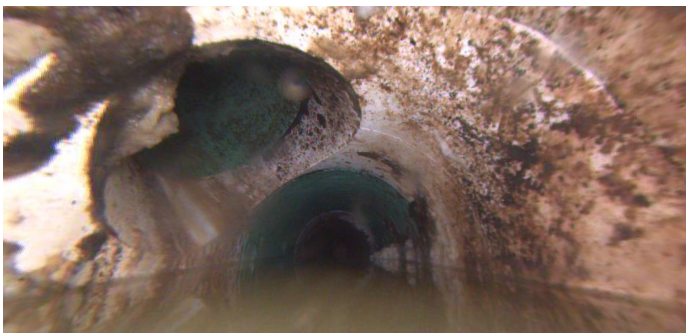
Code: **TF**
Description: **Tap Factory**

Distance (ft): **203.7**
Structural Grade: **0**
O&M Grade: **0**
Clock Start/From: **11**
Clock To:
1st Value: **4.000**
2nd Value:
Value Percent:
Continuous Index:
Within 8" of Joint:
Remarks:

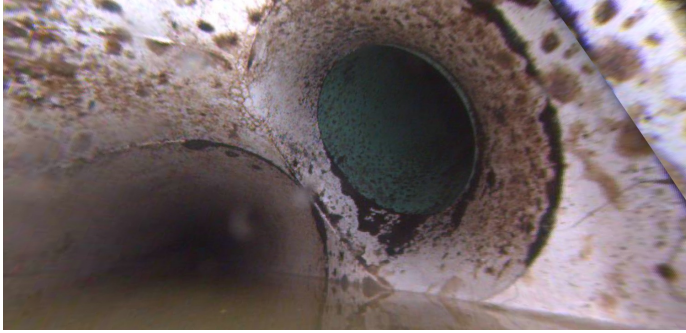
Code: **TF**
Description: **Tap Factory**

Distance (ft): **205.5**
Structural Grade: **0**
O&M Grade: **0**
Clock Start/From: **2**
Clock To:
1st Value: **4.000**
2nd Value:
Value Percent:
Continuous Index:
Within 8" of Joint:
Remarks:

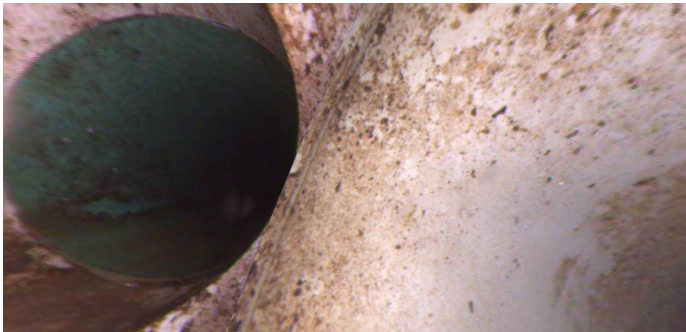
Code: **TF**
Description: **Tap Factory**

Distance (ft): **264.5**
Structural Grade: **0**
O&M Grade: **0**
Clock Start/From: **10**
Clock To:
1st Value: **4.000**
2nd Value:
Value Percent:
Continuous Index:
Within 8" of Joint: **YES**
Remarks:

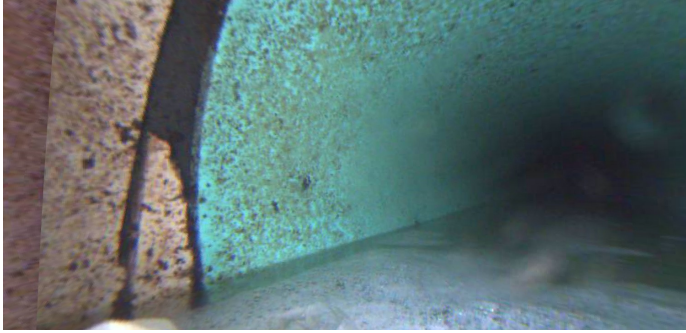
Code: **B**
Description: **Broken**

Distance (ft): **267.3**
Structural Grade: **3**
O&M Grade: **0**
Clock Start/From: **9**
Clock To:
1st Value:
2nd Value:
Value Percent:
Continuous Index:
Within 8" of Joint: **YES**
Remarks:
