Profile/Photo Observation Report

Street:	TANAGER ST	Flow Control:	Not Controlled
City:	Hobart, IN	Year Renewed:	
Location:	Sidewalk	Tape/Media #:	
Purpose:	Maintenance Related	Dia/Height:	8"
Use:	Sanitary	Material:	PVC
Drain Area:	NA	Lining:	
Category:	NA		
Comment:	Flow direction wrong.

Location Details:		Direction of Survey:	Downstream
US MH:	M-809-014	DS MH:	M-809-015
		Total Length Surveyed (ft):	69.4

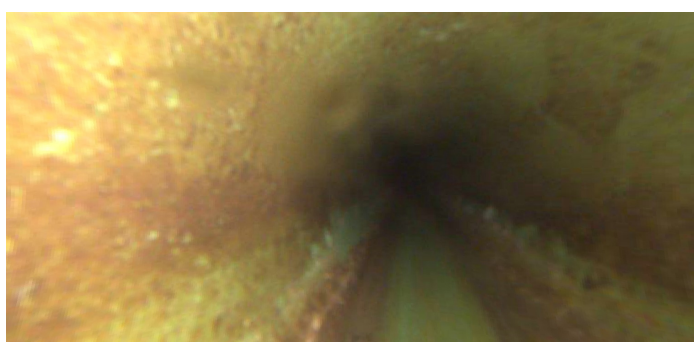
Code: **AMH**
Description: **Manhole**

Distance (ft): **.0**
Structural Grade: **0**
O&M Grade: **0**
Clock Start/From:
Clock To:
1st Value:
2nd Value:
Value Percent:
Continuous Index:
Within 8" of Joint: **NO**
Remarks: **M-809-014**

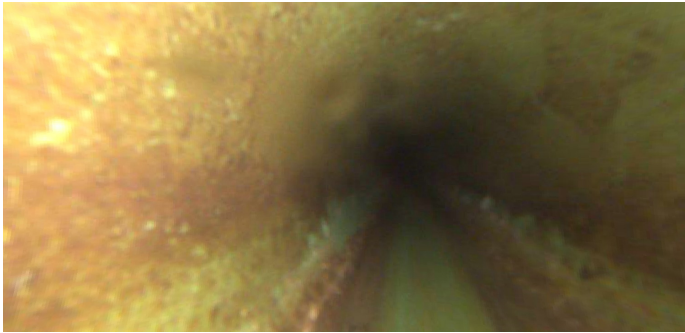
Code:	MWL
Description:	Water Level

Distance (ft):	.0
Structural Grade:	0
O&M Grade:	0
Clock Start/From:	
Clock To:	
1st Value:	
2nd Value:	
Value Percent:	5.000
Continuous Index:	
Within 8" of Joint:	NO
Remarks:

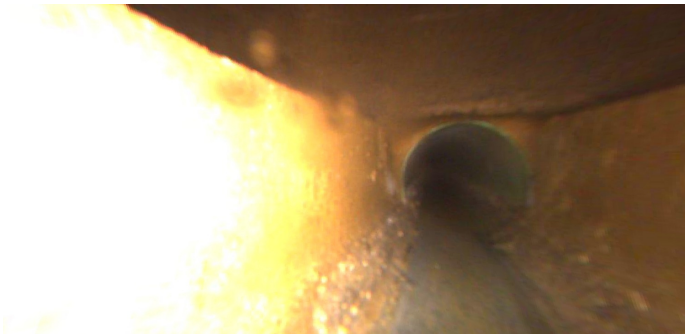
Code:	AMH
Description:	Manhole

Distance (ft):	69.4
Structural Grade:	0
O&M Grade:	0
Clock Start/From:	
Clock To:	
1st Value:	
2nd Value:	
Value Percent:	
Continuous Index:	
Within 8" of Joint:	NO
Remarks:	M-809-015
