Profile/Photo Observation Report

Street:	Tanager	Flow Control:	Not Controlled
City:	Hobart, IN	Year Renewed:	
Location:	Sidewalk	Tape/Media #:	
Purpose:	Maintenance Related	Dia/Height:	8"
Use:	Sanitary	Material:	PVC
Drain Area:	NA	Lining:	
Category:	NA		
Comment:	Flow direction wrong.

Location Details:		Direction of Survey:	Downstream
US MH:	M-809-014	DS MH:	M-809-015
		Total Length Surveyed (ft):	69.4

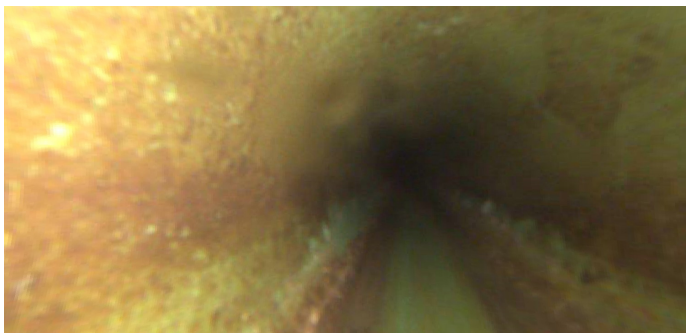
Code: **AMH**
Description: **Manhole**

Distance (ft): **.0**
Structural Grade: **0**
O&M Grade: **0**
Clock Start/From:
Clock To:
1st Value:
2nd Value:
Value Percent:
Continuous Index:
Within 8" of Joint: **NO**
Remarks: **M-809-014**

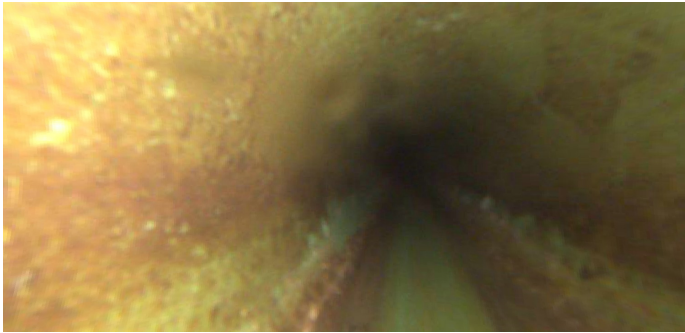
Code:	MWL
Description:	Water Level

Distance (ft):	.0
Structural Grade:	0
O&M Grade:	0
Clock Start/From:	
Clock To:	
1st Value:	
2nd Value:	
Value Percent:	5.000
Continuous Index:	
Within 8" of Joint:	NO
Remarks:

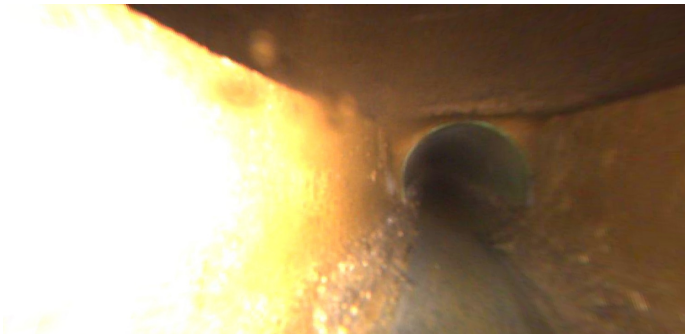
Code:	AMH
Description:	Manhole

Distance (ft):	69.4
Structural Grade:	0
O&M Grade:	0
Clock Start/From:	
Clock To:	
1st Value:	
2nd Value:	
Value Percent:	
Continuous Index:	
Within 8" of Joint:	NO
Remarks:	M-809-015
