## Profile/Photo Observation Report

Street:	<b>TANAGER ST</b>	Flow Control:	<b>Not Controlled</b>
City:	<b>Hobart, IN</b>	Year Renewed:	
Location:	<b>Sidewalk</b>	Tape/Media #:	
Purpose:	<b>Maintenance Related</b>	Dia/Height:	<b>8"</b>
Use:	<b>Sanitary</b>	Material:	<b>PVC</b>
Drain Area:	<b>NA</b>	Lining:	
Category:	<b>NA</b>		
Comment:	<b>Flow direction wrong.</b>

Location Details:		Direction of Survey:	<b>Downstream</b>
US MH:	<b>M-809-016</b>	DS MH:	<b>M-809-017</b>
		Total Length Surveyed (ft):	<b>78.5</b>

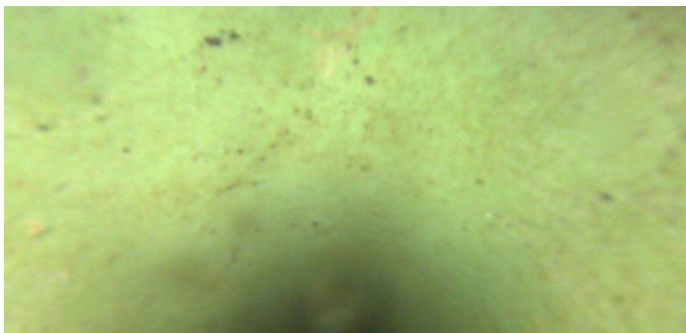
Code: **AMH**  
Description: **Manhole**

Distance (ft): **.0**  
Structural Grade: **0**  
O&M Grade: **0**  
Clock Start/From:  
Clock To:  
1st Value:  
2nd Value:  
Value Percent:  
Continuous Index:  
Within 8" of Joint: **NO**  
Remarks: **M-809-016**

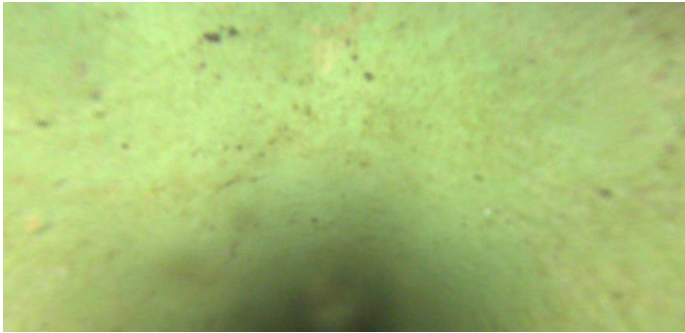
Code:	<b>MWL</b>
Description:	<b>Water Level</b>

Distance (ft):	<b>.0</b>
Structural Grade:	<b>0</b>
O&M Grade:	<b>0</b>
Clock Start/From:	
Clock To:	
1st Value:	
2nd Value:	
Value Percent:	<b>5.000</b>
Continuous Index:	
Within 8" of Joint:	<b>NO</b>
Remarks:

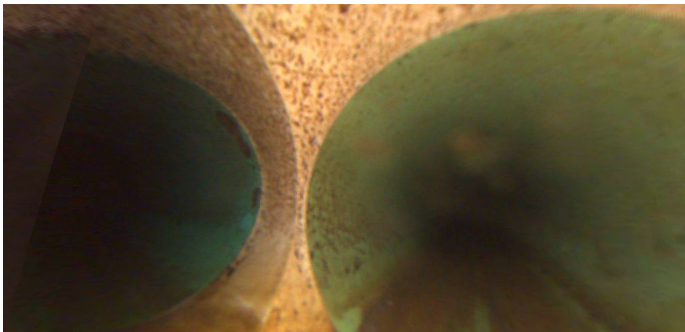
Code:	<b>TF</b>
Description:	<b>Tap Factory</b>

Distance (ft):	<b>12.3</b>
Structural Grade:	<b>0</b>
O&M Grade:	<b>0</b>
Clock Start/From:	<b>9</b>
Clock To:	
1st Value:	<b>4.000</b>
2nd Value:	
Value Percent:	
Continuous Index:	
Within 8" of Joint:	<b>YES</b>
Remarks:

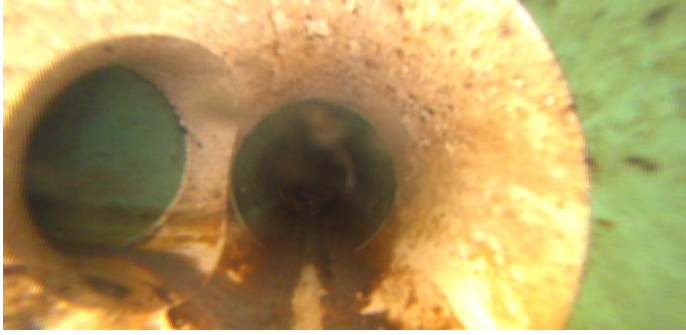
Code: **TF**  
Description: **Tap Factory**

Distance (ft): **50.2**  
Structural Grade: **0**  
O&M Grade: **0**  
Clock Start/From: **9**  
Clock To:  
1st Value: **4.000**  
2nd Value:  
Value Percent:  
Continuous Index:  
Within 8" of Joint: **YES**  
Remarks:

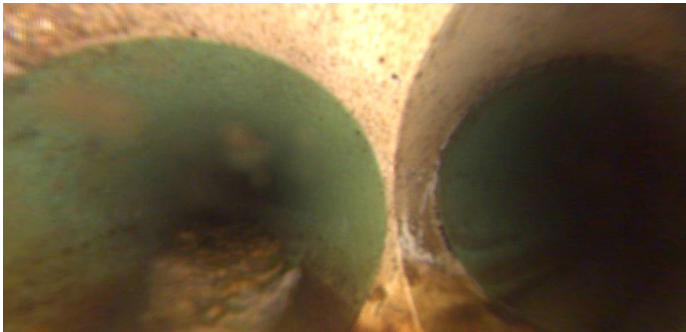
Code: **TF**  
Description: **Tap Factory**

Distance (ft): **52.3**  
Structural Grade: **0**  
O&M Grade: **0**  
Clock Start/From: **3**  
Clock To:  
1st Value: **4.000**  
2nd Value:  
Value Percent:  
Continuous Index:  
Within 8" of Joint: **YES**  
Remarks:

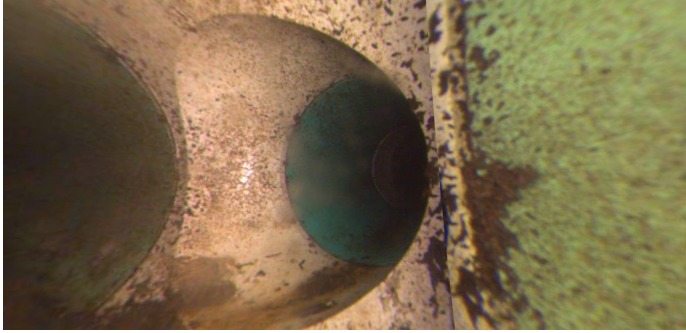
Code: **TF**  
Description: **Tap Factory**

Distance (ft): **72.0**  
Structural Grade: **0**  
O&M Grade: **0**  
Clock Start/From: **9**  
Clock To:  
1st Value: **4.000**  
2nd Value:  
Value Percent:  
Continuous Index:  
Within 8" of Joint:  
Remarks:

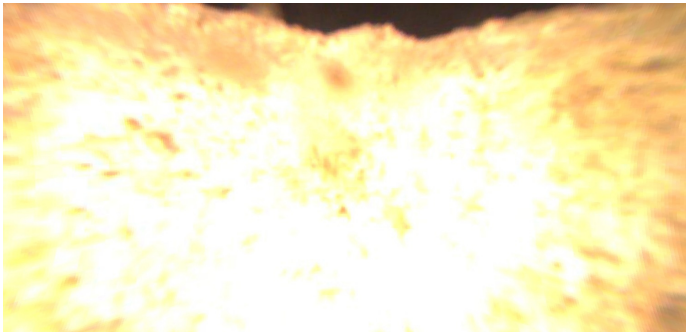
Code: **AMH**  
Description: **Manhole**

Distance (ft): **78.5**  
Structural Grade: **0**  
O&M Grade: **0**  
Clock Start/From:  
Clock To:  
1st Value:  
2nd Value:  
Value Percent:  
Continuous Index:  
Within 8" of Joint: **NO**  
Remarks: **M-809-017**
