## Profile/Photo Observation Report

Street:	<b>TANAGER ST</b>	Flow Control:	<b>Not Controlled</b>
City:	<b>Hobart, IN</b>	Year Renewed:	
Location:	<b>Light Highway</b>	Tape/Media #:	
Purpose:	<b>Maintenance Related</b>	Dia/Height:	<b>12"</b>
Use:	<b>Sanitary</b>	Material:	<b>PVC</b>
Drain Area:	<b>NA</b>	Lining:	
Category:	<b>NA</b>		
Comment:

Location Details:		Direction of Survey:	<b>Upstream</b>
US MH:	<b>M-809-018</b>	DS MH:	<b>M-809-033</b>
		Total Length Surveyed (ft):	<b>353.6</b>

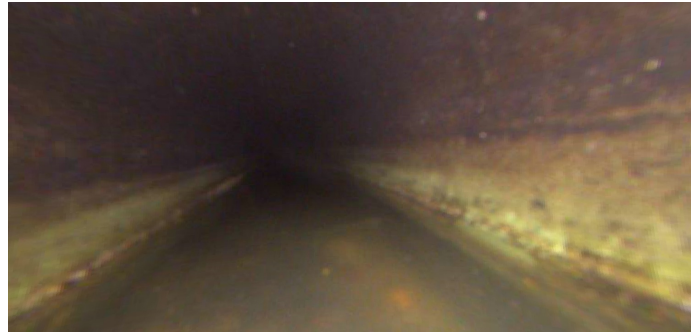
Code: **MWL**  
Description: **Water Level**

Distance (ft): **.0**  
Structural Grade: **0**  
O&M Grade: **0**  
Clock Start/From:  
Clock To:  
1st Value:  
2nd Value:  
Value Percent: **5.000**  
Continuous Index:  
Within 8" of Joint: **NO**  
Remarks:

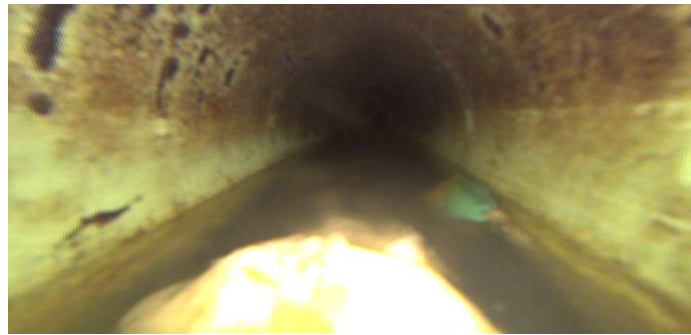
Code: **DSZ**  
Description: **Deposits Settled Other**

Distance (ft): **57.3**  
Structural Grade: **0**  
O&M Grade: **2**  
Clock Start/From: **6**  
Clock To:  
1st Value:  
2nd Value:  
Value Percent: **5.000**  
Continuous Index:  
Within 8" of Joint: **NO**  
Remarks: **tissue**

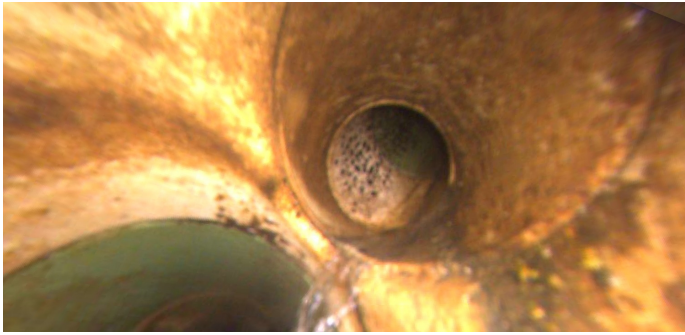
Code: **TFA**  
Description: **Tap Factory Active**

Distance (ft): **64.5**  
Structural Grade: **0**  
O&M Grade: **0**  
Clock Start/From: **1**  
Clock To:  
1st Value: **4.000**  
2nd Value:  
Value Percent:  
Continuous Index:  
Within 8" of Joint:  
Remarks:

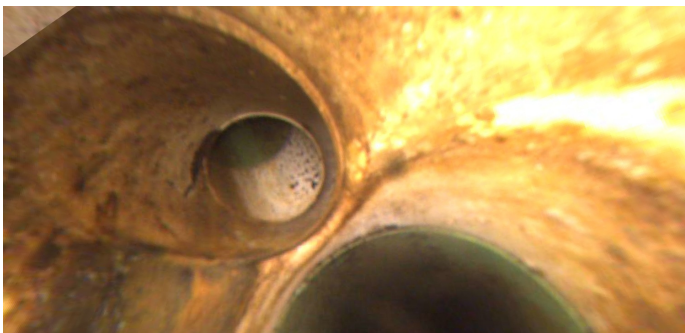
Code: **TF**  
Description: **Tap Factory**

Distance (ft): **66.8**  
Structural Grade: **0**  
O&M Grade: **0**  
Clock Start/From: **10**  
Clock To:  
1st Value: **4.000**  
2nd Value:  
Value Percent:  
Continuous Index:  
Within 8" of Joint:  
Remarks:

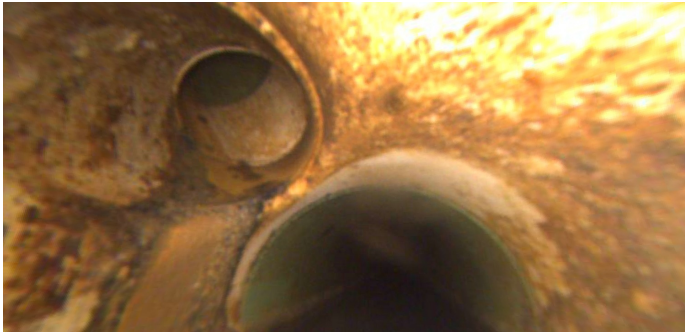
Code: **TB**  
Description: **Tap Break-in**

Distance (ft): **145.3**  
Structural Grade: **0**  
O&M Grade: **0**  
Clock Start/From: **11**  
Clock To:  
1st Value: **4.000**  
2nd Value:  
Value Percent:  
Continuous Index:  
Within 8" of Joint:  
Remarks:

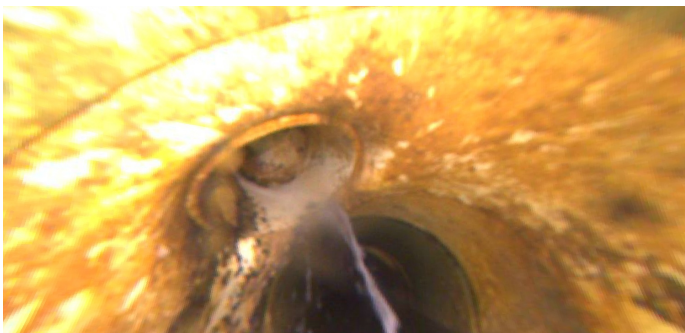
Code: **TFA**  
Description: **Tap Factory Active**

Distance (ft): **210.9**  
Structural Grade: **0**  
O&M Grade: **0**  
Clock Start/From: **11**  
Clock To:  
1st Value: **4.000**  
2nd Value:  
Value Percent:  
Continuous Index:  
Within 8" of Joint: **YES**  
Remarks:

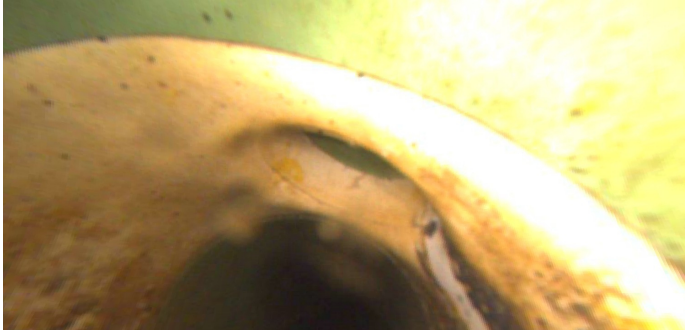
Code: **TF**  
Description: **Tap Factory**

Distance (ft): **213.4**  
Structural Grade: **0**  
O&M Grade: **0**  
Clock Start/From: **1**  
Clock To:  
1st Value: **4.000**  
2nd Value:  
Value Percent:  
Continuous Index:  
Within 8" of Joint: **YES**  
Remarks:

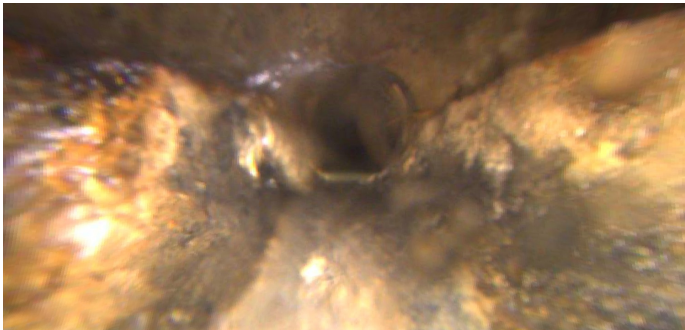
Code: **AMH**  
Description: **Manhole**

Distance (ft): **353.6**  
Structural Grade: **0**  
O&M Grade: **0**  
Clock Start/From:  
Clock To:  
1st Value:  
2nd Value:  
Value Percent:  
Continuous Index:  
Within 8" of Joint: **NO**  
Remarks: **M-809-018**
