## Profile/Photo Observation Report

Date:	<b>03/24/2018</b>	Weather:		Coding:	<b>PACP 6.0</b>
Pipe Length (ft):	<b>357.6</b>	Owner:	<b>NA</b>	Pre Clean:	<b>Not Known</b>
P.O.#:		Surveyor:	<b>Byrd Fitzgerald</b>	PSR:	<b>P-809-018-033</b>
Customer:		Clean Date:	<b>01/01/1900</b>	Shape:	<b>C</b>

Street:	<b>Oak</b>	Flow Control:	<b>Not Controlled</b>
City:	<b>Hobart, IN</b>	Year Renewed:	
Location:	<b>Light Highway</b>	Tape/Media #:	
Purpose:	<b>Maintenance Related</b>	Dia/Height:	<b>12"</b>
Use:	<b>Sanitary</b>	Material:	<b>PVC</b>
Drain Area:	<b>NA</b>	Lining:	
Category:	<b>NA</b>		
Comment:

Location Details:		Direction of Survey:	<b>Upstream</b>
US MH:	<b>M-809-018</b>	DS MH:	<b>M-809-033</b>
		Total Length Surveyed (ft):	<b>353.6</b>

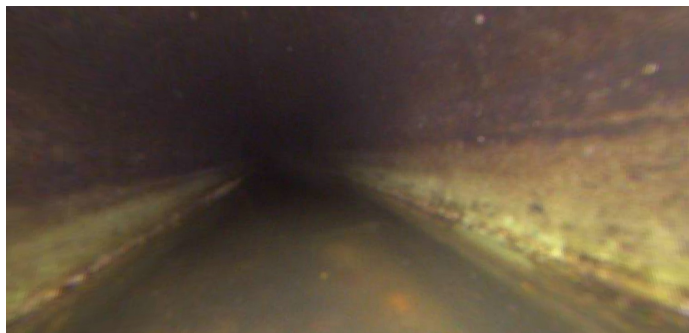
Code: **AMH**  
 Description: **Manhole**  
 Distance (ft): **.0**  
 Structural Grade: **0**  
 O&M Grade: **0**  
 Clock Start/From:  
 Clock To:  
 1st Value:  
 2nd Value:  
 Value Percent:  
 Continuous Index:  
 Within 8" of Joint: **NO**  
 Remarks: **M-809-033**

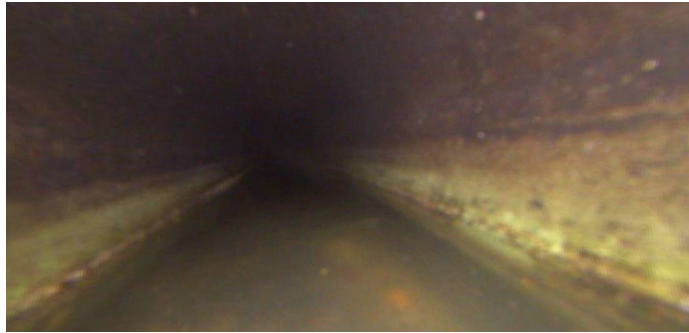
Code: **MWL**  
Description: **Water Level**

Distance (ft): **.0**  
Structural Grade: **0**  
O&M Grade: **0**  
Clock Start/From:  
Clock To:  
1st Value:  
2nd Value:  
Value Percent: **5.000**  
Continuous Index:  
Within 8" of Joint: **NO**  
Remarks:

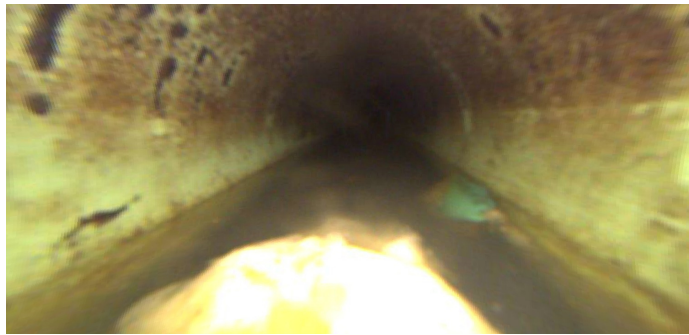
Code: **DSZ**  
Description: **Deposits Settled Other**

Distance (ft): **57.3**  
Structural Grade: **0**  
O&M Grade: **2**  
Clock Start/From: **6**  
Clock To:  
1st Value:  
2nd Value:  
Value Percent: **5.000**  
Continuous Index:  
Within 8" of Joint: **NO**  
Remarks: **tissue**

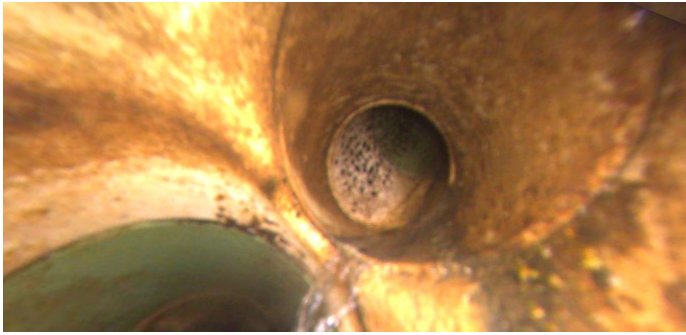
Code: **TFA**  
Description: **Tap Factory Active**

Distance (ft): **64.5**  
Structural Grade: **0**  
O&M Grade: **0**  
Clock Start/From: **1**  
Clock To:  
1st Value: **4.000**  
2nd Value:  
Value Percent:  
Continuous Index:  
Within 8" of Joint:  
Remarks:

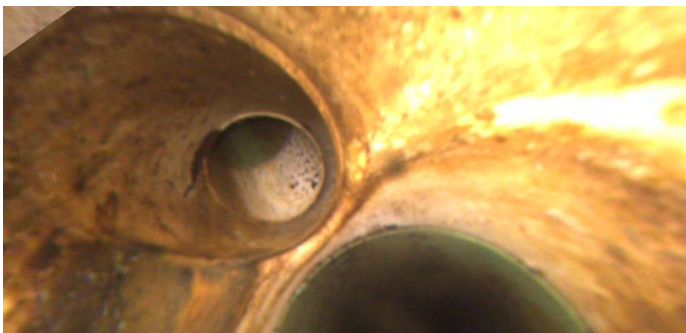
Code: **TF**  
Description: **Tap Factory**

Distance (ft): **66.8**  
Structural Grade: **0**  
O&M Grade: **0**  
Clock Start/From: **10**  
Clock To:  
1st Value: **4.000**  
2nd Value:  
Value Percent:  
Continuous Index:  
Within 8" of Joint:  
Remarks:

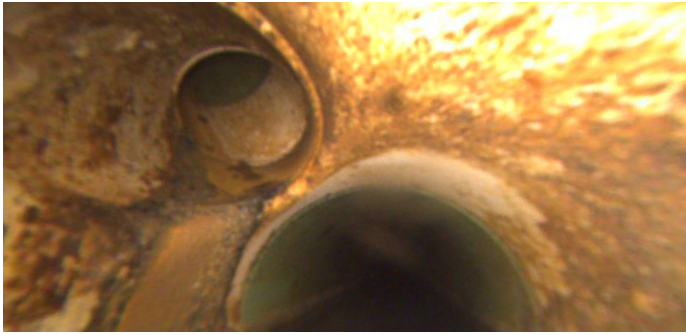
Code: **TB**  
Description: **Tap Break-in**

Distance (ft): **145.3**  
Structural Grade: **0**  
O&M Grade: **0**  
Clock Start/From: **11**  
Clock To:  
1st Value: **4.000**  
2nd Value:  
Value Percent:  
Continuous Index:  
Within 8" of Joint:  
Remarks:

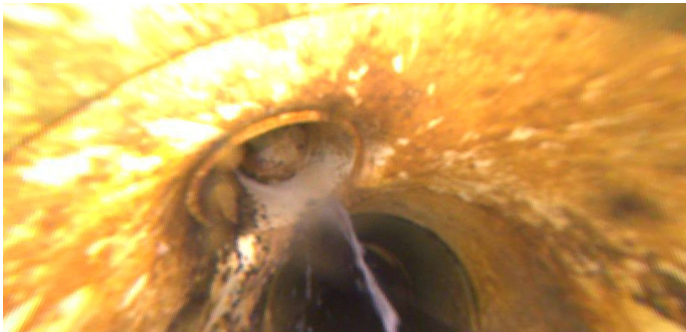
Code: **TFA**  
Description: **Tap Factory Active**

Distance (ft): **210.9**  
Structural Grade: **0**  
O&M Grade: **0**  
Clock Start/From: **11**  
Clock To:  
1st Value: **4.000**  
2nd Value:  
Value Percent:  
Continuous Index:  
Within 8" of Joint: **YES**  
Remarks:

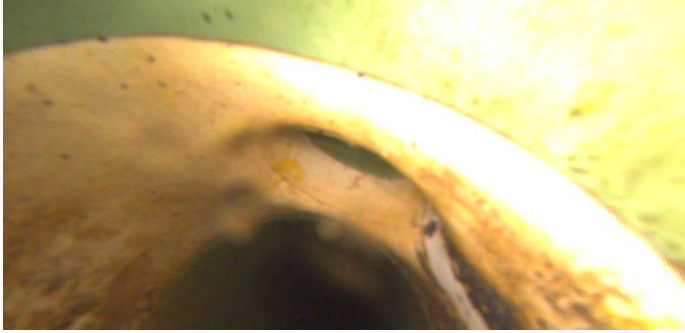
Code: **TF**  
Description: **Tap Factory**

Distance (ft): **213.4**  
Structural Grade: **0**  
O&M Grade: **0**  
Clock Start/From: **1**  
Clock To:  
1st Value: **4.000**  
2nd Value:  
Value Percent:  
Continuous Index:  
Within 8" of Joint: **YES**  
Remarks:

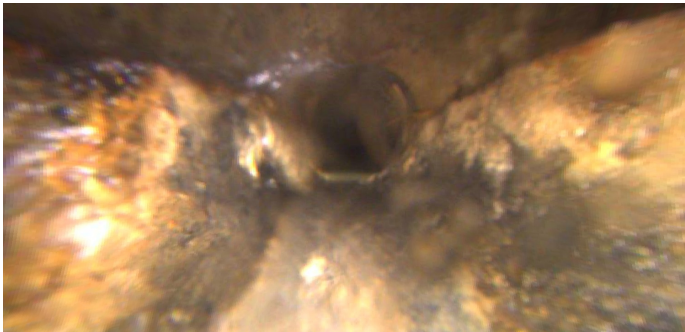
Code: **AMH**  
Description: **Manhole**

Distance (ft): **353.6**  
Structural Grade: **0**  
O&M Grade: **0**  
Clock Start/From:  
Clock To:  
1st Value:  
2nd Value:  
Value Percent:  
Continuous Index:  
Within 8" of Joint: **NO**  
Remarks: **M-809-018**
