## Profile/Photo Observation Report

Street:	<b>BRACKEN PKWY</b>	Flow Control:	<b>Not Controlled</b>
City:	<b>Hobart, IN</b>	Year Renewed:	
Location:	<b>Sidewalk</b>	Tape/Media #:	
Purpose:	<b>Maintenance Related</b>	Dia/Height:	<b>10"</b>
Use:	<b>Sanitary</b>	Material:	<b>PVC</b>
Drain Area:	<b>NA</b>	Lining:	
Category:	<b>NA</b>		
Comment:	<b>debris pile at 3'.</b>

Location Details:		Direction of Survey:	<b>Downstream</b>
US MH:	<b>M-809-019</b>	DS MH:	<b>M-809-018</b>
		Total Length Surveyed (ft):	<b>4.6</b>

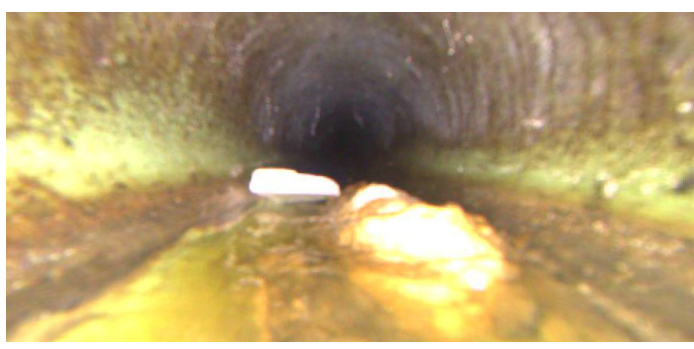
Code: **AMH**  
Description: **Manhole**

Distance (ft): **.0**  
Structural Grade: **0**  
O&M Grade: **0**  
Clock Start/From:  
Clock To:  
1st Value:  
2nd Value:  
Value Percent:  
Continuous Index:  
Within 8" of Joint: **NO**  
Remarks: **M-809-019**

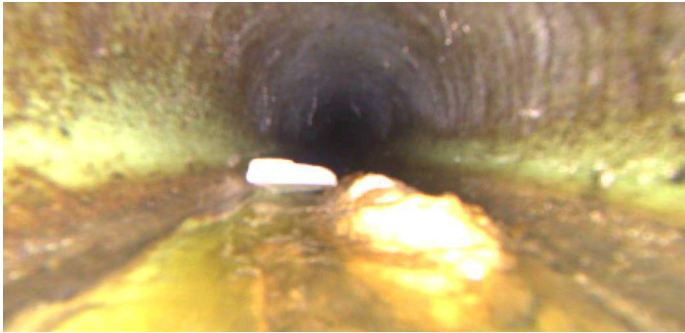
Code:	<b>MWL</b>
Description:	<b>Water Level</b>

Distance (ft):	<b>.0</b>
Structural Grade:	<b>0</b>
O&M Grade:	<b>0</b>
Clock Start/From:	
Clock To:	
1st Value:	
2nd Value:	
Value Percent:	<b>20.000</b>
Continuous Index:	
Within 8" of Joint:	<b>NO</b>
Remarks:

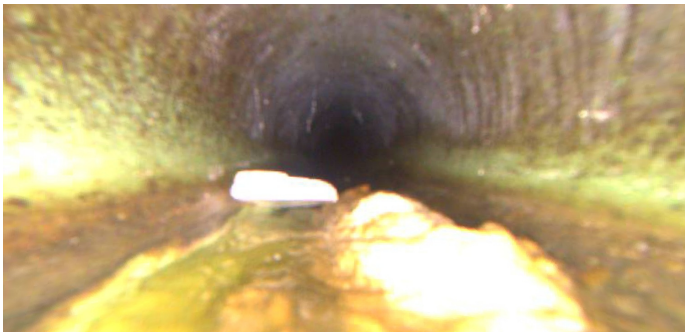
Code:	<b>OBZ</b>
Description:	<b>Obstacle Other</b>

Distance (ft):	<b>.3</b>
Structural Grade:	<b>0</b>
O&M Grade:	<b>3</b>
Clock Start/From:	<b>4</b>
Clock To:	<b>8</b>
1st Value:	
2nd Value:	
Value Percent:	<b>20.000</b>
Continuous Index:	
Within 8" of Joint:	<b>NO</b>
Remarks:	<b>MISC</b>

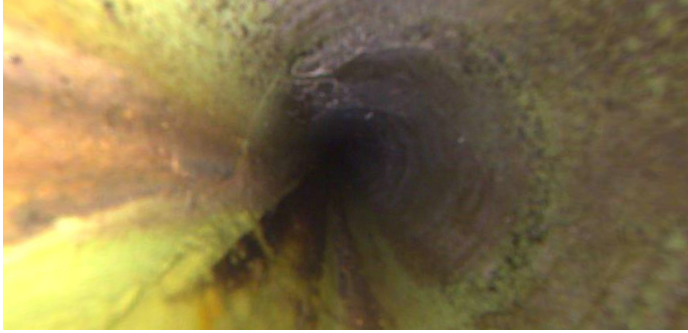
Code:	<b>MSA</b>
Description:	<b>Abandoned Survey</b>
Distance (ft):	<b>4.6</b>
Structural Grade:	<b>0</b>
O&M Grade:	<b>0</b>
Clock Start/From:	
Clock To:	
1st Value:	
2nd Value:	
Value Percent:	
Continuous Index:	
Within 8" of Joint:	<b>NO</b>
Remarks:	<b>OVERTURNED</b>
