Profile/Photo Observation Report

Date:	03/24/2018	Weather:		Coding:	PACP 6.0
Pipe Length (ft):	374.3	Owner:	NA	Pre Clean:	Not Known
P.O.#:		Surveyor:	Byrd Fitzgerald	PSR:	P-809-019-018
Customer:		Clean Date:	01/01/1900	Shape:	C

Street:	BRACKEN PKWY	Flow Control:	Not Controlled
City:	Hobart, IN	Year Renewed:	
Location:	Sidewalk	Tape/Media #:	
Purpose:	Maintenance Related	Dia/Height:	10"
Use:	Sanitary	Material:	PVC
Drain Area:	NA	Lining:	
Category:	NA		
Comment:	Reverse setup.

Location Details:		Direction of Survey:	Upstream
US MH:	M-809-019	DS MH:	M-809-018
		Total Length Surveyed (ft):	366.0

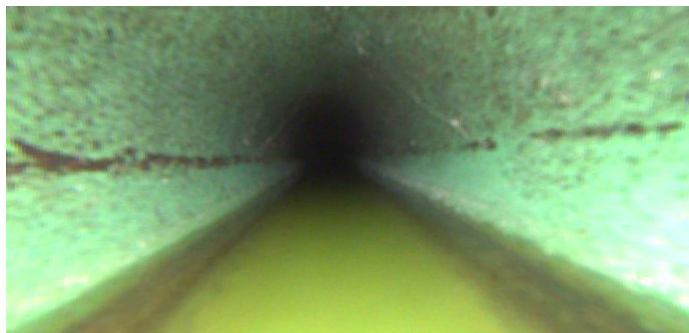
Code: **AMH**
Description: **Manhole**

Distance (ft): **.0**
Structural Grade: **0**
O&M Grade: **0**
Clock Start/From:
Clock To:
1st Value:
2nd Value:
Value Percent:
Continuous Index:
Within 8" of Joint: **NO**
Remarks: **M-809-018**

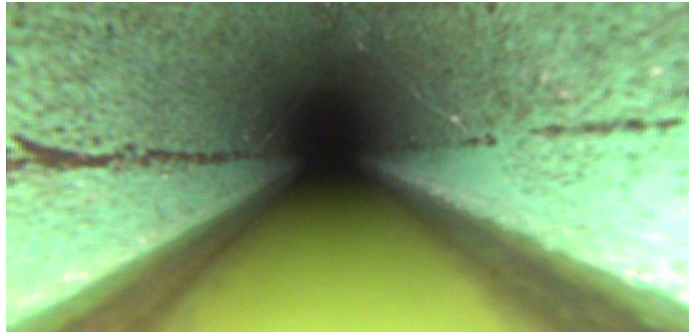
Code:	MWL
Description:	Water Level
Distance (ft):	.0
Structural Grade:	0
O&M Grade:	0
Clock Start/From:	
Clock To:	
1st Value:	
2nd Value:	
Value Percent:	5.000
Continuous Index:	
Within 8" of Joint:	NO
Remarks:

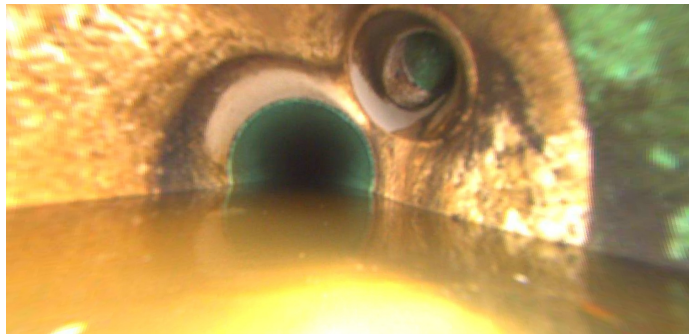
Code:	TF
Description:	Tap Factory
Distance (ft):	109.7
Structural Grade:	0
O&M Grade:	0
Clock Start/From:	1
Clock To:	
1st Value:	4.000
2nd Value:	
Value Percent:	
Continuous Index:	
Within 8" of Joint:	YES
Remarks:

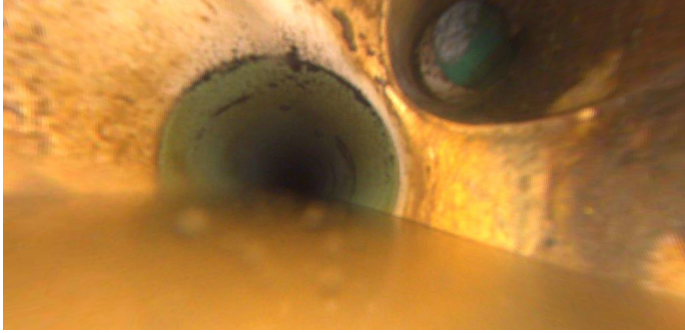
Code: **TF**
Description: **Tap Factory**

Distance (ft): **232.1**
Structural Grade: **0**
O&M Grade: **0**
Clock Start/From: **1**
Clock To:
1st Value: **4.000**
2nd Value:
Value Percent:
Continuous Index:
Within 8" of Joint: **YES**
Remarks:

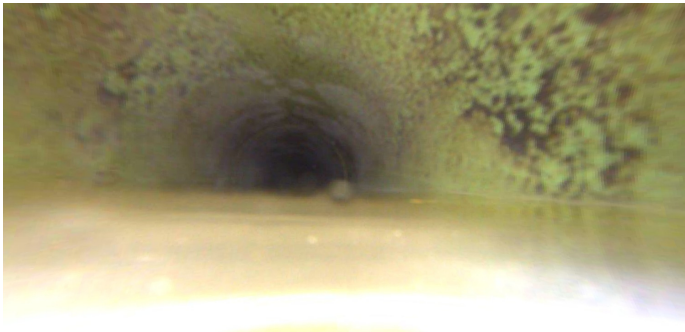
Code: **MWL**
Description: **Water Level**

Distance (ft): **345.4**
Structural Grade: **0**
O&M Grade: **0**
Clock Start/From:
Clock To:
1st Value:
2nd Value:
Value Percent: **25.000**
Continuous Index:
Within 8" of Joint: **NO**
Remarks:

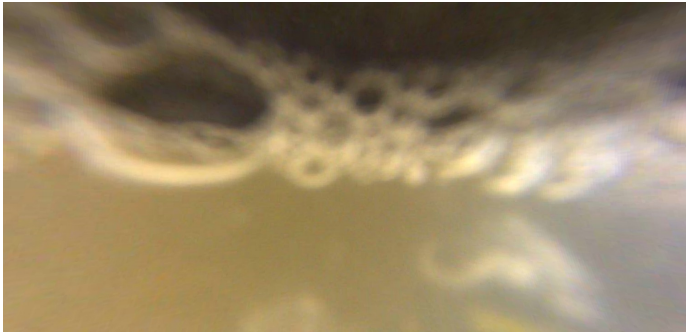
Code: **MCU**
Description: **Camera Underwater**

Distance (ft): **358.6**
Structural Grade: **0**
O&M Grade: **4**
Clock Start/From:
Clock To:
1st Value:
2nd Value:
Value Percent:
Continuous Index:
Within 8" of Joint: **NO**
Remarks:

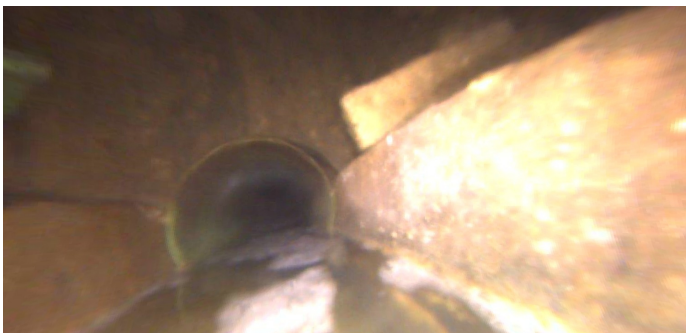
Code: **AMH**
Description: **Manhole**

Distance (ft): **366.0**
Structural Grade: **0**
O&M Grade: **0**
Clock Start/From:
Clock To:
1st Value:
2nd Value:
Value Percent:
Continuous Index:
Within 8" of Joint: **NO**
Remarks: **M-809-019**
