## Profile/Photo Observation Report

Street:	<b>Oak</b>	Flow Control:	<b>Not Controlled</b>
City:	<b>Hobart, IN</b>	Year Renewed:	
Location:	<b>Sidewalk</b>	Tape/Media #:	
Purpose:	<b>Maintenance Related</b>	Dia/Height:	<b>10"</b>
Use:	<b>Sanitary</b>	Material:	<b>PVC</b>
Drain Area:	<b>NA</b>	Lining:	
Category:	<b>NA</b>		
Comment:	<b>Reverse setup.</b>

Location Details:		Direction of Survey:	<b>Upstream</b>
US MH:	<b>M-809-019</b>	DS MH:	<b>M-809-018</b>
		Total Length Surveyed (ft):	<b>366.0</b>

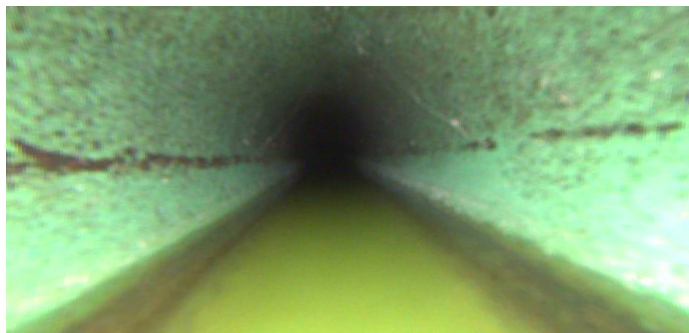
Code: **AMH**  
Description: **Manhole**

Distance (ft): **.0**  
Structural Grade: **0**  
O&M Grade: **0**  
Clock Start/From:  
Clock To:  
1st Value:  
2nd Value:  
Value Percent:  
Continuous Index:  
Within 8" of Joint: **NO**  
Remarks: **M-809-018**

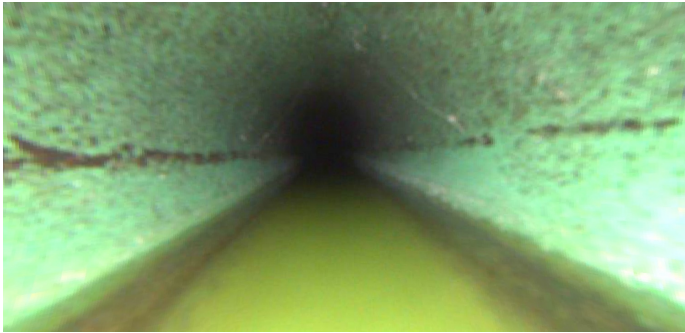
Code:	<b>MWL</b>
Description:	<b>Water Level</b>

Distance (ft):	<b>.0</b>
Structural Grade:	<b>0</b>
O&M Grade:	<b>0</b>
Clock Start/From:	
Clock To:	
1st Value:	
2nd Value:	
Value Percent:	<b>5.000</b>
Continuous Index:	
Within 8" of Joint:	<b>NO</b>
Remarks:

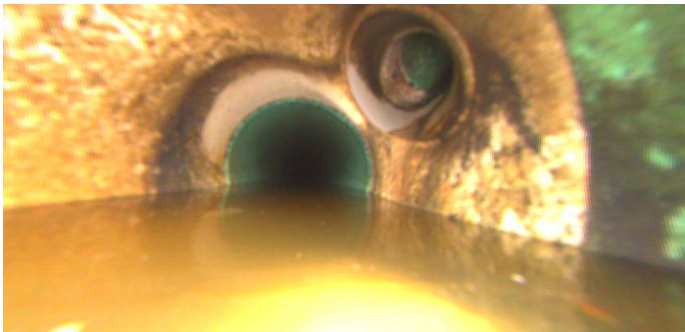
Code:	<b>TF</b>
Description:	<b>Tap Factory</b>

Distance (ft):	<b>109.7</b>
Structural Grade:	<b>0</b>
O&M Grade:	<b>0</b>
Clock Start/From:	<b>1</b>
Clock To:	
1st Value:	<b>4.000</b>
2nd Value:	
Value Percent:	
Continuous Index:	
Within 8" of Joint:	<b>YES</b>
Remarks:

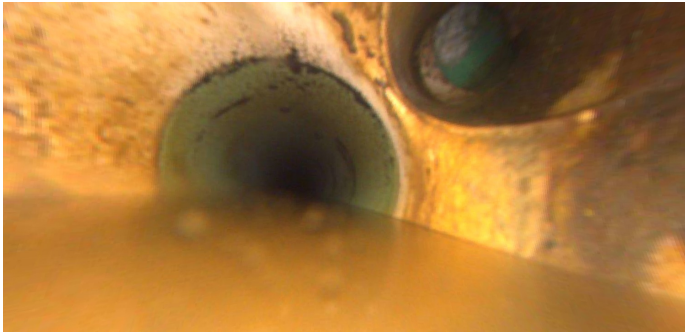
Code: **TF**  
Description: **Tap Factory**

Distance (ft): **232.1**  
Structural Grade: **0**  
O&M Grade: **0**  
Clock Start/From: **1**  
Clock To:  
1st Value: **4.000**  
2nd Value:  
Value Percent:  
Continuous Index:  
Within 8" of Joint: **YES**  
Remarks:

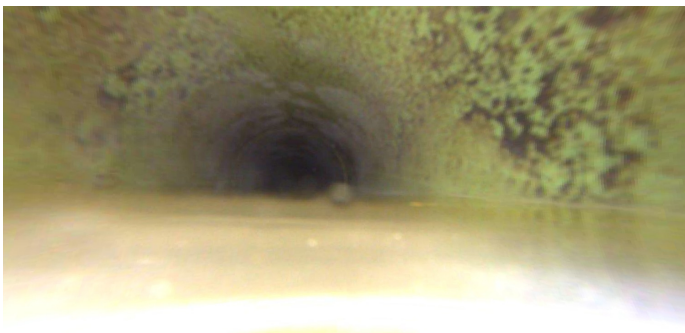
Code: **MWL**  
Description: **Water Level**

Distance (ft): **345.4**  
Structural Grade: **0**  
O&M Grade: **0**  
Clock Start/From:  
Clock To:  
1st Value:  
2nd Value:  
Value Percent: **25.000**  
Continuous Index:  
Within 8" of Joint: **NO**  
Remarks:

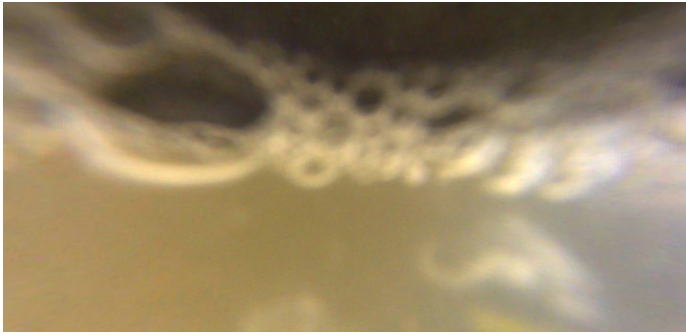
Code: **MCU**  
Description: **Camera Underwater**

Distance (ft): **358.6**  
Structural Grade: **0**  
O&M Grade: **4**  
Clock Start/From:  
Clock To:  
1st Value:  
2nd Value:  
Value Percent:  
Continuous Index:  
Within 8" of Joint: **NO**  
Remarks:

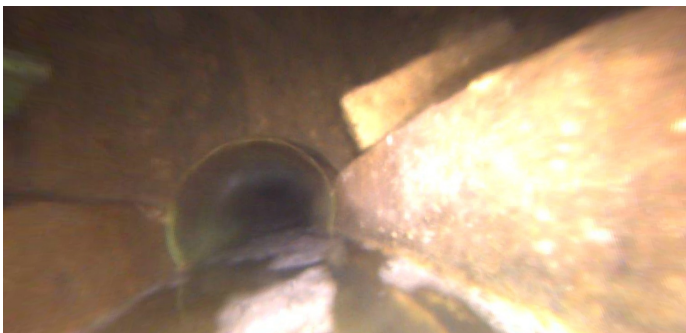
Code: **AMH**  
Description: **Manhole**

Distance (ft): **366.0**  
Structural Grade: **0**  
O&M Grade: **0**  
Clock Start/From:  
Clock To:  
1st Value:  
2nd Value:  
Value Percent:  
Continuous Index:  
Within 8" of Joint: **NO**  
Remarks: **M-809-019**
