## Profile/Photo Observation Report

Street:	<b>BRACKEN PKWY &amp; EIDER ST</b>	Flow Control:	<b>Not Controlled</b>
City:	<b>Hobart, IN</b>	Year Renewed:	
Location:	<b>Sidewalk</b>	Tape/Media #:	
Purpose:	<b>Maintenance Related</b>	Dia/Height:	<b>10"</b>
Use:	<b>Sanitary</b>	Material:	<b>PVC</b>
Drain Area:	<b>NA</b>	Lining:	
Category:	<b>NA</b>		
Comment:			
Location Details:		Direction of Survey:	<b>Downstream</b>
US MH:	<b>M-809-019</b>	DS MH:	<b>M-809-020</b>
		Total Length Surveyed (ft):	<b>84.2</b>

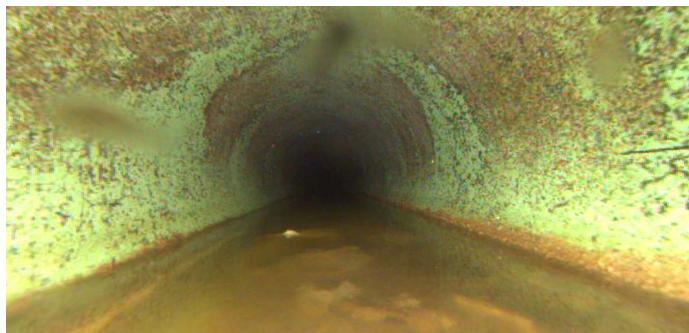
Code: **AMH**  
Description: **Manhole**

Distance (ft): **.0**  
Structural Grade: **0**  
O&M Grade: **0**  
Clock Start/From:  
Clock To:  
1st Value:  
2nd Value:  
Value Percent:  
Continuous Index:  
Within 8" of Joint: **NO**  
Remarks: **M-809-019**

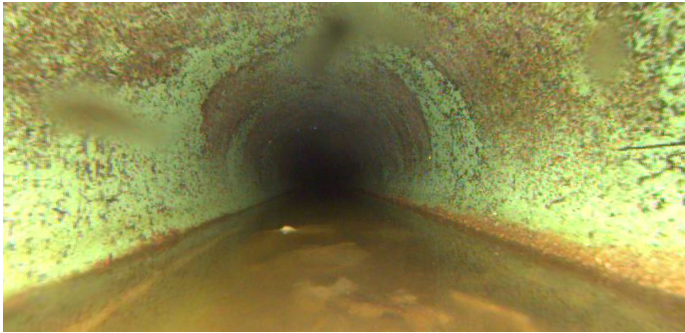
Code:	<b>MWL</b>
Description:	<b>Water Level</b>

Distance (ft):	<b>.0</b>
Structural Grade:	<b>0</b>
O&M Grade:	<b>0</b>
Clock Start/From:	
Clock To:	
1st Value:	
2nd Value:	
Value Percent:	<b>30.000</b>
Continuous Index:	
Within 8" of Joint:	<b>NO</b>
Remarks:

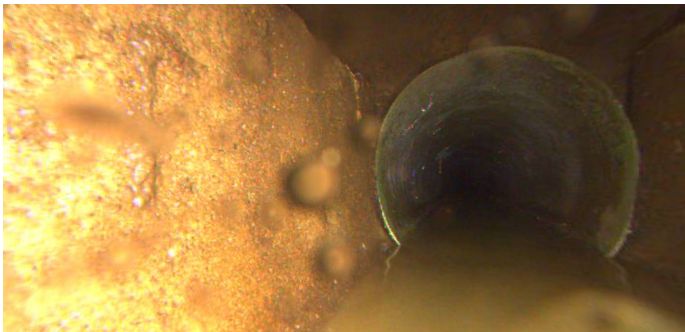
Code:	<b>AMH</b>
Description:	<b>Manhole</b>

Distance (ft):	<b>84.2</b>
Structural Grade:	<b>0</b>
O&M Grade:	<b>0</b>
Clock Start/From:	
Clock To:	
1st Value:	
2nd Value:	
Value Percent:	
Continuous Index:	
Within 8" of Joint:	<b>NO</b>
Remarks:	<b>M-809-020</b>
