Profile/Photo Observation Report

Date:	03/23/2018	Weather:		Coding:	PACP 6.0
Pipe Length (ft):	125.3	Owner:	NA	Pre Clean:	Not Known
P.O.#:		Surveyor:	Justin Gonzales	PSR:	P-809-021-020
Customer:		Clean Date:	01/01/1900	Shape:	C

Street:	BRACKEN PKWY	Flow Control:	Not Controlled
City:	Hobart, IN	Year Renewed:	
Location:	Sidewalk	Tape/Media #:	
Purpose:	Maintenance Related	Dia/Height:	10"
Use:	Sanitary	Material:	PVC
Drain Area:	NA	Lining:	
Category:	NA		
Comment:

Location Details:		Direction of Survey:	Upstream
US MH:	M-809-020	DS MH:	M-809-021
		Total Length Surveyed (ft):	122.6

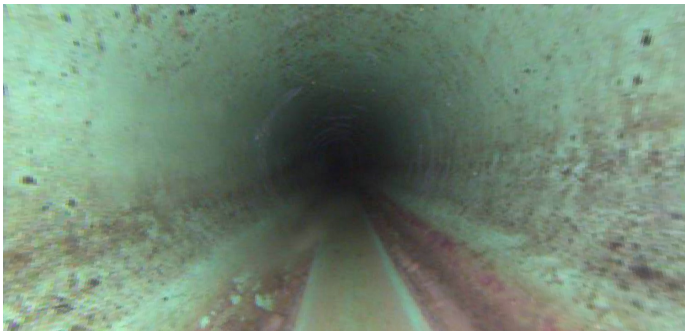
Code: **AMH**
Description: **Manhole**

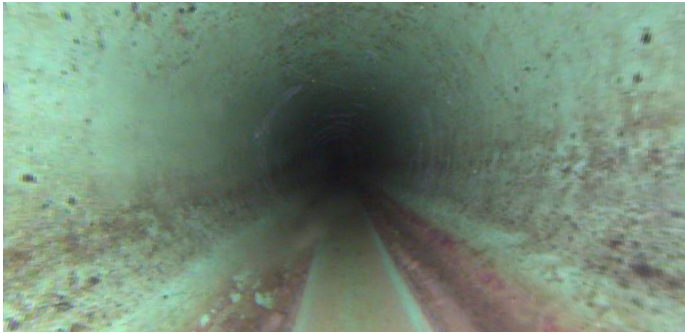
Code:	MWL
Description:	Water Level

Distance (ft):	.0
Structural Grade:	0
O&M Grade:	0
Clock Start/From:	
Clock To:	
1st Value:	
2nd Value:	
Value Percent:	5.000
Continuous Index:	
Within 8" of Joint:	NO
Remarks:

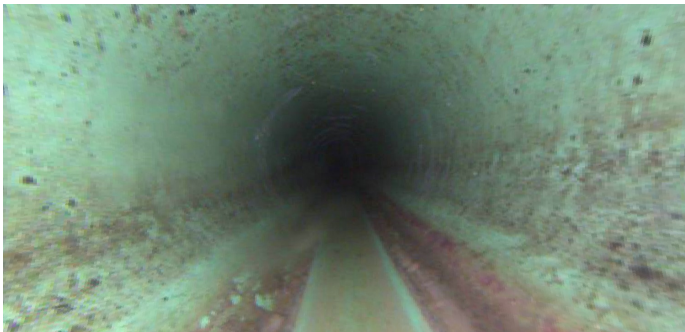
Code:	DAZ
Description:	Deposits Attached Other

Distance (ft):	.0
Structural Grade:	0
O&M Grade:	2
Clock Start/From:	7
Clock To:	5
1st Value:	
2nd Value:	
Value Percent:	5.000
Continuous Index:	S01
Within 8" of Joint:	YES
Remarks:	WANDER

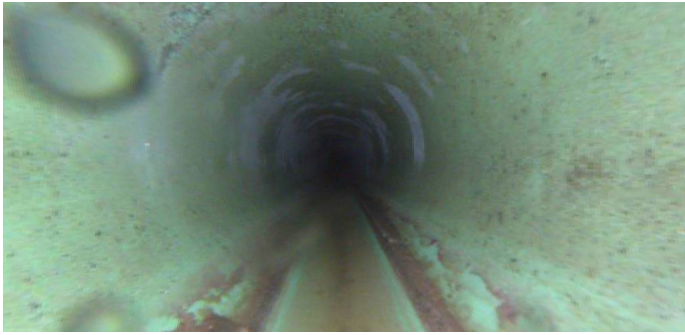
Code: **DAGS**
Description: **Deposits Attached Grease**

Distance (ft): **5.8**
Structural Grade: **0**
O&M Grade: **2**
Clock Start/From: **7**
Clock To: **5**
1st Value:
2nd Value:
Value Percent: **5.000**
Continuous Index: **S02**
Within 8" of Joint: **YES**
Remarks: **WANDER**

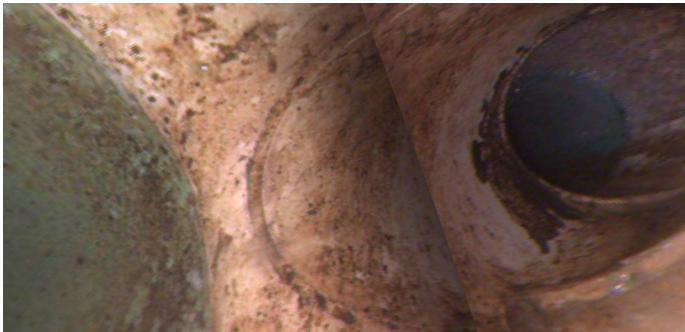
Code: **TF**
Description: **Tap Factory**

Distance (ft): **23.2**
Structural Grade: **0**
O&M Grade: **0**
Clock Start/From: **2**
Clock To:
1st Value: **4.000**
2nd Value:
Value Percent:
Continuous Index:
Within 8" of Joint:
Remarks:

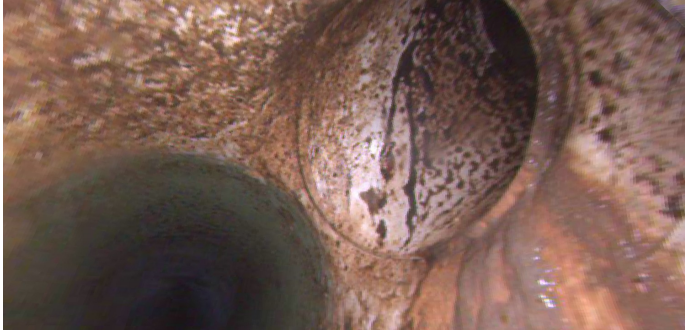
Code: **TF**
Description: **Tap Factory**

Distance (ft): **81.0**
Structural Grade: **0**
O&M Grade: **0**
Clock Start/From: **2**
Clock To:
1st Value: **4.000**
2nd Value:
Value Percent:
Continuous Index:
Within 8" of Joint:
Remarks:

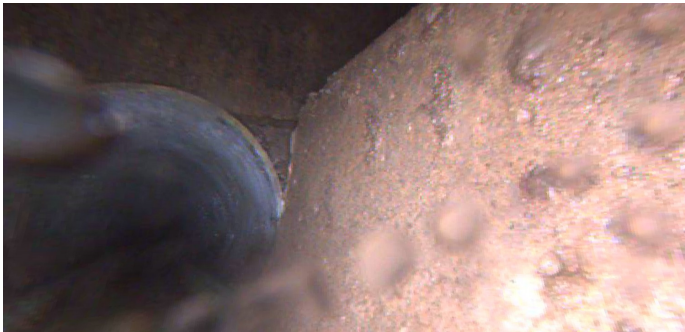
Code: **AMH**
Description: **Manhole**

Distance (ft): **122.6**
Structural Grade: **0**
O&M Grade: **0**
Clock Start/From:
Clock To:
1st Value:
2nd Value:
Value Percent:
Continuous Index:
Within 8" of Joint: **NO**
Remarks: **M-809-020**

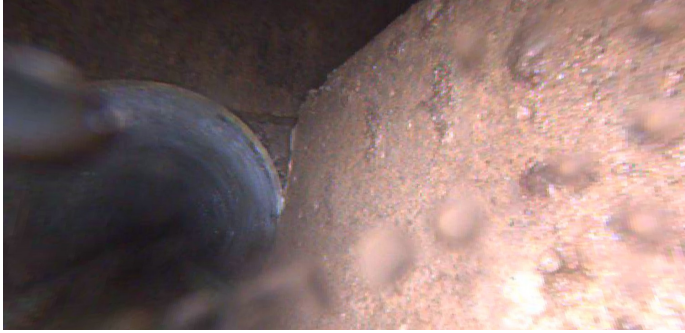
Code: **DAZ**
Description: **Deposits Attached Other**

Distance (ft): **122.6**
Structural Grade: **0**
O&M Grade: **2**
Clock Start/From: **7**
Clock To: **5**
1st Value:
2nd Value:
Value Percent: **5.000**
Continuous Index: **F01**
Within 8" of Joint: **YES**
Remarks: **WANDER**

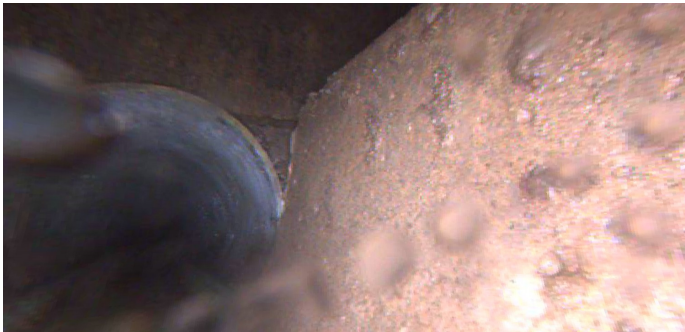
Code: **DAGS**
Description: **Deposits Attached Grease**

Distance (ft): **122.6**
Structural Grade: **0**
O&M Grade: **2**
Clock Start/From: **7**
Clock To: **5**
1st Value:
2nd Value:
Value Percent: **5.000**
Continuous Index: **F02**
Within 8" of Joint: **YES**
Remarks: **WANDER**
