Profile/Photo Observation Report

Date:	03/23/2018	Weather:		Coding:	PACP 6.0
Pipe Length (ft):	125.3	Owner:	NA	Pre Clean:	Not Known
P.O.#:		Surveyor:	Justin Gonzales	PSR:	P-809-021-020
Customer:		Clean Date:	01/01/1900	Shape:	C

Street:	Oak	Flow Control:	Not Controlled
City:	Hobart, IN	Year Renewed:	
Location:	Sidewalk	Tape/Media #:	
Purpose:	Maintenance Related	Dia/Height:	10"
Use:	Sanitary	Material:	PVC
Drain Area:	NA	Lining:	
Category:	NA		
Comment:

Location Details:		Direction of Survey:	Upstream
US MH:	M-809-020	DS MH:	M-809-021
		Total Length Surveyed (ft):	122.6

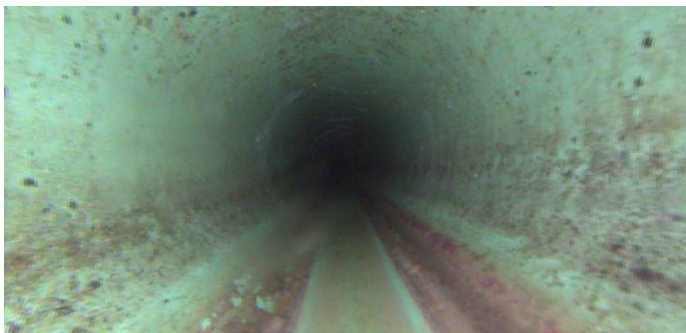
Code: **AMH**
Description: **Manhole**

Distance (ft): **.0**
Structural Grade: **0**
O&M Grade: **0**
Clock Start/From:
Clock To:
1st Value:
2nd Value:
Value Percent:
Continuous Index:
Within 8" of Joint: **NO**
Remarks: **M-809-021**

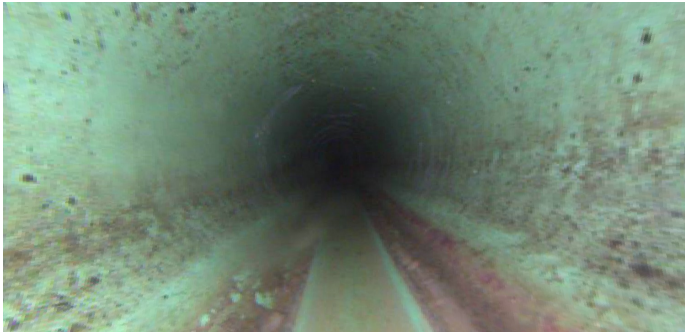
Code:	MWL
Description:	Water Level

Distance (ft):	.0
Structural Grade:	0
O&M Grade:	0
Clock Start/From:	
Clock To:	
1st Value:	
2nd Value:	
Value Percent:	5.000
Continuous Index:	
Within 8" of Joint:	NO
Remarks:

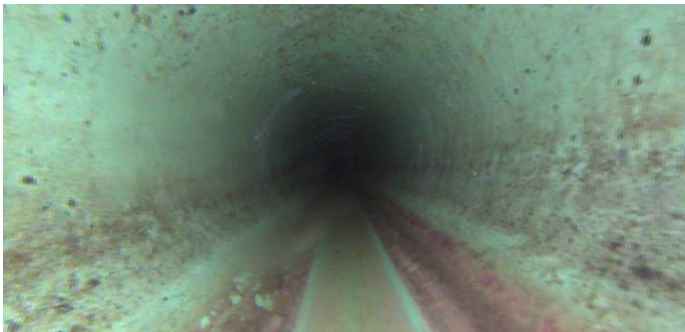
Code:	DAZ
Description:	Deposits Attached Other

Distance (ft):	.0
Structural Grade:	0
O&M Grade:	2
Clock Start/From:	7
Clock To:	5
1st Value:	
2nd Value:	
Value Percent:	5.000
Continuous Index:	S01
Within 8" of Joint:	YES
Remarks:	WANDER

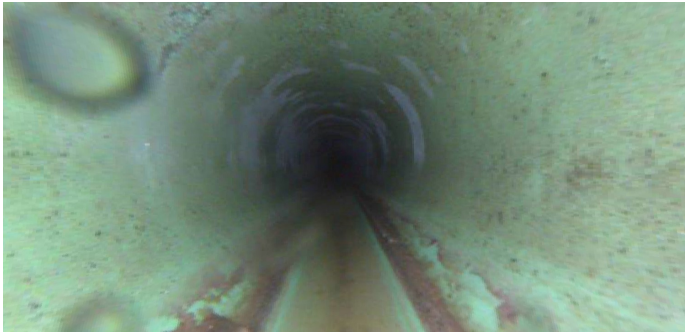
Code: **DAGS**
Description: **Deposits Attached Grease**

Distance (ft): **5.8**
Structural Grade: **0**
O&M Grade: **2**
Clock Start/From: **7**
Clock To: **5**
1st Value:
2nd Value:
Value Percent: **5.000**
Continuous Index: **S02**
Within 8" of Joint: **YES**
Remarks: **WANDER**

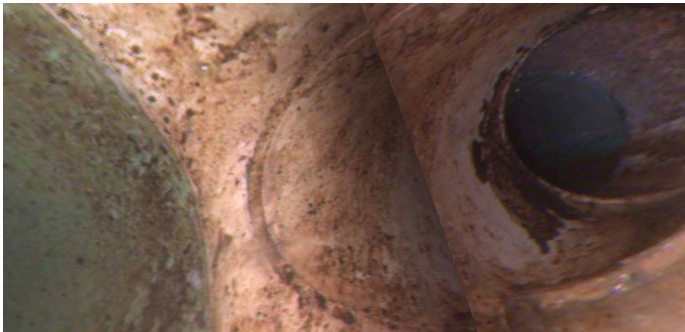
Code: **TF**
Description: **Tap Factory**

Distance (ft): **23.2**
Structural Grade: **0**
O&M Grade: **0**
Clock Start/From: **2**
Clock To:
1st Value: **4.000**
2nd Value:
Value Percent:
Continuous Index:
Within 8" of Joint:
Remarks:

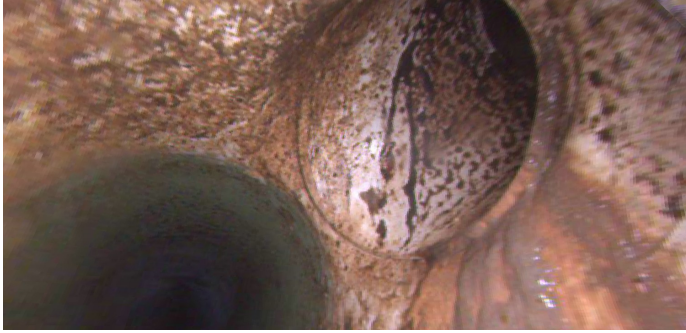
Code: **TF**
Description: **Tap Factory**

Distance (ft): **81.0**
Structural Grade: **0**
O&M Grade: **0**
Clock Start/From: **2**
Clock To:
1st Value: **4.000**
2nd Value:
Value Percent:
Continuous Index:
Within 8" of Joint:
Remarks:

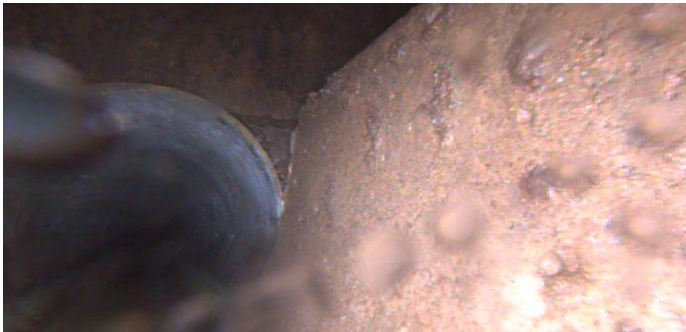
Code: **AMH**
Description: **Manhole**

Distance (ft): **122.6**
Structural Grade: **0**
O&M Grade: **0**
Clock Start/From:
Clock To:
1st Value:
2nd Value:
Value Percent:
Continuous Index:
Within 8" of Joint: **NO**
Remarks: **M-809-020**

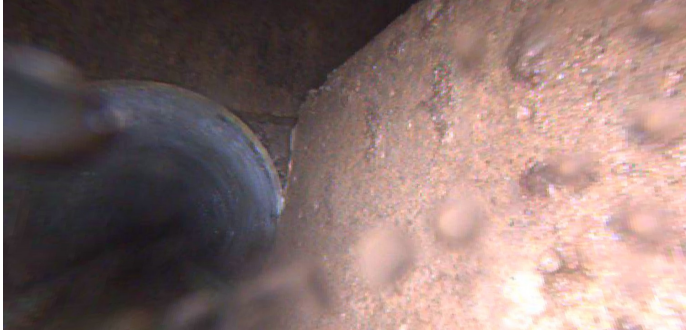
Code: **DAZ**
Description: **Deposits Attached Other**

Distance (ft): **122.6**
Structural Grade: **0**
O&M Grade: **2**
Clock Start/From: **7**
Clock To: **5**
1st Value:
2nd Value:
Value Percent: **5.000**
Continuous Index: **F01**
Within 8" of Joint: **YES**
Remarks: **WANDER**

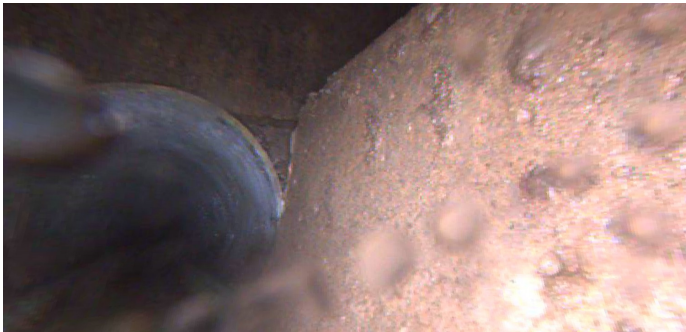
Code: **DAGS**
Description: **Deposits Attached Grease**

Distance (ft): **122.6**
Structural Grade: **0**
O&M Grade: **2**
Clock Start/From: **7**
Clock To: **5**
1st Value:
2nd Value:
Value Percent: **5.000**
Continuous Index: **F02**
Within 8" of Joint: **YES**
Remarks: **WANDER**
