Profile/Photo Observation Report

Date:	03/22/2018	Weather:		Coding:	PACP 6.0
Pipe Length (ft):	231.9	Owner:	NA	Pre Clean:	Not Known
P.O.#:		Surveyor:	Selasie Honu	PSR:	P-809-028-029
Customer:		Clean Date:	01/01/1900	Shape:	C

Location Details:		Direction of Survey:	Upstream
US MH:	M-809-029	DS MH:	M-809-028
		Total Length Surveyed (ft):	227.9

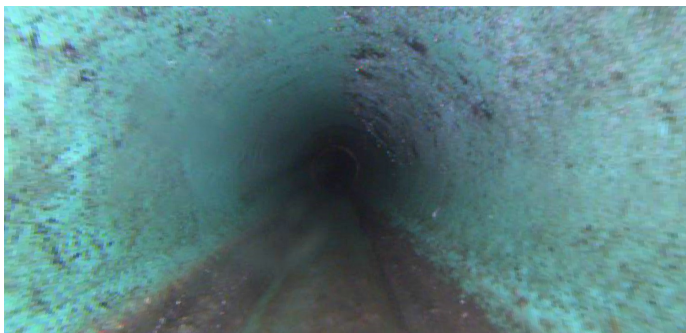
Code: **AMH**
Description: **Manhole**

Distance (ft): **.0**
Structural Grade: **0**
O&M Grade: **0**
Clock Start/From:
Clock To:
1st Value:
2nd Value:
Value Percent:
Continuous Index:
Within 8" of Joint: **NO**
Remarks: **M-809-028**

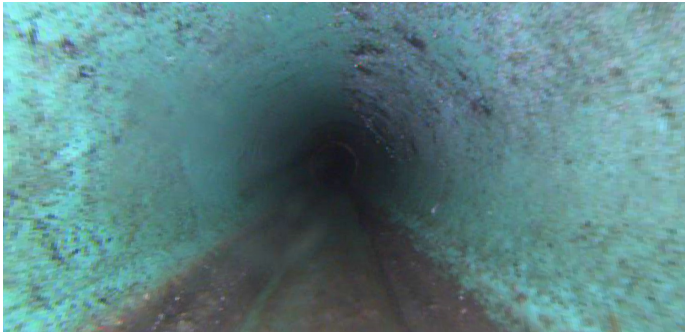
Code:	MWL
Description:	Water Level

Distance (ft):	.0
Structural Grade:	0
O&M Grade:	0
Clock Start/From:	
Clock To:	
1st Value:	
2nd Value:	
Value Percent:	5.000
Continuous Index:	
Within 8" of Joint:	NO
Remarks:

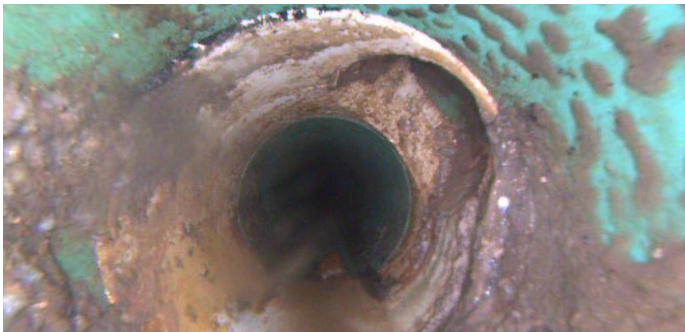
Code:	DAGS
Description:	Deposits Attached Grease

Distance (ft):	4.5
Structural Grade:	0
O&M Grade:	2
Clock Start/From:	8
Clock To:	4
1st Value:	
2nd Value:	
Value Percent:	5.000
Continuous Index:	
Within 8" of Joint:	NO
Remarks:

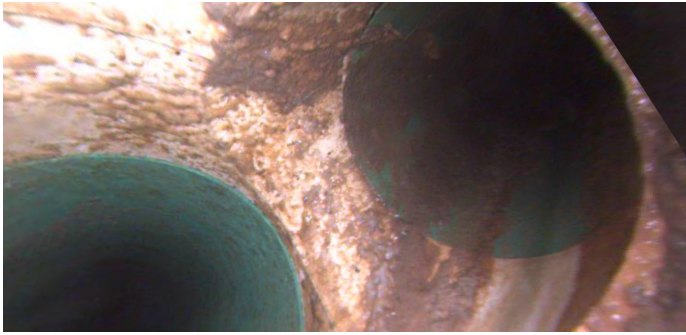
Code: **TF**
Description: **Tap Factory**

Distance (ft): **5.0**
Structural Grade: **0**
O&M Grade: **0**
Clock Start/From: **2**
Clock To:
1st Value: **4.000**
2nd Value:
Value Percent:
Continuous Index:
Within 8" of Joint:
Remarks:

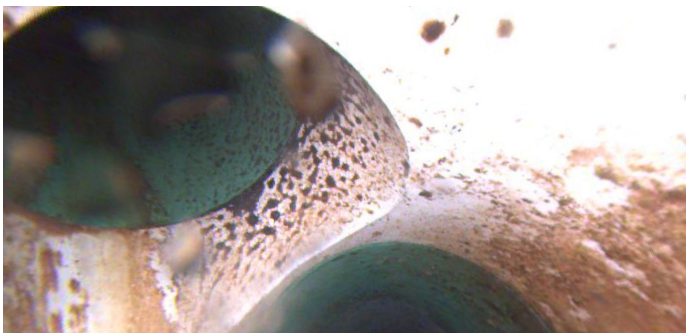
Code: **TF**
Description: **Tap Factory**

Distance (ft): **38.6**
Structural Grade: **0**
O&M Grade: **0**
Clock Start/From: **10**
Clock To:
1st Value: **4.000**
2nd Value:
Value Percent:
Continuous Index:
Within 8" of Joint:
Remarks:

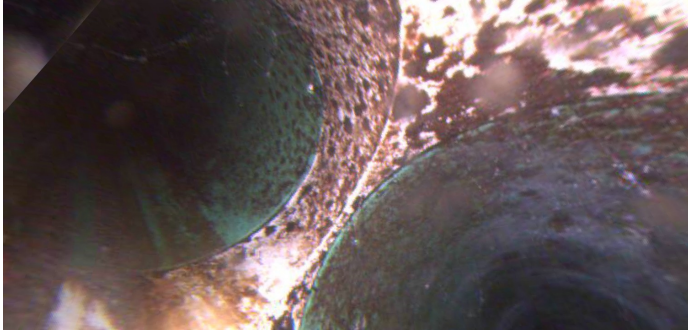
Code: **TF**
Description: **Tap Factory**

Distance (ft): **73.0**
Structural Grade: **0**
O&M Grade: **0**
Clock Start/From: **2**
Clock To:
1st Value: **4.000**
2nd Value:
Value Percent:
Continuous Index:
Within 8" of Joint:
Remarks:

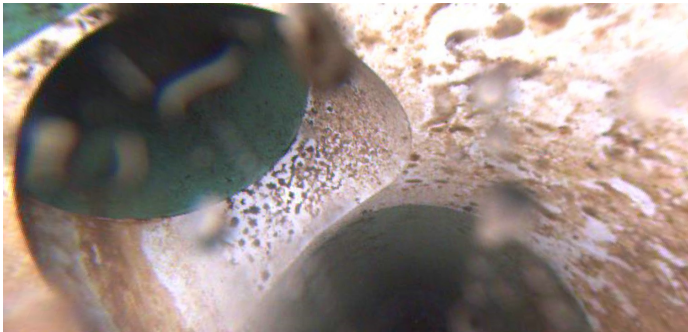
Code: **TF**
Description: **Tap Factory**

Distance (ft): **110.9**
Structural Grade: **0**
O&M Grade: **0**
Clock Start/From: **11**
Clock To:
1st Value: **4.000**
2nd Value:
Value Percent:
Continuous Index:
Within 8" of Joint:
Remarks:

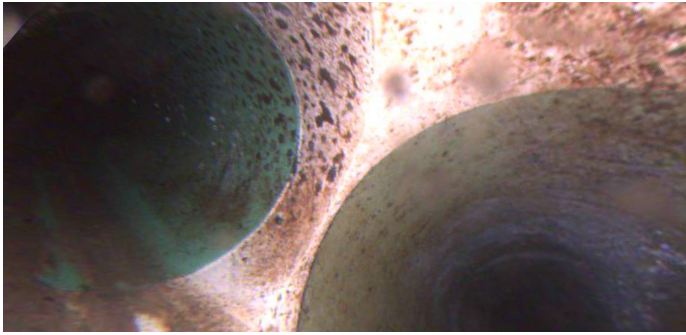
Code: **TF**
Description: **Tap Factory**

Distance (ft): **137.1**
Structural Grade: **0**
O&M Grade: **0**
Clock Start/From: **2**
Clock To:
1st Value: **4.000**
2nd Value:
Value Percent:
Continuous Index:
Within 8" of Joint:
Remarks:

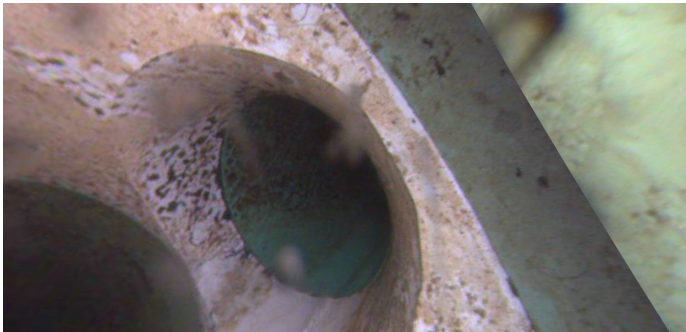
Code: **TF**
Description: **Tap Factory**

Distance (ft): **183.6**
Structural Grade: **0**
O&M Grade: **0**
Clock Start/From: **10**
Clock To:
1st Value: **4.000**
2nd Value:
Value Percent:
Continuous Index:
Within 8" of Joint:
Remarks:

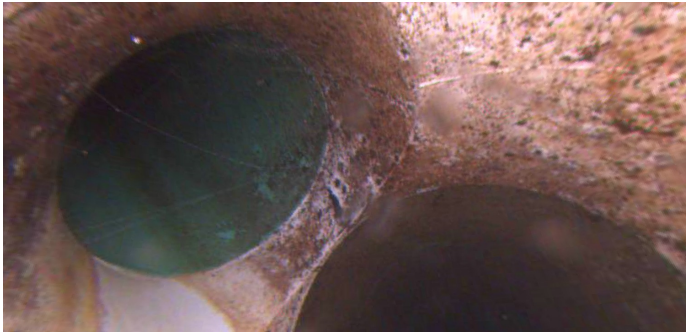
Code: **TF**
Description: **Tap Factory**

Distance (ft): **201.7**
Structural Grade: **0**
O&M Grade: **0**
Clock Start/From: **2**
Clock To:
1st Value: **4.000**
2nd Value:
Value Percent:
Continuous Index:
Within 8" of Joint:
Remarks:
