Profile/Photo Observation Report

Date:	03/22/2018	Weather:		Coding:	PACP 6.0
Pipe Length (ft):	128.4	Owner:	NA	Pre Clean:	Not Known
P.O.#:		Surveyor:	Selasie Honu	PSR:	P-809-029-030
Customer:		Clean Date:	01/01/1900	Shape:	C

Location Details:		Direction of Survey:	Downstream
US MH:	M-809-030	DS MH:	M-809-029
		Total Length Surveyed (ft):	126.5

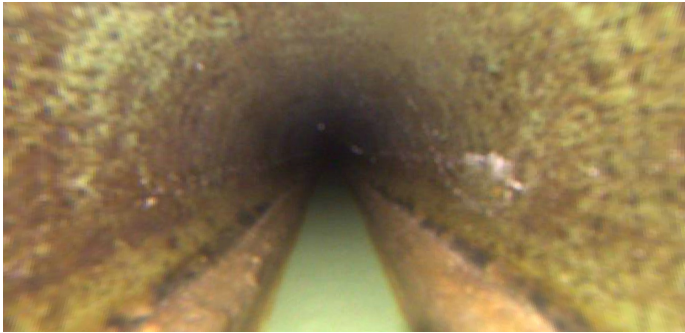
Code:	MWL
Description:	Water Level

Distance (ft):	.0
Structural Grade:	0
O&M Grade:	0
Clock Start/From:	
Clock To:	
1st Value:	
2nd Value:	
Value Percent:	5.000
Continuous Index:	
Within 8" of Joint:	NO
Remarks:

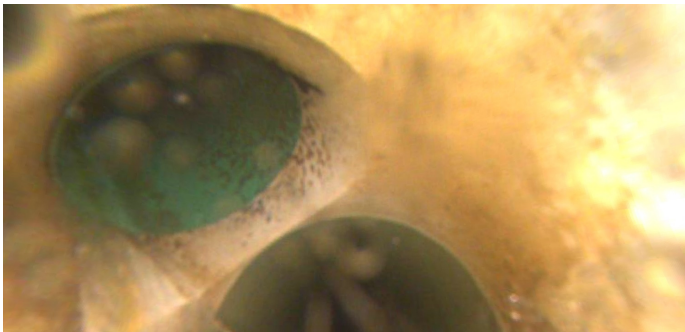
Code:	TFA
Description:	Tap Factory Active

Distance (ft):	50.2
Structural Grade:	0
O&M Grade:	0
Clock Start/From:	10
Clock To:	
1st Value:	4.000
2nd Value:	
Value Percent:	
Continuous Index:	
Within 8" of Joint:	
Remarks:

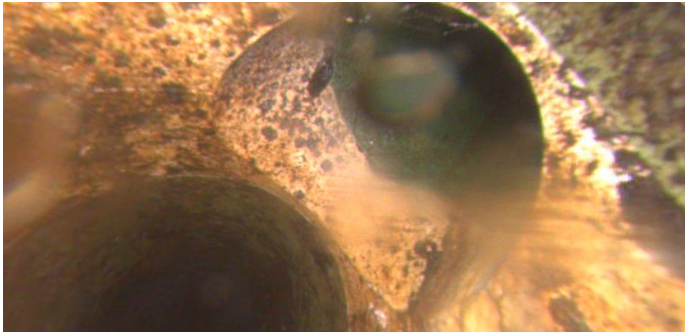
Code: **TF**
Description: **Tap Factory**

Distance (ft): **118.8**
Structural Grade: **0**
O&M Grade: **0**
Clock Start/From: **10**
Clock To:
1st Value: **4.000**
2nd Value:
Value Percent:
Continuous Index:
Within 8" of Joint:
Remarks:

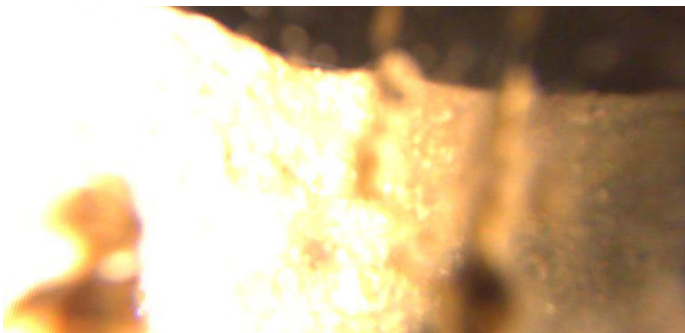
Code: **AMH**
Description: **Manhole**

Distance (ft): **126.5**
Structural Grade: **0**
O&M Grade: **0**
Clock Start/From:
Clock To:
1st Value:
2nd Value:
Value Percent:
Continuous Index:
Within 8" of Joint: **NO**
Remarks: **M-809-029**
