Profile/Photo Observation Report

Street:	Oak	Flow Control:	Not Controlled
City:	Hobart, IN	Year Renewed:	
Location:	Yard	Tape/Media #:	
Purpose:	Maintenance Related	Dia/Height:	8"
Use:	Sanitary	Material:	PVC
Drain Area:	NA	Lining:	
Category:	NA		
Comment:

Location Details:		Direction of Survey:	Upstream
US MH:	M-809-031	DS MH:	M-809-030
		Total Length Surveyed (ft):	26.2

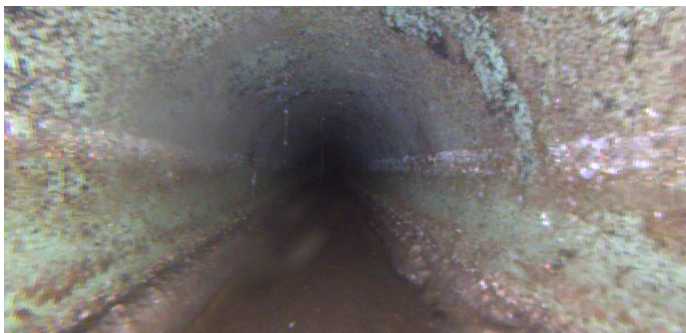
Code: **AMH**
Description: **Manhole**

Distance (ft): **.0**
Structural Grade: **0**
O&M Grade: **0**
Clock Start/From:
Clock To:
1st Value:
2nd Value:
Value Percent:
Continuous Index:
Within 8" of Joint: **NO**
Remarks: **M-809-030**

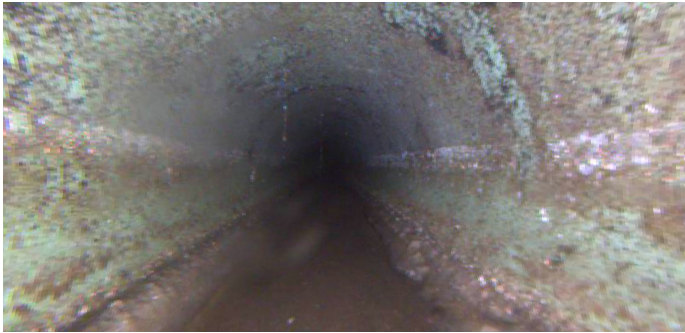
Code:	MWL
Description:	Water Level

Distance (ft):	.0
Structural Grade:	0
O&M Grade:	0
Clock Start/From:	
Clock To:	
1st Value:	
2nd Value:	
Value Percent:	5.000
Continuous Index:	
Within 8" of Joint:	NO
Remarks:
