## Profile/Photo Observation Report

Street:	<b>Oak</b>	Flow Control:	<b>Not Controlled</b>
City:	<b>Hobart, IN</b>	Year Renewed:	
Location:	<b>Sidewalk</b>	Tape/Media #:	
Purpose:	<b>Maintenance Related</b>	Dia/Height:	<b>8"</b>
Use:	<b>Sanitary</b>	Material:	<b>PVC</b>
Drain Area:	<b>NA</b>	Lining:	
Category:	<b>NA</b>		
Comment:

Location Details:		Direction of Survey:	<b>Downstream</b>
US MH:	<b>M-809-032</b>	DS MH:	<b>M-809-019</b>
		Total Length Surveyed (ft):	<b>263.2</b>

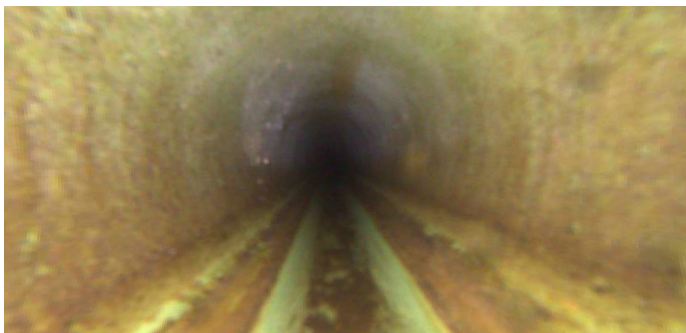
Code: **AMH**  
Description: **Manhole**

Distance (ft): **.0**  
Structural Grade: **0**  
O&M Grade: **0**  
Clock Start/From:  
Clock To:  
1st Value:  
2nd Value:  
Value Percent:  
Continuous Index:  
Within 8" of Joint: **NO**  
Remarks: **M-809-032**

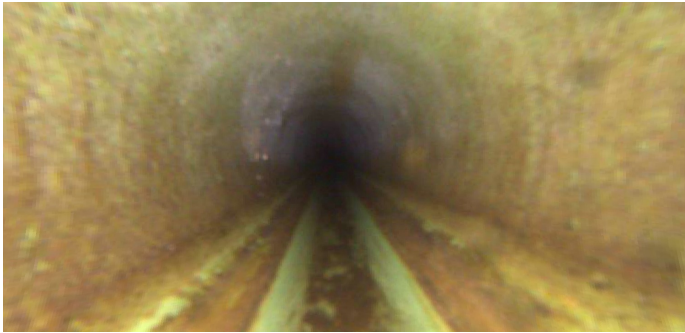
Code:	<b>MWL</b>
Description:	<b>Water Level</b>

Distance (ft):	<b>.0</b>
Structural Grade:	<b>0</b>
O&M Grade:	<b>0</b>
Clock Start/From:	
Clock To:	
1st Value:	
2nd Value:	
Value Percent:	<b>5.000</b>
Continuous Index:	
Within 8" of Joint:	<b>NO</b>
Remarks:

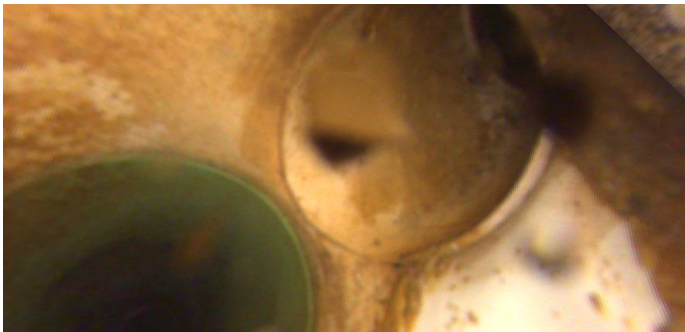
Code:	<b>TF</b>
Description:	<b>Tap Factory</b>

Distance (ft):	<b>42.4</b>
Structural Grade:	<b>0</b>
O&M Grade:	<b>0</b>
Clock Start/From:	<b>2</b>
Clock To:	
1st Value:	<b>4.000</b>
2nd Value:	
Value Percent:	
Continuous Index:	
Within 8" of Joint:	
Remarks:

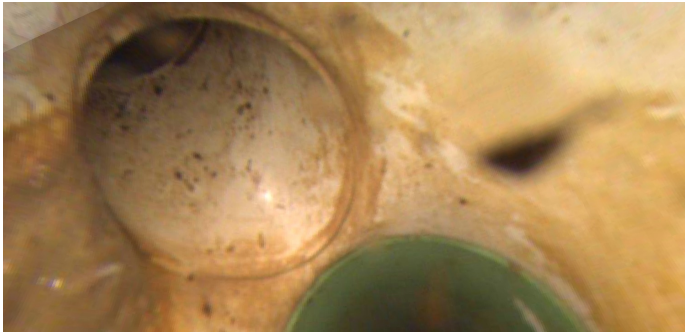
Code: **TF**  
Description: **Tap Factory**

Distance (ft): **47.8**  
Structural Grade: **0**  
O&M Grade: **0**  
Clock Start/From: **11**  
Clock To:  
1st Value: **4.000**  
2nd Value:  
Value Percent:  
Continuous Index:  
Within 8" of Joint:  
Remarks:

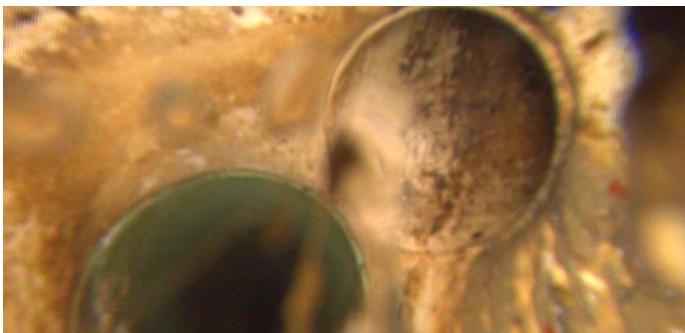
Code: **TF**  
Description: **Tap Factory**

Distance (ft): **132.7**  
Structural Grade: **0**  
O&M Grade: **0**  
Clock Start/From: **2**  
Clock To:  
1st Value: **4.000**  
2nd Value:  
Value Percent:  
Continuous Index:  
Within 8" of Joint:  
Remarks:

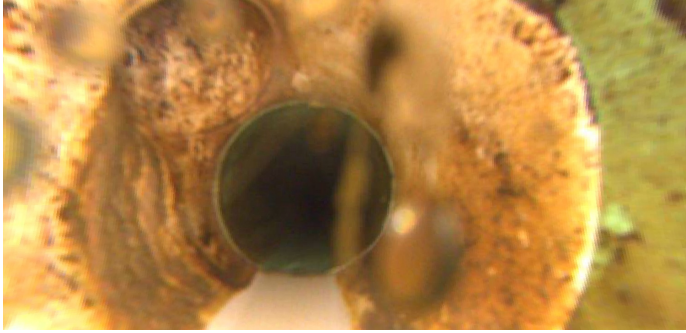
Code: **TF**  
Description: **Tap Factory**

Distance (ft): **137.9**  
Structural Grade: **0**  
O&M Grade: **0**  
Clock Start/From: **10**  
Clock To:  
1st Value: **4.000**  
2nd Value:  
Value Percent:  
Continuous Index:  
Within 8" of Joint:  
Remarks:

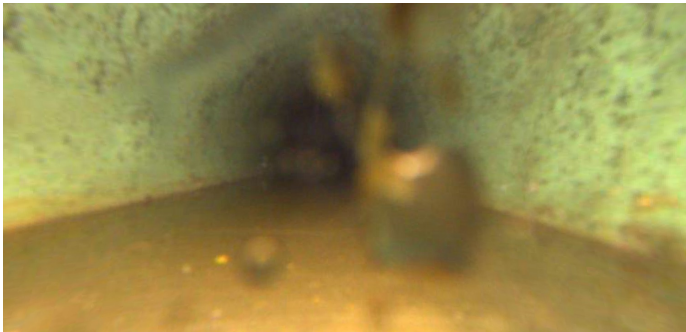
Code: **MWL**  
Description: **Water Level**

Distance (ft): **258.6**  
Structural Grade: **0**  
O&M Grade: **0**  
Clock Start/From:  
Clock To:  
1st Value:  
2nd Value:  
Value Percent: **40.000**  
Continuous Index:  
Within 8" of Joint: **NO**  
Remarks:
