## Profile/Photo Observation Report

Date:	<b>03/23/2018</b>	Weather:		Coding:	<b>PACP 6.0</b>
Pipe Length (ft):	<b>246.0</b>	Owner:	<b>NA</b>	Pre Clean:	<b>Not Known</b>
P.O.#:		Surveyor:	<b>Justin Gonzales</b>	PSR:	<b>P-809-031-032</b>
Customer:		Clean Date:	<b>01/01/1900</b>	Shape:	<b>C</b>

Location Details:		Direction of Survey:	<b>Downstream</b>
US MH:	<b>M-809-032</b>	DS MH:	<b>M-809-031</b>
		Total Length Surveyed (ft):	<b>241.3</b>

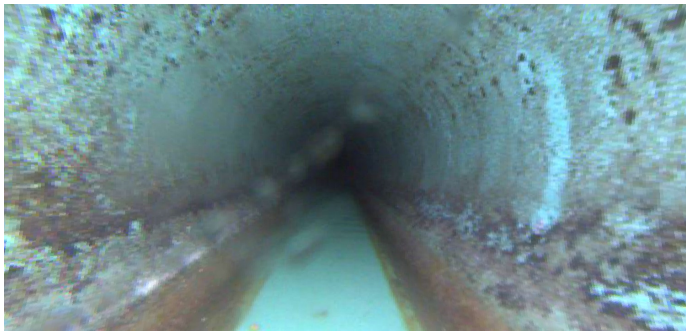
Code: **AMH**  
Description: **Manhole**

Distance (ft): **.0**  
Structural Grade: **0**  
O&M Grade: **0**  
Clock Start/From:  
Clock To:  
1st Value:  
2nd Value:  
Value Percent:  
Continuous Index:  
Within 8" of Joint: **NO**  
Remarks: **M-809-032**

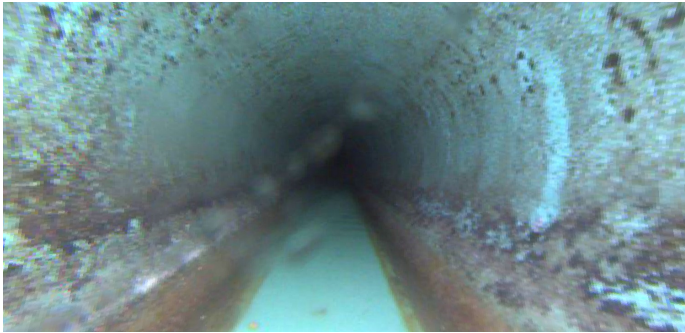
Code:	<b>MWL</b>
Description:	<b>Water Level</b>

Distance (ft):	<b>.0</b>
Structural Grade:	<b>0</b>
O&M Grade:	<b>0</b>
Clock Start/From:	
Clock To:	
1st Value:	
2nd Value:	
Value Percent:	<b>5.000</b>
Continuous Index:	
Within 8" of Joint:	<b>NO</b>
Remarks:

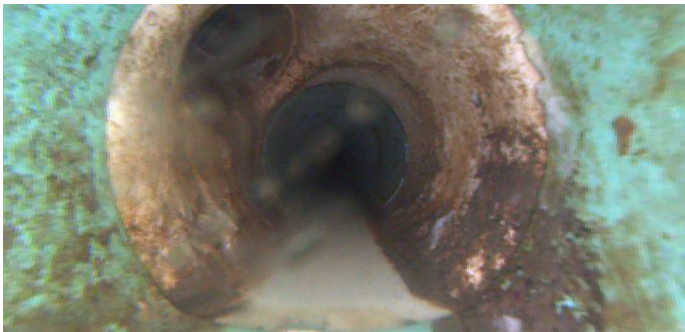
Code:	<b>TF</b>
Description:	<b>Tap Factory</b>

Distance (ft):	<b>22.6</b>
Structural Grade:	<b>0</b>
O&M Grade:	<b>0</b>
Clock Start/From:	<b>10</b>
Clock To:	
1st Value:	<b>4.000</b>
2nd Value:	
Value Percent:	
Continuous Index:	
Within 8" of Joint:	
Remarks:

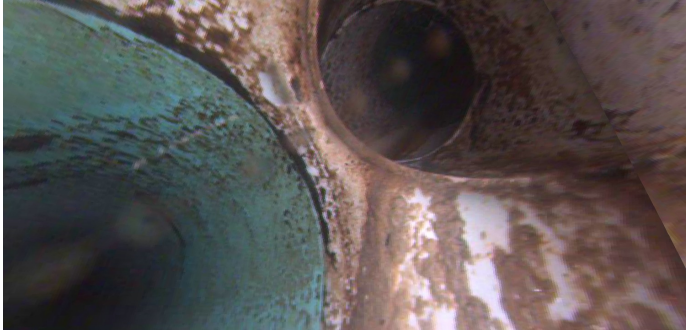
Code: **TF**  
Description: **Tap Factory**

Distance (ft): **31.6**  
Structural Grade: **0**  
O&M Grade: **0**  
Clock Start/From: **2**  
Clock To:  
1st Value: **4.000**  
2nd Value:  
Value Percent:  
Continuous Index:  
Within 8" of Joint:  
Remarks:

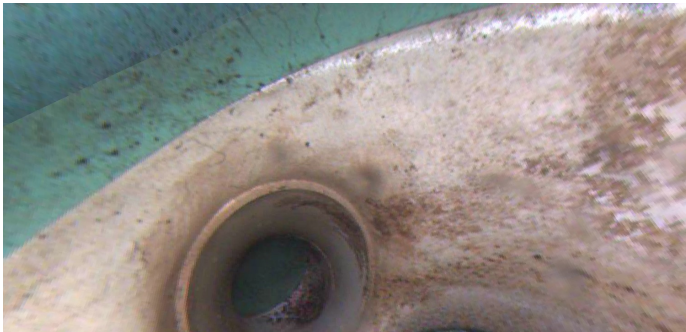
Code: **TF**  
Description: **Tap Factory**

Distance (ft): **89.1**  
Structural Grade: **0**  
O&M Grade: **0**  
Clock Start/From: **10**  
Clock To:  
1st Value: **4.000**  
2nd Value:  
Value Percent:  
Continuous Index:  
Within 8" of Joint:  
Remarks:

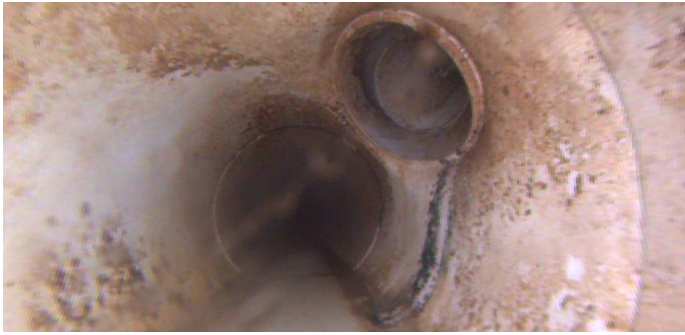
Code: **TF**  
Description: **Tap Factory**

Distance (ft): **148.9**  
Structural Grade: **0**  
O&M Grade: **0**  
Clock Start/From: **2**  
Clock To:  
1st Value: **4.000**  
2nd Value:  
Value Percent:  
Continuous Index:  
Within 8" of Joint:  
Remarks:

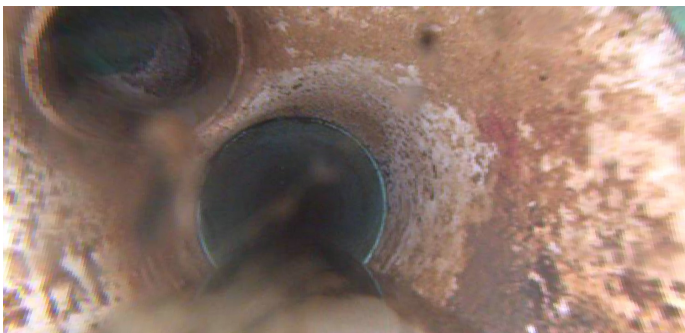
Code: **TF**  
Description: **Tap Factory**

Distance (ft): **176.2**  
Structural Grade: **0**  
O&M Grade: **0**  
Clock Start/From: **10**  
Clock To:  
1st Value: **4.000**  
2nd Value:  
Value Percent:  
Continuous Index:  
Within 8" of Joint:  
Remarks:

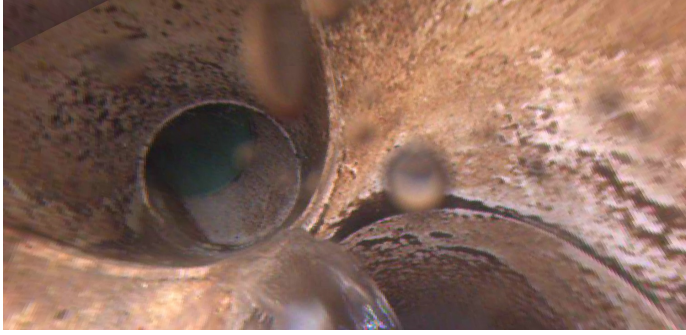
Code: **TFA**  
Description: **Tap Factory Active**

Distance (ft): **228.9**  
Structural Grade: **0**  
O&M Grade: **0**  
Clock Start/From: **10**  
Clock To:  
1st Value: **4.000**  
2nd Value:  
Value Percent:  
Continuous Index:  
Within 8" of Joint:  
Remarks:

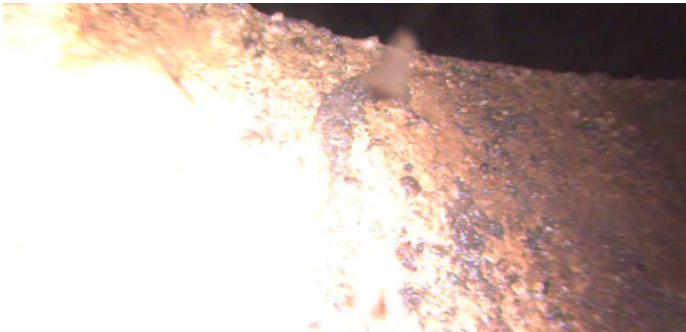
Code: **AMH**  
Description: **Manhole**

Distance (ft): **241.3**  
Structural Grade: **0**  
O&M Grade: **0**  
Clock Start/From:  
Clock To:  
1st Value:  
2nd Value:  
Value Percent:  
Continuous Index:  
Within 8" of Joint: **NO**  
Remarks: **M-809-031**
