Profile/Photo Observation Report

Street:	TANAGER ST	Flow Control:	Not Controlled
City:	Hobart, IN	Year Renewed:	
Location:	Sidewalk	Tape/Media #:	
Purpose:	Maintenance Related	Dia/Height:	12"
Use:	Sanitary	Material:	PVC
Drain Area:	NA	Lining:	
Category:	NA		
Comment:	unknown pipe configuration at 4'.		
Location Details:		Direction of Survey:	Upstream
US MH:	M-809-034	DS MH:	M-809-035
		Total Length Surveyed (ft):	5.6

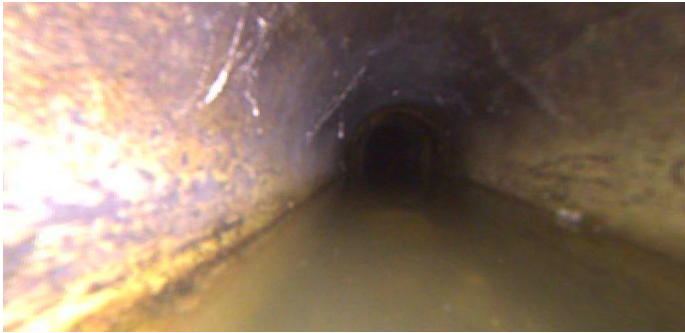
Code:	MWL
Description:	Water Level

Distance (ft):	.0
Structural Grade:	0
O&M Grade:	0
Clock Start/From:	
Clock To:	
1st Value:	
2nd Value:	
Value Percent:	10.000
Continuous Index:	
Within 8" of Joint:	NO
Remarks:

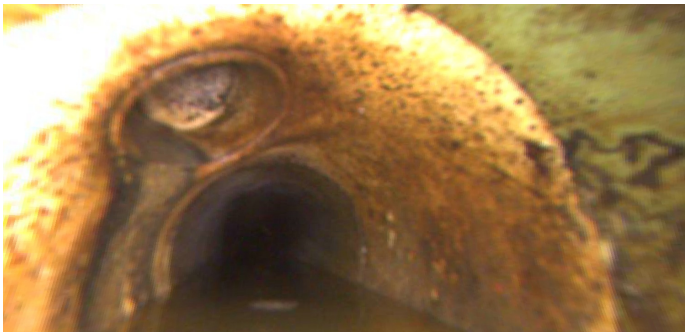
Code:	TF
Description:	Tap Factory

Distance (ft):	3.7
Structural Grade:	0
O&M Grade:	0
Clock Start/From:	11
Clock To:	
1st Value:	4.000
2nd Value:	
Value Percent:	
Continuous Index:	
Within 8" of Joint:	YES
Remarks:

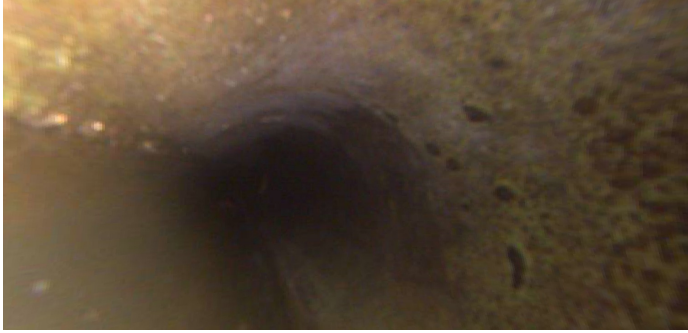
Code:	MSA
Description:	Abandoned Survey
Distance (ft):	5.6
Structural Grade:	0
O&M Grade:	0
Clock Start/From:	
Clock To:	
1st Value:	
2nd Value:	
Value Percent:	
Continuous Index:	
Within 8" of Joint:	NO
Remarks:	camera flipped
