## Profile/Photo Observation Report

Date:	<b>03/24/2018</b>	Weather:		Coding:	<b>PACP 6.0</b>
Pipe Length (ft):	<b>217.1</b>	Owner:	<b>NA</b>	Pre Clean:	<b>Not Known</b>
P.O.#:		Surveyor:	<b>Byrd Fitzgerald</b>	PSR:	<b>P-809-034-035</b>
Customer:		Clean Date:	<b>01/01/1900</b>	Shape:	<b>C</b>

Location Details:		Direction of Survey:	<b>Upstream</b>
US MH:	<b>M-809-034</b>	DS MH:	<b>M-809-035</b>
		Total Length Surveyed (ft):	<b>5.6</b>

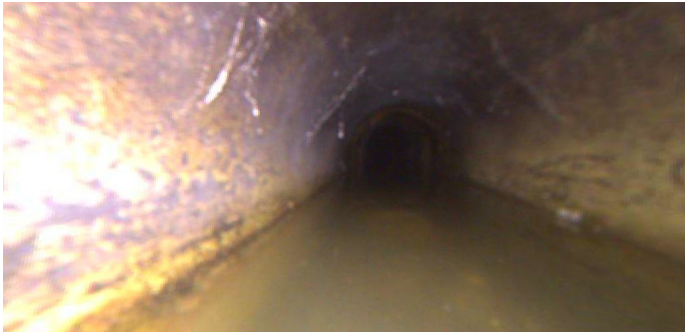
Code:	<b>MWL</b>
Description:	<b>Water Level</b>

Distance (ft):	<b>.0</b>
Structural Grade:	<b>0</b>
O&M Grade:	<b>0</b>
Clock Start/From:	
Clock To:	
1st Value:	
2nd Value:	
Value Percent:	<b>10.000</b>
Continuous Index:	
Within 8" of Joint:	<b>NO</b>
Remarks:

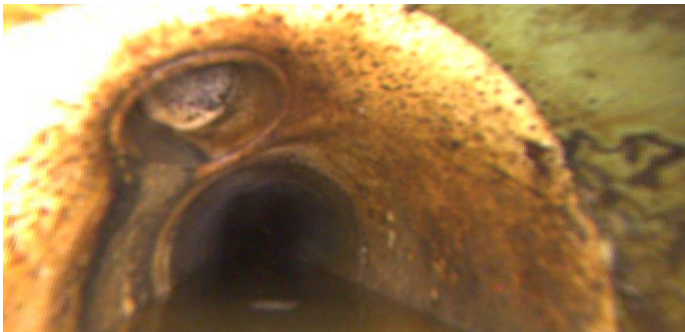
Code:	<b>TF</b>
Description:	<b>Tap Factory</b>

Distance (ft):	<b>3.7</b>
Structural Grade:	<b>0</b>
O&M Grade:	<b>0</b>
Clock Start/From:	<b>11</b>
Clock To:	
1st Value:	<b>4.000</b>
2nd Value:	
Value Percent:	
Continuous Index:	
Within 8" of Joint:	<b>YES</b>
Remarks:

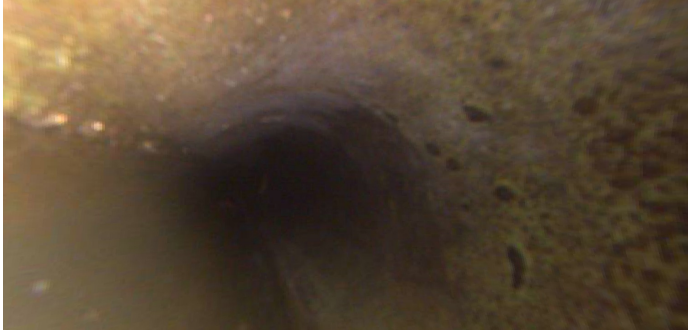
Code:	<b>MSA</b>
Description:	<b>Abandoned Survey</b>
Distance (ft):	<b>5.6</b>
Structural Grade:	<b>0</b>
O&M Grade:	<b>0</b>
Clock Start/From:	
Clock To:	
1st Value:	
2nd Value:	
Value Percent:	
Continuous Index:	
Within 8" of Joint:	<b>NO</b>
Remarks:	<b>camera flipped</b>
