Profile/Photo Observation Report

Street:	MERGANSE ST	Flow Control:	Not Controlled
City:	Hobart, IN	Year Renewed:	
Location:	Sidewalk	Tape/Media #:	
Purpose:	Maintenance Related	Dia/Height:	12"
Use:	Sanitary	Material:	PVC
Drain Area:	NA	Lining:	
Category:	NA		
Comment:	unknown at 1'.

Location Details:		Direction of Survey:	Upstream
US MH:	M-809-035	DS MH:	M-809-036
		Total Length Surveyed (ft):	2.9

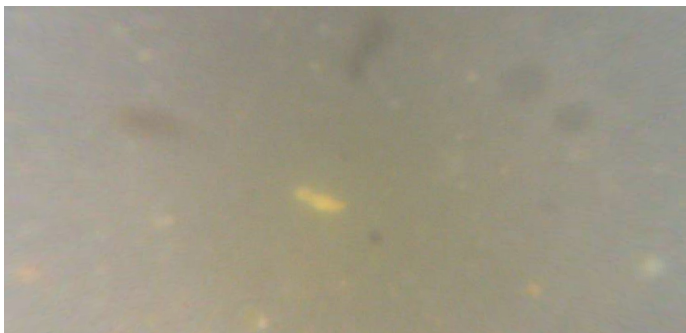
Code: **AMH**
Description: **Manhole**

Distance (ft): **.0**
Structural Grade: **0**
O&M Grade: **0**
Clock Start/From:
Clock To:
1st Value:
2nd Value:
Value Percent:
Continuous Index:
Within 8" of Joint: **NO**
Remarks: **M-809-036**

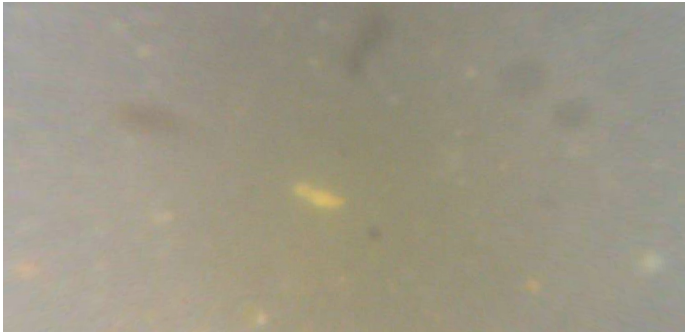
Code:	MWL
Description:	Water Level

Distance (ft):	.0
Structural Grade:	0
O&M Grade:	0
Clock Start/From:	
Clock To:	
1st Value:	
2nd Value:	
Value Percent:	100.000
Continuous Index:	
Within 8" of Joint:	NO
Remarks:	mcu

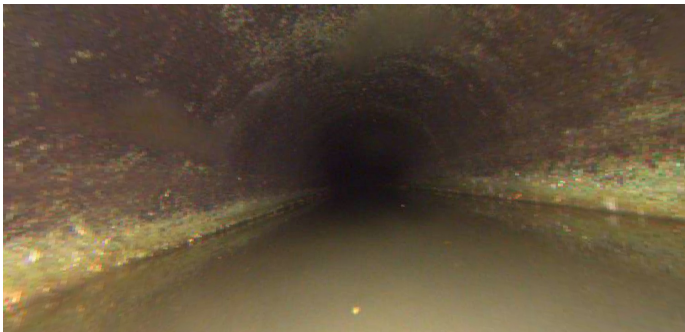
Code:	MWL
Description:	Water Level

Distance (ft):	1.0
Structural Grade:	0
O&M Grade:	0
Clock Start/From:	
Clock To:	
1st Value:	
2nd Value:	
Value Percent:	10.000
Continuous Index:	
Within 8" of Joint:	NO
Remarks:
