## Profile/Photo Observation Report

Date:	<b>03/24/2018</b>	Weather:		Coding:	<b>PACP 6.0</b>
Pipe Length (ft):	<b>108.0</b>	Owner:	<b>NA</b>	Pre Clean:	<b>Not Known</b>
P.O.#:		Surveyor:	<b>Byrd Fitzgerald</b>	PSR:	<b>P-809-035-036</b>
Customer:		Clean Date:	<b>01/01/1900</b>	Shape:	<b>C</b>

Location Details:		Direction of Survey:	<b>Upstream</b>
US MH:	<b>M-809-035</b>	DS MH:	<b>M-809-036</b>
		Total Length Surveyed (ft):	<b>2.9</b>

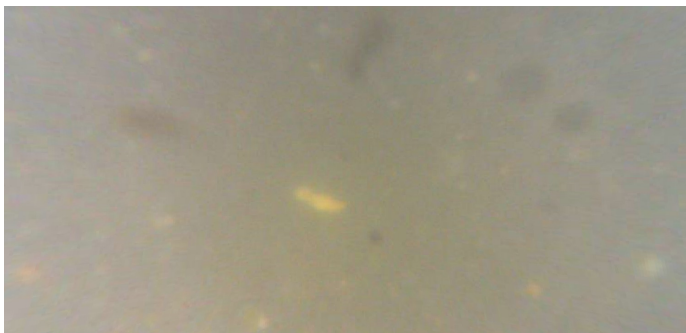
Code: **AMH**  
Description: **Manhole**

Distance (ft): **.0**  
Structural Grade: **0**  
O&M Grade: **0**  
Clock Start/From:  
Clock To:  
1st Value:  
2nd Value:  
Value Percent:  
Continuous Index:  
Within 8" of Joint: **NO**  
Remarks: **M-809-036**

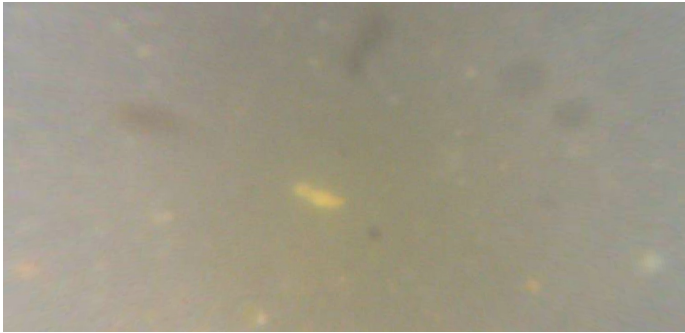
Code:	<b>MWL</b>
Description:	<b>Water Level</b>

Distance (ft):	<b>.0</b>
Structural Grade:	<b>0</b>
O&M Grade:	<b>0</b>
Clock Start/From:	
Clock To:	
1st Value:	
2nd Value:	
Value Percent:	<b>100.000</b>
Continuous Index:	
Within 8" of Joint:	<b>NO</b>
Remarks:	<b>mcu</b>

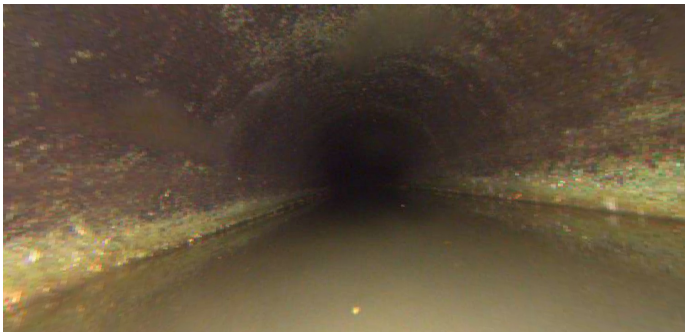
Code:	<b>MWL</b>
Description:	<b>Water Level</b>

Distance (ft):	<b>1.0</b>
Structural Grade:	<b>0</b>
O&M Grade:	<b>0</b>
Clock Start/From:	
Clock To:	
1st Value:	
2nd Value:	
Value Percent:	<b>10.000</b>
Continuous Index:	
Within 8" of Joint:	<b>NO</b>
Remarks:
