## Profile/Photo Observation Report

| Street: | <b>MERGANSE ST</b> | Flow Control: | <b>Not Controlled</b> |
| City: | <b>Hobart, IN</b> | Year Renewed: | |
| US MH: | <b>M-809-035</b> | DS MH: | <b>M-809-036</b> |

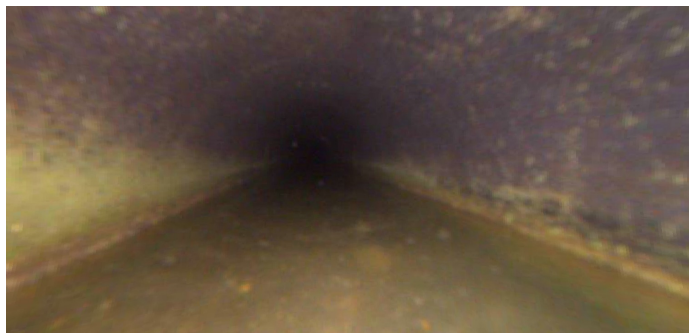
Code: **AMH**  
 Description: **Manhole**

Distance (ft): **.0**  
 Structural Grade: **0**  
 O&M Grade: **0**  
 Clock Start/From:  
 Clock To:  
 1st Value:  
 2nd Value:  
 Value Percent:  
 Continuous Index:  
 Within 8" of Joint: **NO**  
 Remarks: **M-809-035**

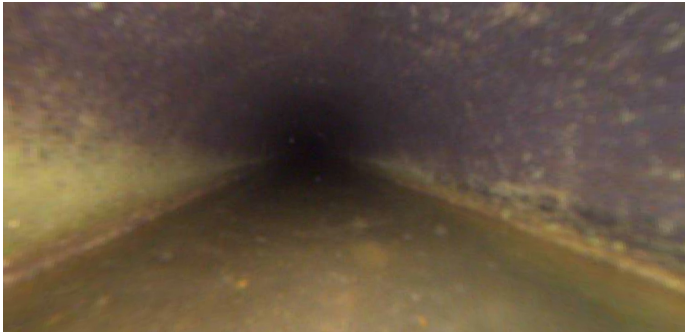
| Description: | <b>Water Level</b> |

| Value Percent: | <b>5.000</b> |

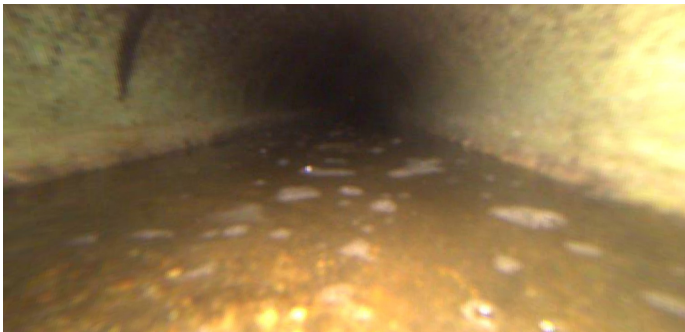
| Distance (ft): | <b>45.3</b> |
| Remarks: | <b>heavy sediments in flow</b> |

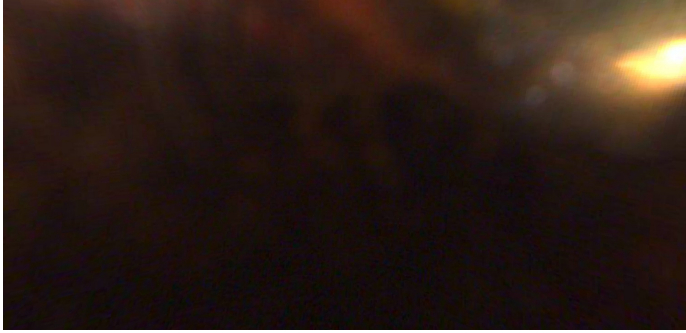
Distance (ft): **55.3**  
Structural Grade: **0**  
O&M Grade: **0**  
Clock Start/From:  
Clock To:  
1st Value:  
2nd Value:  
Value Percent:  
Continuous Index:  
Within 8" of Joint: **NO**  
Remarks: **lense covered**

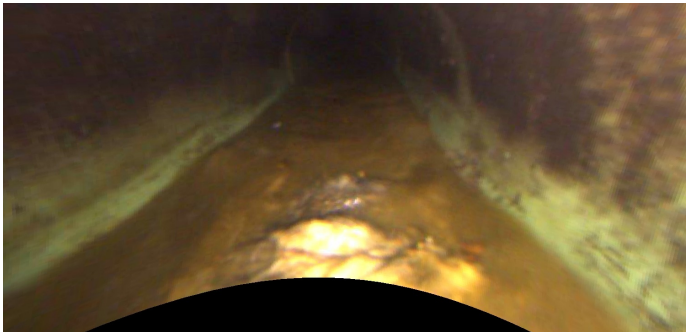
| | Position | Code | Observation | Video (sec) | Grade |
|--|---|---|---|---|---|
| | 63.0 | DSZ | Deposits Settled Other | 182 | M 2 |

Code: **DSZ**  
Description: **Deposits Settled Other**

Distance (ft): **63.0**  
Structural Grade: **0**  
O&M Grade: **2**  
Clock Start/From: **6**  
Clock To:  
1st Value:  
2nd Value:  
Value Percent: **5.000**  
Continuous Index:  
Within 8" of Joint: **NO**  
Remarks: **debris**

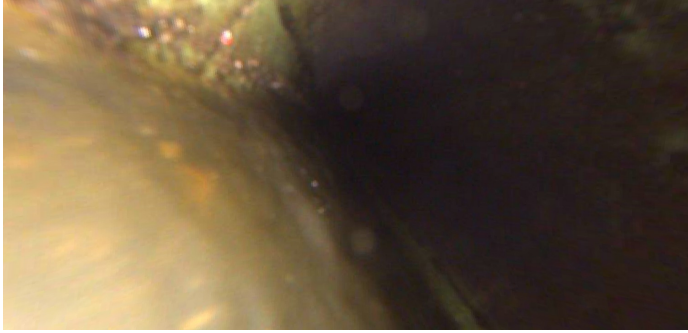
| Comment: | <b>Reverse setup. gravel/sediment at 89'.</b> | | |

| Description: | <b>Abandoned Survey</b> |
| Distance (ft): | <b>90.9</b> |
| Remarks: | <b>debris under water</b> |
