Profile/Photo Observation Report

Date:	03/24/2018	Weather:		Coding:	PACP 6.0
Pipe Length (ft):	108.0	Owner:	NA	Pre Clean:	Not Known
P.O.#:		Surveyor:	Byrd Fitzgerald	PSR:	P-809-035-036
Customer:		Clean Date:	01/01/1900	Shape:	C

Street:	Oak	Flow Control:	Not Controlled
City:	Hobart, IN	Year Renewed:	
Location:	Sidewalk	Tape/Media #:	
Purpose:	Maintenance Related	Dia/Height:	12"
Use:	Sanitary	Material:	PVC
Drain Area:	NA	Lining:	
Category:	NA		
Comment:	Reverse setup. gravel/sediment at 89'.

Location Details:		Direction of Survey:	Downstream
US MH:	M-809-035	DS MH:	M-809-036
		Total Length Surveyed (ft):	90.9

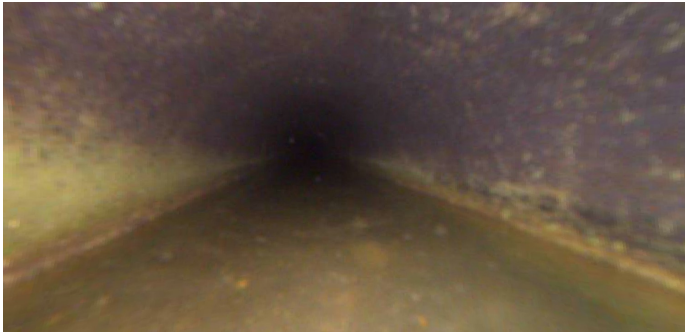
Code:	MWL
Description:	Water Level

Distance (ft):	.0
Structural Grade:	0
O&M Grade:	0
Clock Start/From:	
Clock To:	
1st Value:	
2nd Value:	
Value Percent:	5.000
Continuous Index:	
Within 8" of Joint:	NO
Remarks:

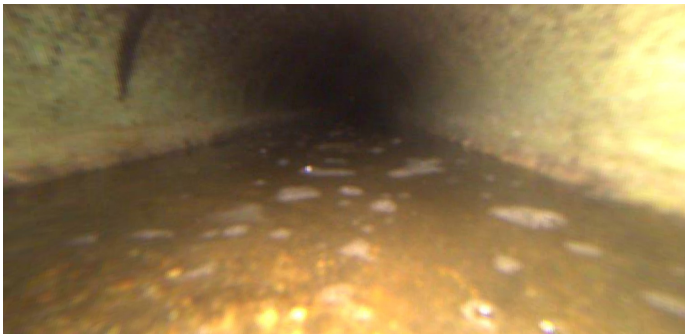
Code:	MGO
Description:	General Observation

Distance (ft):	45.3
Structural Grade:	0
O&M Grade:	0
Clock Start/From:	
Clock To:	
1st Value:	
2nd Value:	
Value Percent:	
Continuous Index:	
Within 8" of Joint:	NO
Remarks:	heavy sediments in flow

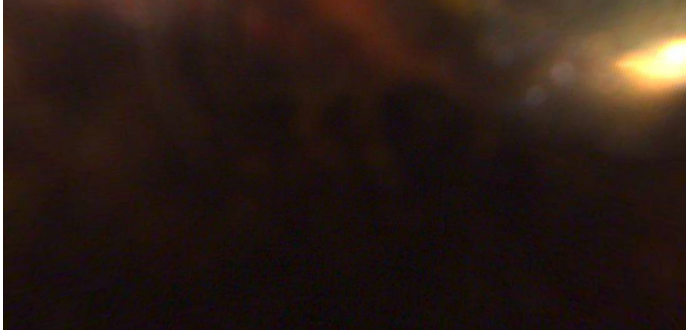
Code: **MGO**
Description: **General Observation**

Distance (ft): **55.3**
Structural Grade: **0**
O&M Grade: **0**
Clock Start/From:
Clock To:
1st Value:
2nd Value:
Value Percent:
Continuous Index:
Within 8" of Joint: **NO**
Remarks: **lense covered**

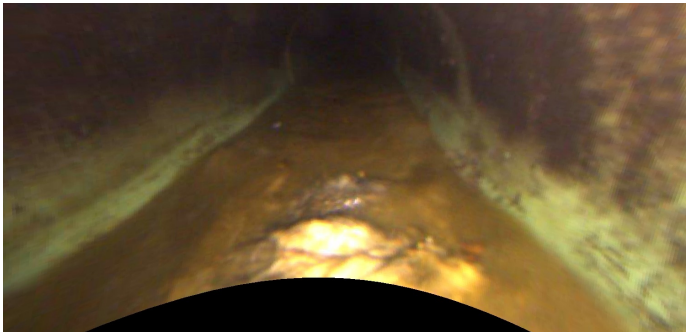
Code: **DSZ**
Description: **Deposits Settled Other**

Distance (ft): **63.0**
Structural Grade: **0**
O&M Grade: **2**
Clock Start/From: **6**
Clock To:
1st Value:
2nd Value:
Value Percent: **5.000**
Continuous Index:
Within 8" of Joint: **NO**
Remarks: **debris**

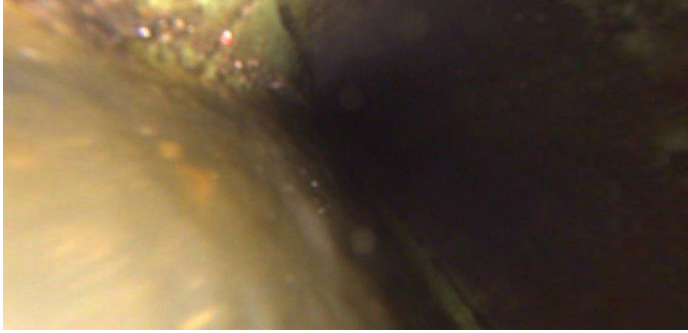
Code:	MSA
Description:	Abandoned Survey
Distance (ft):	90.9
Structural Grade:	0
O&M Grade:	0
Clock Start/From:	
Clock To:	
1st Value:	
2nd Value:	
Value Percent:	
Continuous Index:	
Within 8" of Joint:	NO
Remarks:	debris under water
