Profile/Photo Observation Report

Street:	MERGANSE ST & KESTREL ST	Flow Control:	Not Controlled
City:	Hobart, IN	Year Renewed:	
Location:	Sidewalk	Tape/Media #:	
Purpose:	Maintenance Related	Dia/Height:	12"
Use:	Sanitary	Material:	PVC
Drain Area:	NA	Lining:	
Category:	NA		
Comment:	unknown at 240'.

Location Details:		Direction of Survey:	Upstream
US MH:	M-809-038	DS MH:	M-709-036
		Total Length Surveyed (ft):	242.0

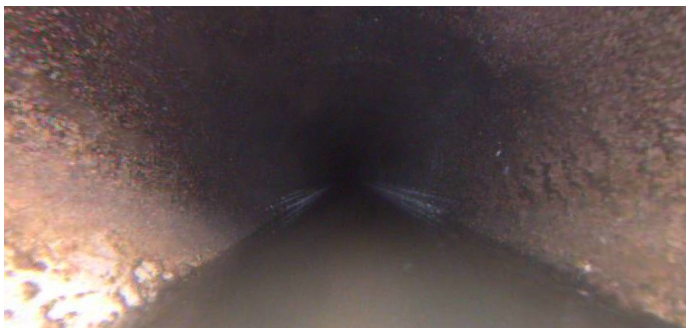
Code: **AMH**
Description: **Manhole**

Distance (ft): **.0**
Structural Grade: **0**
O&M Grade: **0**
Clock Start/From:
Clock To:
1st Value:
2nd Value:
Value Percent:
Continuous Index:
Within 8" of Joint: **NO**
Remarks: **M-709-036**

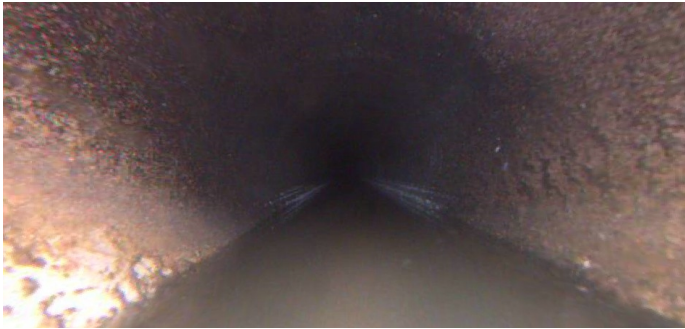
Code:	MWL
Description:	Water Level

Distance (ft):	.0
Structural Grade:	0
O&M Grade:	0
Clock Start/From:	
Clock To:	
1st Value:	
2nd Value:	
Value Percent:	20.000
Continuous Index:	
Within 8" of Joint:	NO
Remarks:

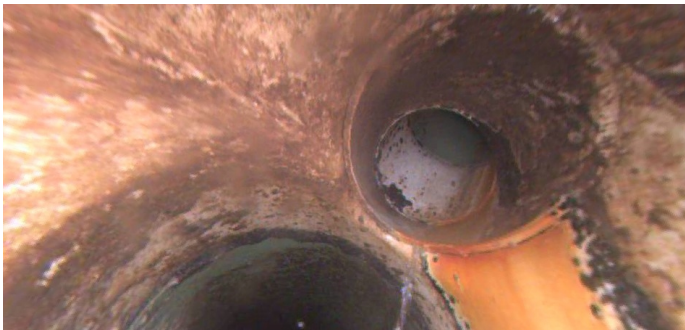
Code:	TFA
Description:	Tap Factory Active

Distance (ft):	70.5
Structural Grade:	0
O&M Grade:	0
Clock Start/From:	1
Clock To:	
1st Value:	4.000
2nd Value:	
Value Percent:	
Continuous Index:	
Within 8" of Joint:	
Remarks:

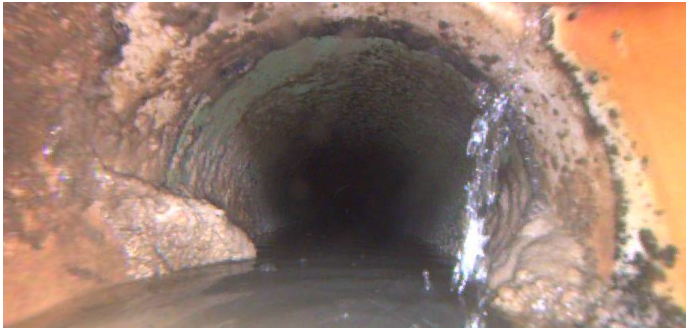
Code: **DAGS**
Description: **Deposits Attached Grease**

Distance (ft): **70.8**
Structural Grade: **0**
O&M Grade: **2**
Clock Start/From: **3**
Clock To: **9**
1st Value:
2nd Value:
Value Percent: **10.000**
Continuous Index:
Within 8" of Joint: **YES**
Remarks:

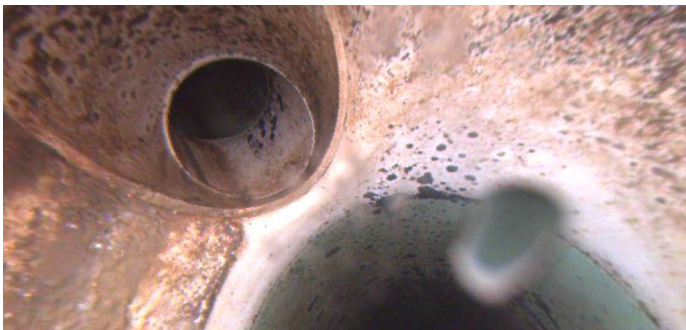
Code: **TF**
Description: **Tap Factory**

Distance (ft): **77.9**
Structural Grade: **0**
O&M Grade: **0**
Clock Start/From: **11**
Clock To:
1st Value: **4.000**
2nd Value:
Value Percent:
Continuous Index:
Within 8" of Joint:
Remarks:

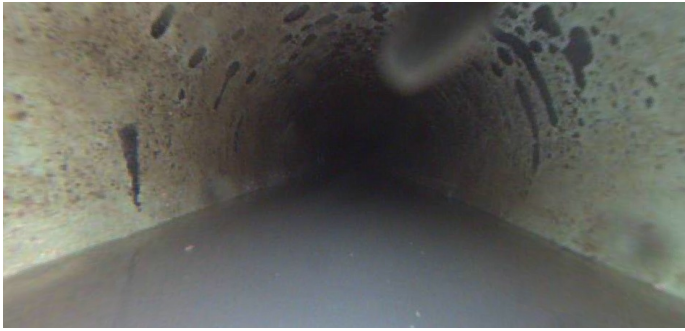
Code: **MWL**
Description: **Water Level**

Distance (ft): **78.5**
Structural Grade: **0**
O&M Grade: **0**
Clock Start/From:
Clock To:
1st Value:
2nd Value:
Value Percent: **30.000**
Continuous Index:
Within 8" of Joint: **NO**
Remarks:

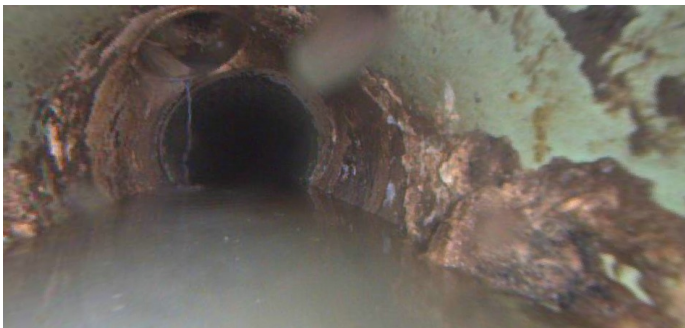
Code: **DAZ**
Description: **Deposits Attached Other**

Distance (ft): **154.7**
Structural Grade: **0**
O&M Grade: **2**
Clock Start/From: **3**
Clock To: **4**
1st Value:
2nd Value:
Value Percent: **10.000**
Continuous Index:
Within 8" of Joint: **NO**
Remarks: **Mixed materials**

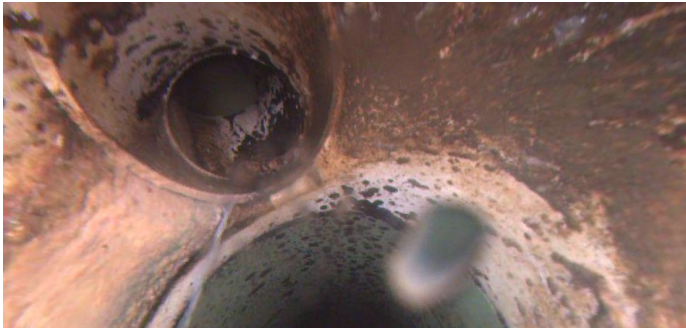
Code: **TFA**
Description: **Tap Factory Active**

Distance (ft): **155.8**
Structural Grade: **0**
O&M Grade: **0**
Clock Start/From: **11**
Clock To:
1st Value: **4.000**
2nd Value:
Value Percent:
Continuous Index:
Within 8" of Joint:
Remarks:

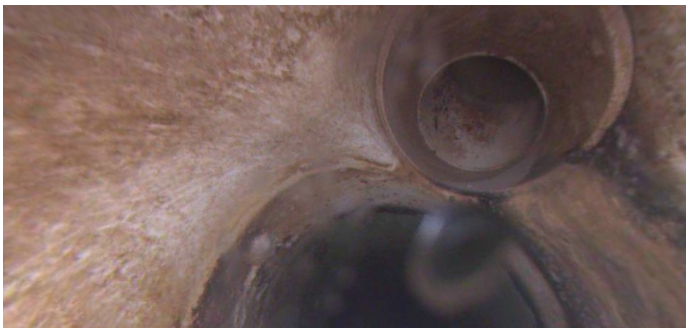
Code: **TF**
Description: **Tap Factory**

Distance (ft): **213.1**
Structural Grade: **0**
O&M Grade: **0**
Clock Start/From: **1**
Clock To:
1st Value: **4.000**
2nd Value:
Value Percent:
Continuous Index:
Within 8" of Joint:
Remarks:

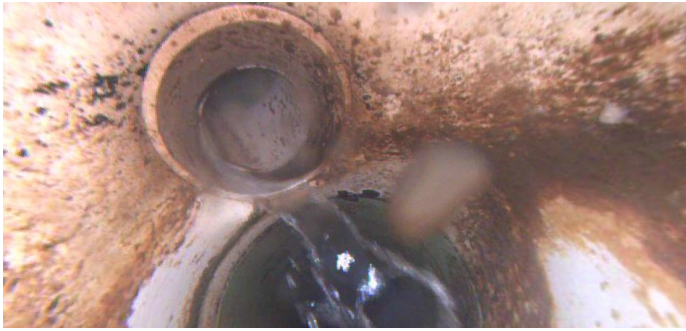
Code: **TFA**
Description: **Tap Factory Active**

Distance (ft): **221.9**
Structural Grade: **0**
O&M Grade: **0**
Clock Start/From: **11**
Clock To:
1st Value: **4.000**
2nd Value:
Value Percent:
Continuous Index:
Within 8" of Joint:
Remarks:

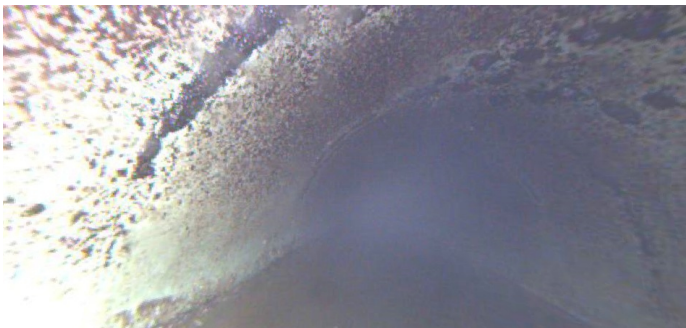
Code: **MSA**
Description: **Abandoned Survey**

Distance (ft): **242.0**
Structural Grade: **0**
O&M Grade: **0**
Clock Start/From:
Clock To:
1st Value:
2nd Value:
Value Percent:
Continuous Index:
Within 8" of Joint: **NO**
Remarks: **Unknown**
