Profile/Photo Observation Report

Street:	Oak	Flow Control:	Not Controlled
City:	Hobart, IN	Year Renewed:	
Location:	Sidewalk	Tape/Media #:	
Purpose:	Maintenance Related	Dia/Height:	12"
Use:	Sanitary	Material:	PVC
Drain Area:	NA	Lining:	
Category:	NA		
Comment:	unknown at 240'.

Location Details:		Direction of Survey:	Upstream
US MH:	M-809-038	DS MH:	M-709-036
		Total Length Surveyed (ft):	242.0

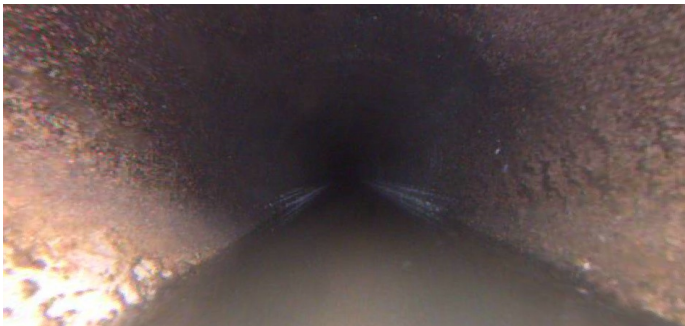
Code: **AMH**
Description: **Manhole**

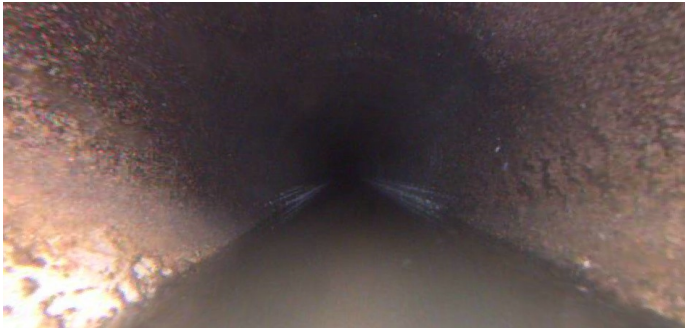
Code:	MWL
Description:	Water Level

Distance (ft):	.0
Structural Grade:	0
O&M Grade:	0
Clock Start/From:	
Clock To:	
1st Value:	
2nd Value:	
Value Percent:	20.000
Continuous Index:	
Within 8" of Joint:	NO
Remarks:

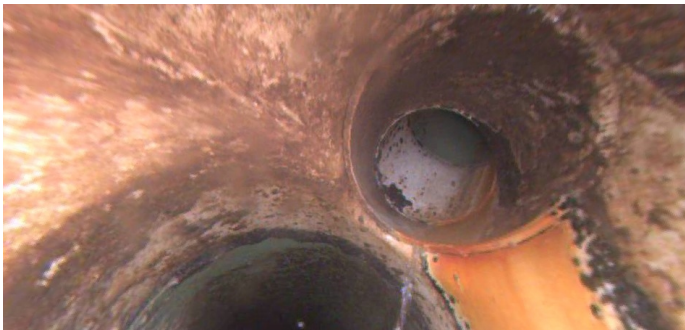
Code:	TFA
Description:	Tap Factory Active

Distance (ft):	70.5
Structural Grade:	0
O&M Grade:	0
Clock Start/From:	1
Clock To:	
1st Value:	4.000
2nd Value:	
Value Percent:	
Continuous Index:	
Within 8" of Joint:	
Remarks:

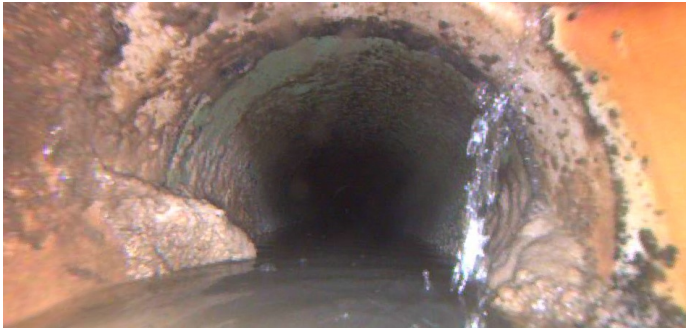
Code: **DAGS**
Description: **Deposits Attached Grease**

Distance (ft): **70.8**
Structural Grade: **0**
O&M Grade: **2**
Clock Start/From: **3**
Clock To: **9**
1st Value:
2nd Value:
Value Percent: **10.000**
Continuous Index:
Within 8" of Joint: **YES**
Remarks:

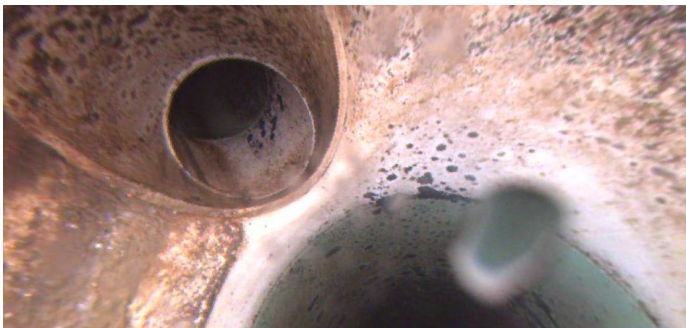
Code: **TF**
Description: **Tap Factory**

Distance (ft): **77.9**
Structural Grade: **0**
O&M Grade: **0**
Clock Start/From: **11**
Clock To:
1st Value: **4.000**
2nd Value:
Value Percent:
Continuous Index:
Within 8" of Joint:
Remarks:

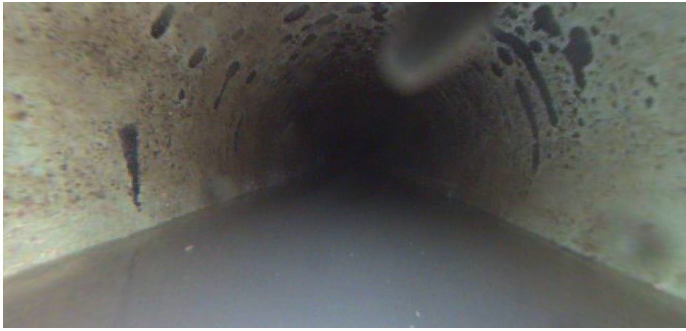
Code: **MWL**
Description: **Water Level**

Distance (ft): **78.5**
Structural Grade: **0**
O&M Grade: **0**
Clock Start/From:
Clock To:
1st Value:
2nd Value:
Value Percent: **30.000**
Continuous Index:
Within 8" of Joint: **NO**
Remarks:

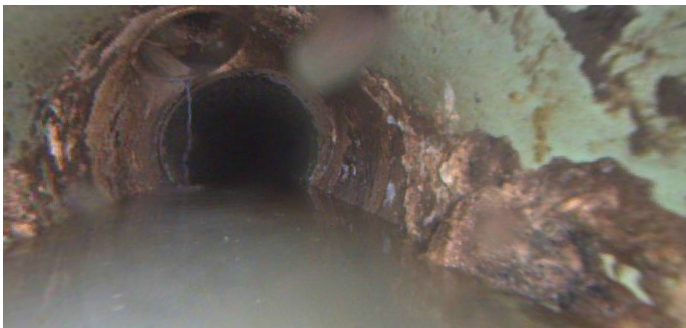
Code: **DAZ**
Description: **Deposits Attached Other**

Distance (ft): **154.7**
Structural Grade: **0**
O&M Grade: **2**
Clock Start/From: **3**
Clock To: **4**
1st Value:
2nd Value:
Value Percent: **10.000**
Continuous Index:
Within 8" of Joint: **NO**
Remarks: **Mixed materials**

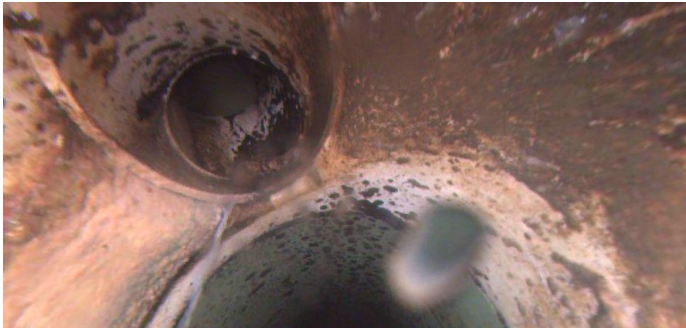
Code: **TFA**
Description: **Tap Factory Active**

Distance (ft): **155.8**
Structural Grade: **0**
O&M Grade: **0**
Clock Start/From: **11**
Clock To:
1st Value: **4.000**
2nd Value:
Value Percent:
Continuous Index:
Within 8" of Joint:
Remarks:

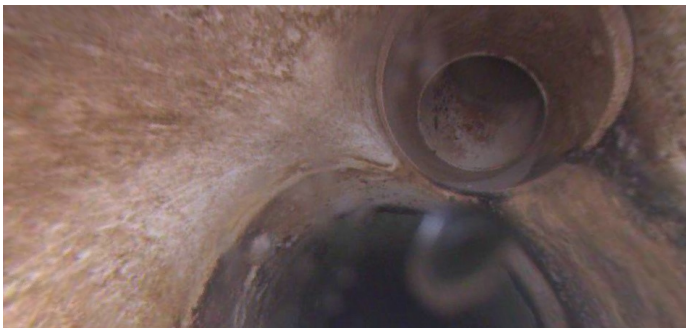
Code: **TF**
Description: **Tap Factory**

Distance (ft): **213.1**
Structural Grade: **0**
O&M Grade: **0**
Clock Start/From: **1**
Clock To:
1st Value: **4.000**
2nd Value:
Value Percent:
Continuous Index:
Within 8" of Joint:
Remarks:

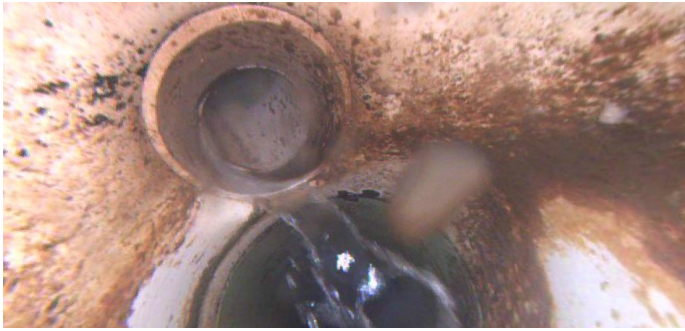
Code: **TFA**
Description: **Tap Factory Active**

Distance (ft): **221.9**
Structural Grade: **0**
O&M Grade: **0**
Clock Start/From: **11**
Clock To:
1st Value: **4.000**
2nd Value:
Value Percent:
Continuous Index:
Within 8" of Joint:
Remarks:

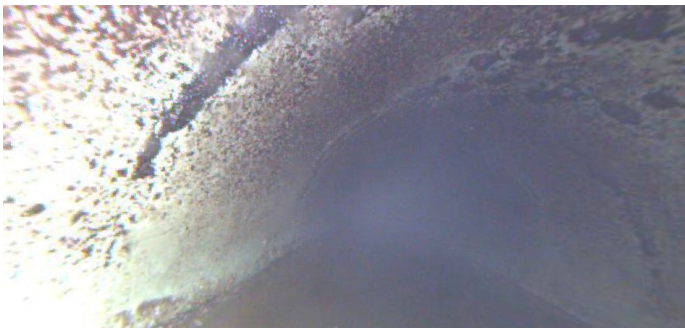
Code: **MSA**
Description: **Abandoned Survey**

Distance (ft): **242.0**
Structural Grade: **0**
O&M Grade: **0**
Clock Start/From:
Clock To:
1st Value:
2nd Value:
Value Percent:
Continuous Index:
Within 8" of Joint: **NO**
Remarks: **Unknown**
