Profile/Photo Observation Report

Street:	MERGANSE ST & KESTREL ST	Flow Control:	Not Controlled
City:	Hobart, IN	Year Renewed:	
Location:	Sidewalk	Tape/Media #:	
Purpose:	Maintenance Related	Dia/Height:	12"
Use:	Sanitary	Material:	PVC
Drain Area:	NA	Lining:	
Category:	NA		
Comment:	Reverse setup. Debris rollover at 19'.

Location Details:		Direction of Survey:	Downstream
US MH:	M-809-038	DS MH:	M-709-036
		Total Length Surveyed (ft):	20.5

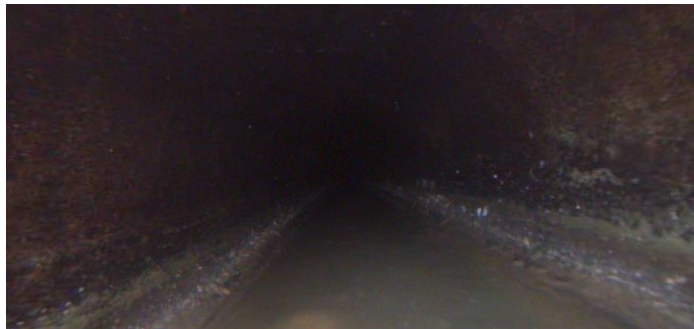
Code: **AMH**
Description: **Manhole**

Distance (ft): **.0**
Structural Grade: **0**
O&M Grade: **0**
Clock Start/From:
Clock To:
1st Value:
2nd Value:
Value Percent:
Continuous Index:
Within 8" of Joint: **NO**
Remarks: **M-809-038**

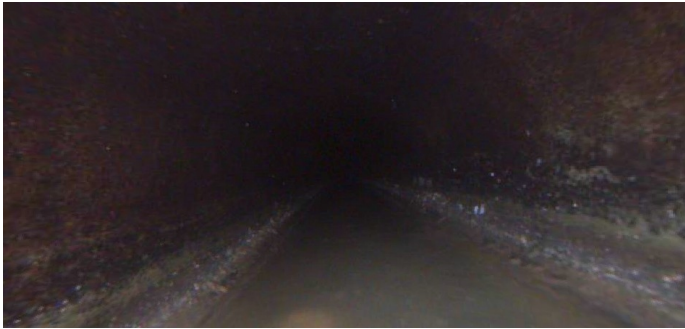
Code:	MWL
Description:	Water Level

Distance (ft):	.0
Structural Grade:	0
O&M Grade:	0
Clock Start/From:	
Clock To:	
1st Value:	
2nd Value:	
Value Percent:	15.000
Continuous Index:	
Within 8" of Joint:	NO
Remarks:

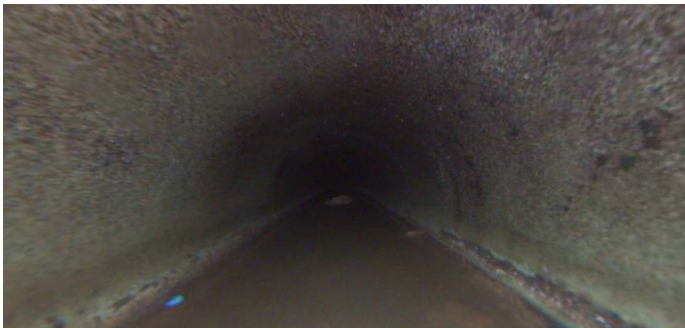
Code:	MWL
Description:	Water Level

Distance (ft):	16.7
Structural Grade:	0
O&M Grade:	0
Clock Start/From:	
Clock To:	
1st Value:	
2nd Value:	
Value Percent:	25.000
Continuous Index:	
Within 8" of Joint:	NO
Remarks:

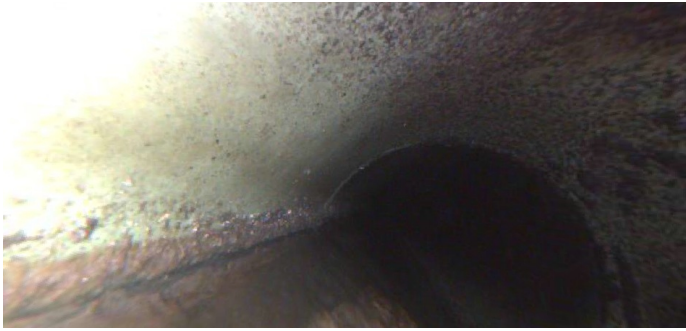
Code:	MSA
Description:	Abandoned Survey
Distance (ft):	20.5
Structural Grade:	0
O&M Grade:	0
Clock Start/From:	
Clock To:	
1st Value:	
2nd Value:	
Value Percent:	
Continuous Index:	
Within 8" of Joint:	NO
Remarks:	Unknown
