## Profile/Photo Observation Report

Street:	<b>Oak</b>	Flow Control:	<b>Not Controlled</b>
City:	<b>Hobart, IN</b>	Year Renewed:	
Location:	<b>Sidewalk</b>	Tape/Media #:	
Purpose:	<b>Maintenance Related</b>	Dia/Height:	<b>12"</b>
Use:	<b>Sanitary</b>	Material:	<b>PVC</b>
Drain Area:	<b>NA</b>	Lining:	
Category:	<b>NA</b>		
Comment:	<b>Reverse setup. Debris rollover at 19'.</b>

Location Details:		Direction of Survey:	<b>Downstream</b>
US MH:	<b>M-809-038</b>	DS MH:	<b>M-709-036</b>
		Total Length Surveyed (ft):	<b>20.5</b>

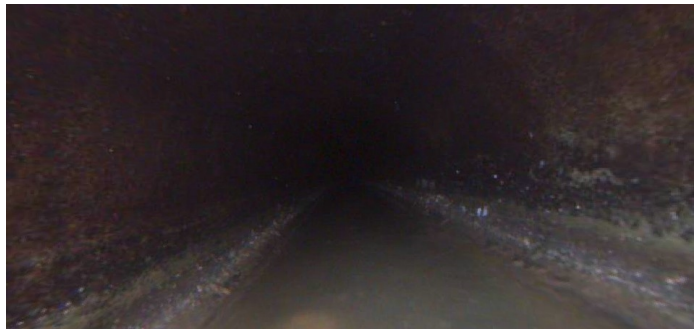
Code: **AMH**  
Description: **Manhole**

Distance (ft): **.0**  
Structural Grade: **0**  
O&M Grade: **0**  
Clock Start/From:  
Clock To:  
1st Value:  
2nd Value:  
Value Percent:  
Continuous Index:  
Within 8" of Joint: **NO**  
Remarks: **M-809-038**

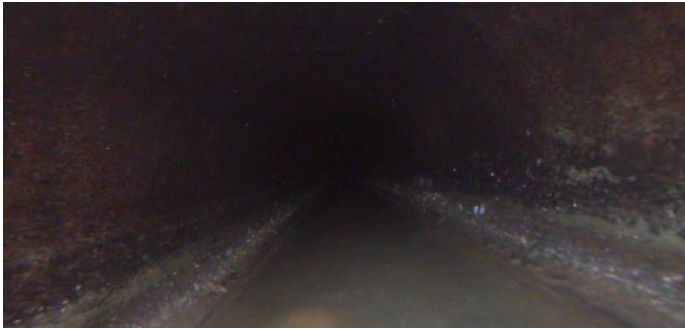
Code:	<b>MWL</b>
Description:	<b>Water Level</b>

Distance (ft):	<b>.0</b>
Structural Grade:	<b>0</b>
O&M Grade:	<b>0</b>
Clock Start/From:	
Clock To:	
1st Value:	
2nd Value:	
Value Percent:	<b>15.000</b>
Continuous Index:	
Within 8" of Joint:	<b>NO</b>
Remarks:

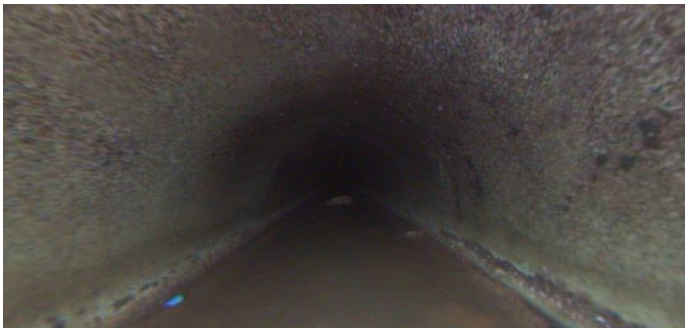
Code:	<b>MWL</b>
Description:	<b>Water Level</b>

Distance (ft):	<b>16.7</b>
Structural Grade:	<b>0</b>
O&M Grade:	<b>0</b>
Clock Start/From:	
Clock To:	
1st Value:	
2nd Value:	
Value Percent:	<b>25.000</b>
Continuous Index:	
Within 8" of Joint:	<b>NO</b>
Remarks:

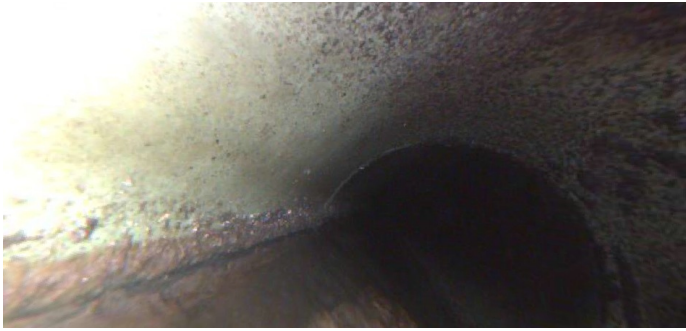
Code:	<b>MSA</b>
Description:	<b>Abandoned Survey</b>
Distance (ft):	<b>20.5</b>
Structural Grade:	<b>0</b>
O&M Grade:	<b>0</b>
Clock Start/From:	
Clock To:	
1st Value:	
2nd Value:	
Value Percent:	
Continuous Index:	
Within 8" of Joint:	<b>NO</b>
Remarks:	<b>Unknown</b>
