# Profile/Photo Observation Report

Date:	<b>03/20/2018</b>	Weather:		Coding:	<b>PACP 6.0</b>
Pipe Length (ft):	<b>86.9</b>	Owner:	<b>NA</b>	Pre Clean:	<b>Not Known</b>
P.O.#:		Surveyor:	<b>John Kuglmaier</b>	PSR:	<b>P-809-040-039</b>
Customer:		Clean Date:	<b>01/01/1900</b>	Shape:	<b>C</b>

Street:	<b>KESTREL ST</b>	Flow Control:	<b>Not Controlled</b>
City:	<b>Hobart, IN</b>	Year Renewed:	
Location:	<b>Sidewalk</b>	Tape/Media #:	
Purpose:	<b>Maintenance Related</b>	Dia/Height:	<b>8"</b>
Use:	<b>Sanitary</b>	Material:	<b>PVC</b>
Drain Area:	<b>NA</b>	Lining:	
Category:	<b>NA</b>		
Comment:	<b>mh, flow direction incorrect.</b>		
Location Details:		Direction of Survey:	<b>Upstream</b>
US MH:	<b>M-809-039</b>	DS MH:	<b>M-809-040</b>
		Total Length Surveyed (ft):	<b>86.1</b>

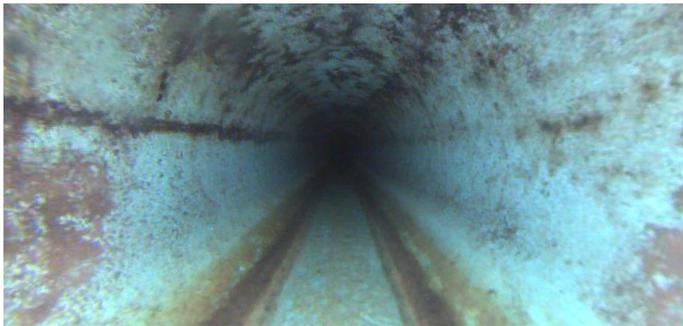
Code: **AMH**  
Description: **Manhole**

Distance (ft): **.0**  
Structural Grade: **0**  
O&M Grade: **0**  
Clock Start/From:  
Clock To:  
1st Value:  
2nd Value:  
Value Percent:  
Continuous Index:  
Within 8" of Joint: **NO**  
Remarks: **M-809-040**

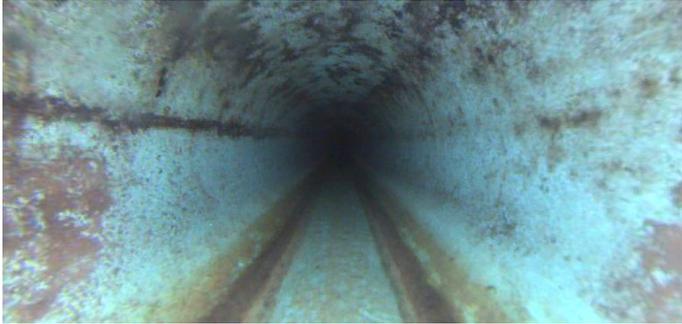
Code: **MWL**  
Description: **Water Level**

Distance (ft): **.0**  
Structural Grade: **0**  
O&M Grade: **0**  
Clock Start/From:  
Clock To:  
1st Value:  
2nd Value:  
Value Percent: **10.000**  
Continuous Index:  
Within 8" of Joint: **NO**  
Remarks:

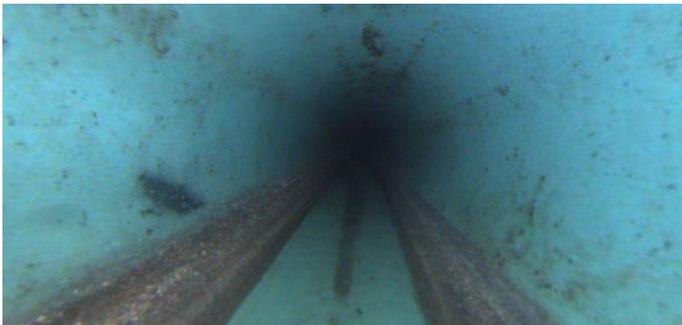
Code: **DAGS**  
Description: **Deposits Attached Grease**

Distance (ft): **29.4**  
Structural Grade: **0**  
O&M Grade: **2**  
Clock Start/From: **4**  
Clock To: **8**  
1st Value:  
2nd Value:  
Value Percent: **10.000**  
Continuous Index: **S01**  
Within 8" of Joint: **NO**  
Remarks:

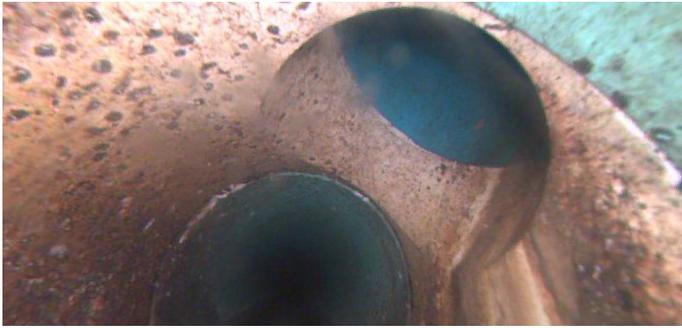
Code: **TF**  
Description: **Tap Factory**

Distance (ft): **33.9**  
Structural Grade: **0**  
O&M Grade: **0**  
Clock Start/From: **2**  
Clock To:  
1st Value: **4.000**  
2nd Value:  
Value Percent:  
Continuous Index:  
Within 8" of Joint:  
Remarks:

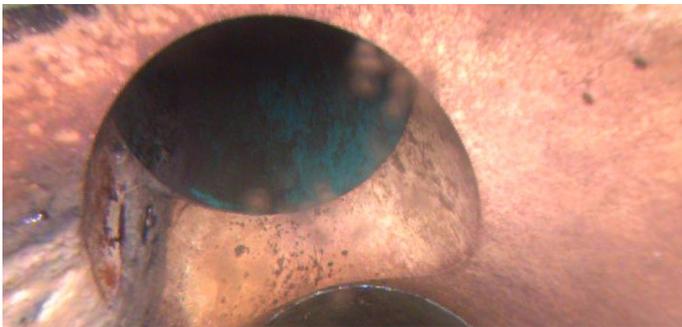
Code: **TF**  
Description: **Tap Factory**

Distance (ft): **57.8**  
Structural Grade: **0**  
O&M Grade: **0**  
Clock Start/From: **11**  
Clock To:  
1st Value: **4.000**  
2nd Value:  
Value Percent:  
Continuous Index:  
Within 8" of Joint:  
Remarks:

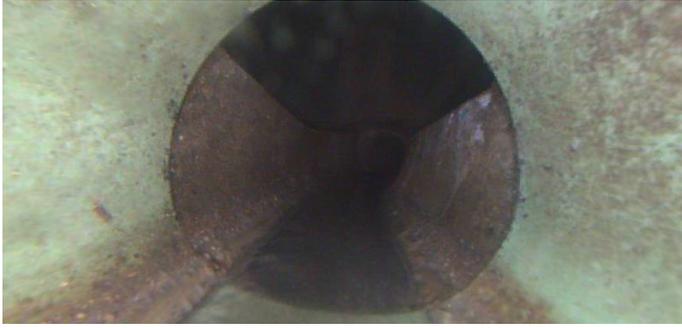
Code: **DAGS**  
Description: **Deposits Attached Grease**

Distance (ft): **83.7**  
Structural Grade: **0**  
O&M Grade: **2**  
Clock Start/From: **4**  
Clock To: **8**  
1st Value:  
2nd Value:  
Value Percent: **10.000**  
Continuous Index: **F01**  
Within 8" of Joint: **NO**  
Remarks: **Clock positions vary**

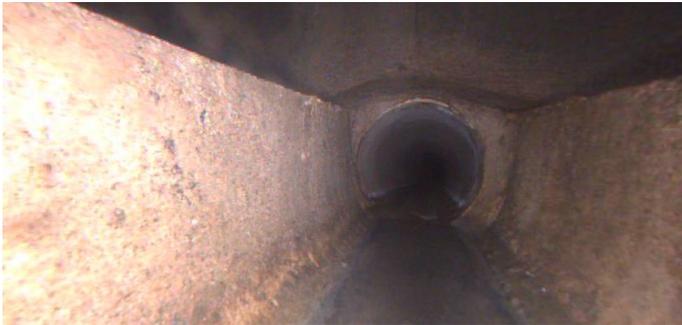
Code: **AMH**  
Description: **Manhole**

Distance (ft): **86.1**  
Structural Grade: **0**  
O&M Grade: **0**  
Clock Start/From:  
Clock To:  
1st Value:  
2nd Value:  
Value Percent:  
Continuous Index:  
Within 8" of Joint: **NO**  
Remarks: **M-809-039**
