## Profile/Photo Observation Report

Street:	<b>KESTREL ST</b>	Flow Control:	<b>Not Controlled</b>
City:	<b>Hobart, IN</b>	Year Renewed:	
Location:	<b>Sidewalk</b>	Tape/Media #:	
Purpose:	<b>Maintenance Related</b>	Dia/Height:	<b>8"</b>
Use:	<b>Sanitary</b>	Material:	<b>PVC</b>
Drain Area:	<b>NA</b>	Lining:	
Category:	<b>NA</b>		
Comment:	<b>debris at 5'. flow direction is wrong.</b>

Location Details:		Direction of Survey:	<b>Downstream</b>
US MH:	<b>M-809-040</b>	DS MH:	<b>M-809-041</b>
		Total Length Surveyed (ft):	<b>6.1</b>

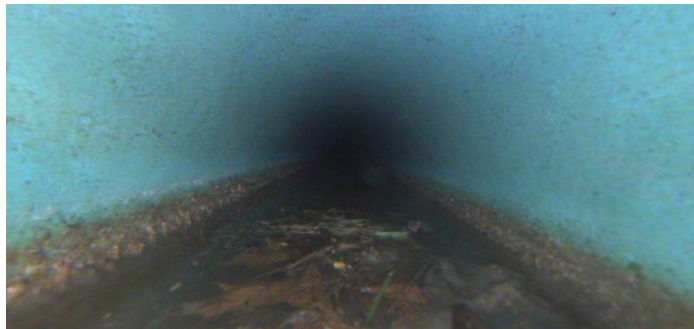
Code: **AMH**  
Description: **Manhole**

Distance (ft): **.0**  
Structural Grade: **0**  
O&M Grade: **0**  
Clock Start/From:  
Clock To:  
1st Value:  
2nd Value:  
Value Percent:  
Continuous Index:  
Within 8" of Joint: **NO**  
Remarks: **M-809-040**

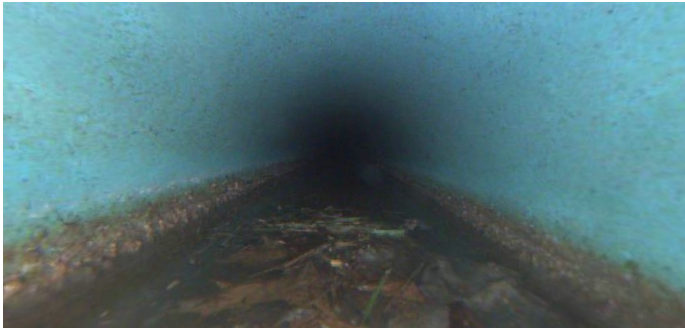
Code:	<b>MWL</b>
Description:	<b>Water Level</b>

Distance (ft):	<b>.0</b>
Structural Grade:	<b>0</b>
O&M Grade:	<b>0</b>
Clock Start/From:	
Clock To:	
1st Value:	
2nd Value:	
Value Percent:	<b>25.000</b>
Continuous Index:	
Within 8" of Joint:	<b>NO</b>
Remarks:

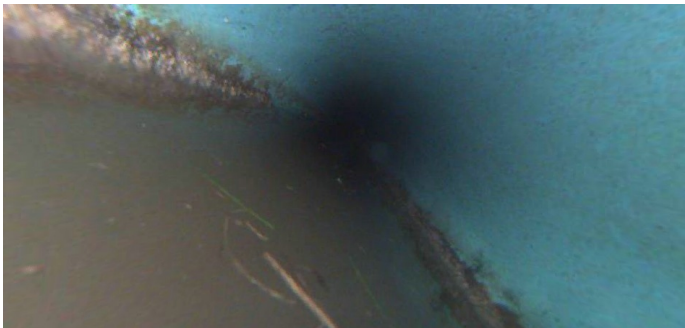
Code:	<b>MSA</b>
Description:	<b>Abandoned Survey</b>

Distance (ft):	<b>6.1</b>
Structural Grade:	<b>0</b>
O&M Grade:	<b>0</b>
Clock Start/From:	
Clock To:	
1st Value:	
2nd Value:	
Value Percent:	
Continuous Index:	
Within 8" of Joint:	<b>NO</b>
Remarks:	<b>Unknown</b>
