Profile/Photo Observation Report

Street:	Oak	Flow Control:	Not Controlled
City:	Hobart, IN	Year Renewed:	
Location:	Sidewalk	Tape/Media #:	
Purpose:	Maintenance Related	Dia/Height:	8"
Use:	Sanitary	Material:	PVC
Drain Area:	NA	Lining:	
Category:	NA		
Comment:	debris at 5'. flow direction is wrong.

Location Details:		Direction of Survey:	Downstream
US MH:	M-809-040	DS MH:	M-809-041
		Total Length Surveyed (ft):	6.1

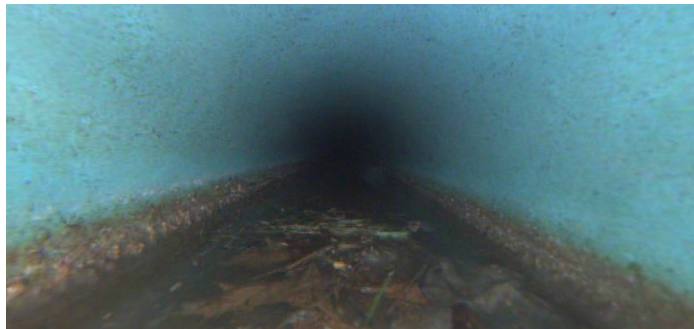
Code: **AMH**
Description: **Manhole**

Distance (ft): **.0**
Structural Grade: **0**
O&M Grade: **0**
Clock Start/From:
Clock To:
1st Value:
2nd Value:
Value Percent:
Continuous Index:
Within 8" of Joint: **NO**
Remarks: **M-809-040**

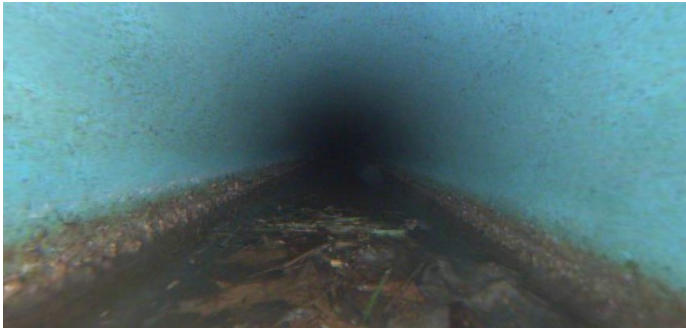
Code:	MWL
Description:	Water Level

Distance (ft):	.0
Structural Grade:	0
O&M Grade:	0
Clock Start/From:	
Clock To:	
1st Value:	
2nd Value:	
Value Percent:	25.000
Continuous Index:	
Within 8" of Joint:	NO
Remarks:

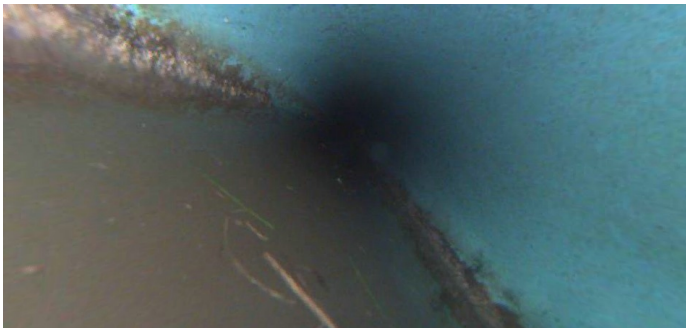
Code:	MSA
Description:	Abandoned Survey

Distance (ft):	6.1
Structural Grade:	0
O&M Grade:	0
Clock Start/From:	
Clock To:	
1st Value:	
2nd Value:	
Value Percent:	
Continuous Index:	
Within 8" of Joint:	NO
Remarks:	Unknown
